Flight control system event involving Cessna 210N, VH-JHF

48 km West of Bourke Airport, New South Wales | 12 September 2011

ATSB Transport Safety Report
Aviation Occurrence Investigation
AO-2011-115
Final – 16 August 2013

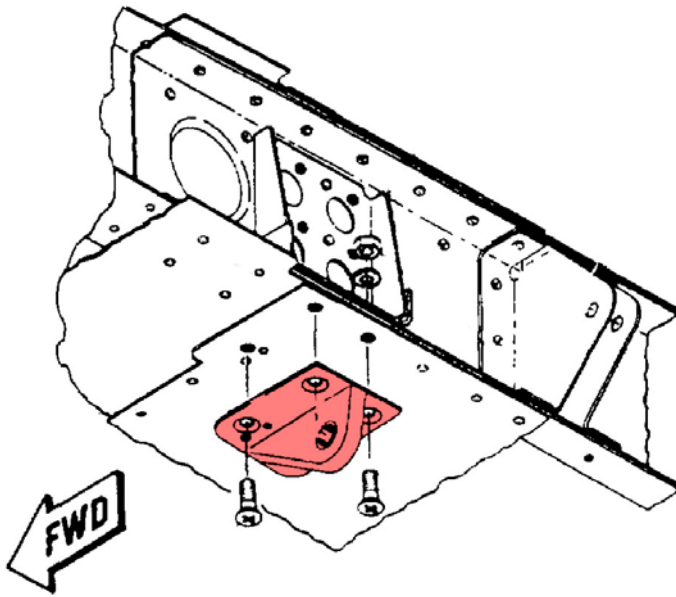
Figure 2: Rear attachment bracket installation

The horizontal stabiliser was secured at the rear by two attachment brackets (part number 1232400, Figure 2). The manufacturer's specifications identified the brackets as being machined from extruded 2024-T3511 aluminium alloy, finished with a conversion coating and paint primer, and having a press-fit bushing installed through the attachment bolt hole. The ATSB's metallurgical assessment of the failed parts found that both conformed to specifications, with the exception that the surface of both was unpainted. The reason for the absence of paint was not determined.

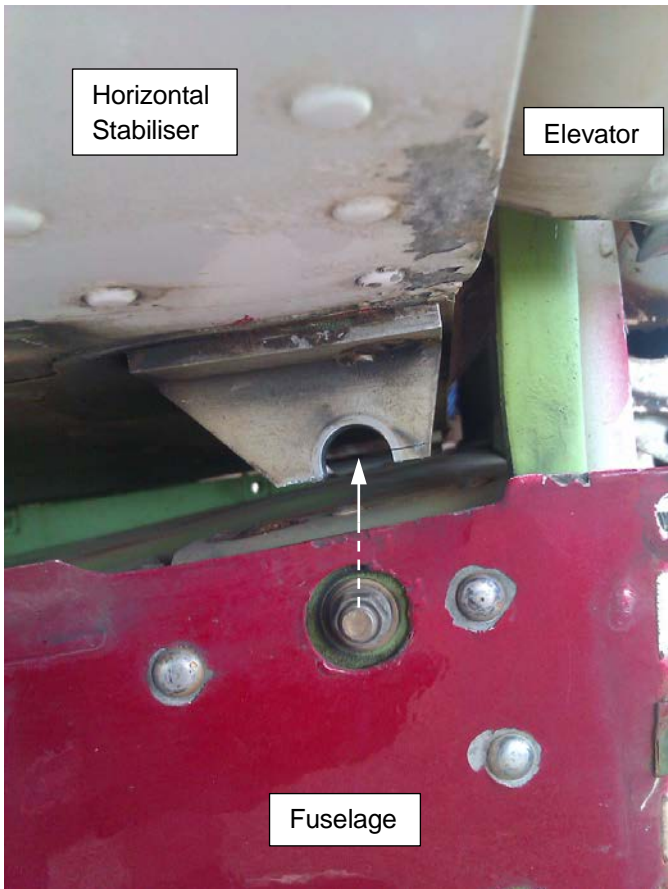
Figure 3: Fractured left bracket, separated from attachment bolt

The left bracket (Figure 3) had fractured across both sides of the bolt hole and no longer provided any support for the stabiliser. The fracture surfaces displayed features consistent with intergranular corrosion and fatigue crack progression (Figure 4). General contamination of the forward fracture surface suggested that the section had failed at some time prior to the incident flight. The right bracket had only fractured through the section forward of the bolt hole (Figure 5) and retained some structural integrity. Separation of the fracture surfaces within the ATSB's laboratories found evidence of fatigue crack progression and a similar level of contamination and staining to the fracture on the left.

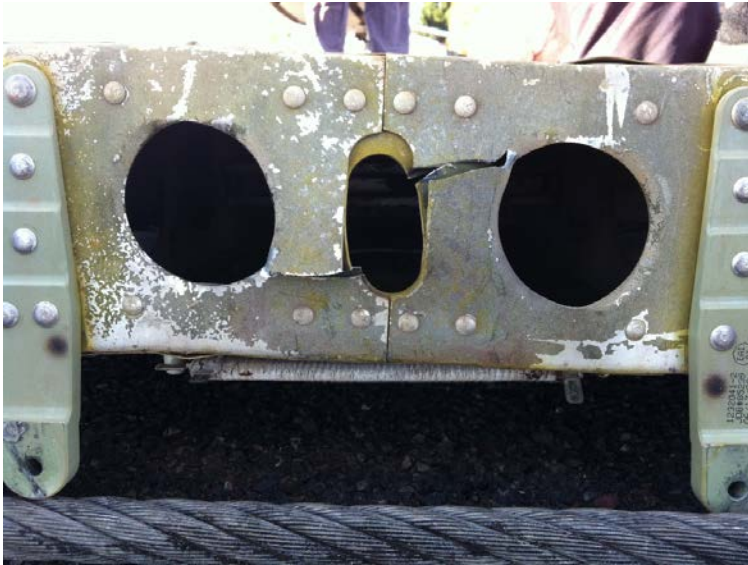
Figure 6: Horizontal stabiliser forward spar

The horizontal stabiliser forward spar assembly had fractured between the centre and adjacent lightening holes (Figure 6). The forward spar was not examined by the ATSB; however, the appearance and location of the cracking visible in photographs of the spar was consistent with that described in Cessna’s mandatory service bulletin SEB02-4 and the associated CASA airworthiness directive AD/CESSNA 210/69.

AD/CESSNA 210/69 amendment 2 was released in September 2004 and related to the inspection of the horizontal stabiliser front spar assembly for cracking between the centre section lightening holes. The inspection was to be carried out prior to the airframe reaching 10,000 hours total time in service and every 110 hours service thereafter. The aircraft maintainer reported that the spar had been inspected per the AD at the required intervals.
