Derailment of train 7SP3

Roto, New South Wales | 4 March 2012

ATSB Transport Safety Report
Rail Occurrence Investigation
RO-2012-002
Final – 30 August 2013

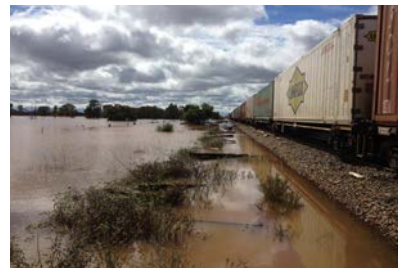
Floodwater adjacent to track

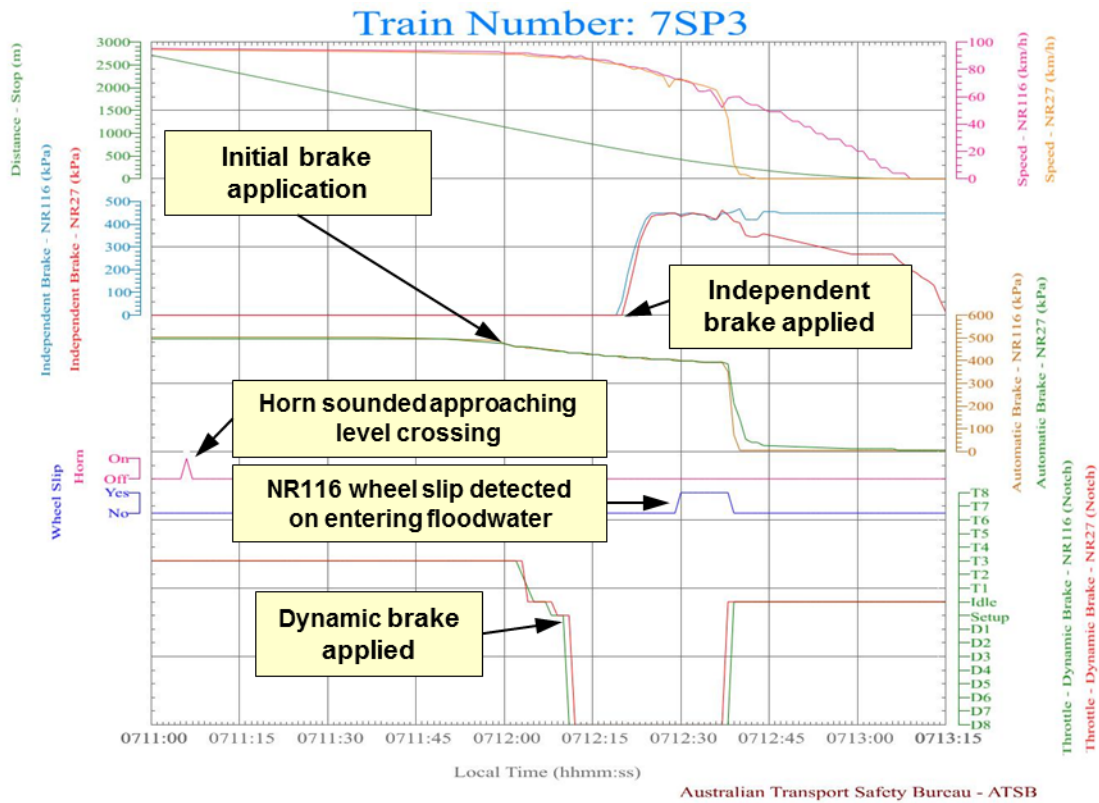
Figure 3: Data logger composite plot for locomotives NR116 and NR27 of train 7SP3

Shortly after the brake application the mentor driver intervened: he moved over to the controls and applied full dynamic braking. He followed this with a full application of the independent brake and service brake (Figure 3). At that point, the mentor driver resumed his seat and instructed the trainee driver to brace, should the train not stop before entering the water.

The train was unable to stop and as the lead locomotive (NR116) traversed the floodwater, the crew reported that the locomotive hit two distinct dips in the track that were about 25 m apart. The drivers felt a significant impact as the locomotive exited each dip, with the second being more severe and resulting in water covering the locomotive windscreen. As the train progressed through the water the lead locomotive remained on track, but the trailing locomotive, (NR27) uncoupled and collided with the rear of the lead locomotive.

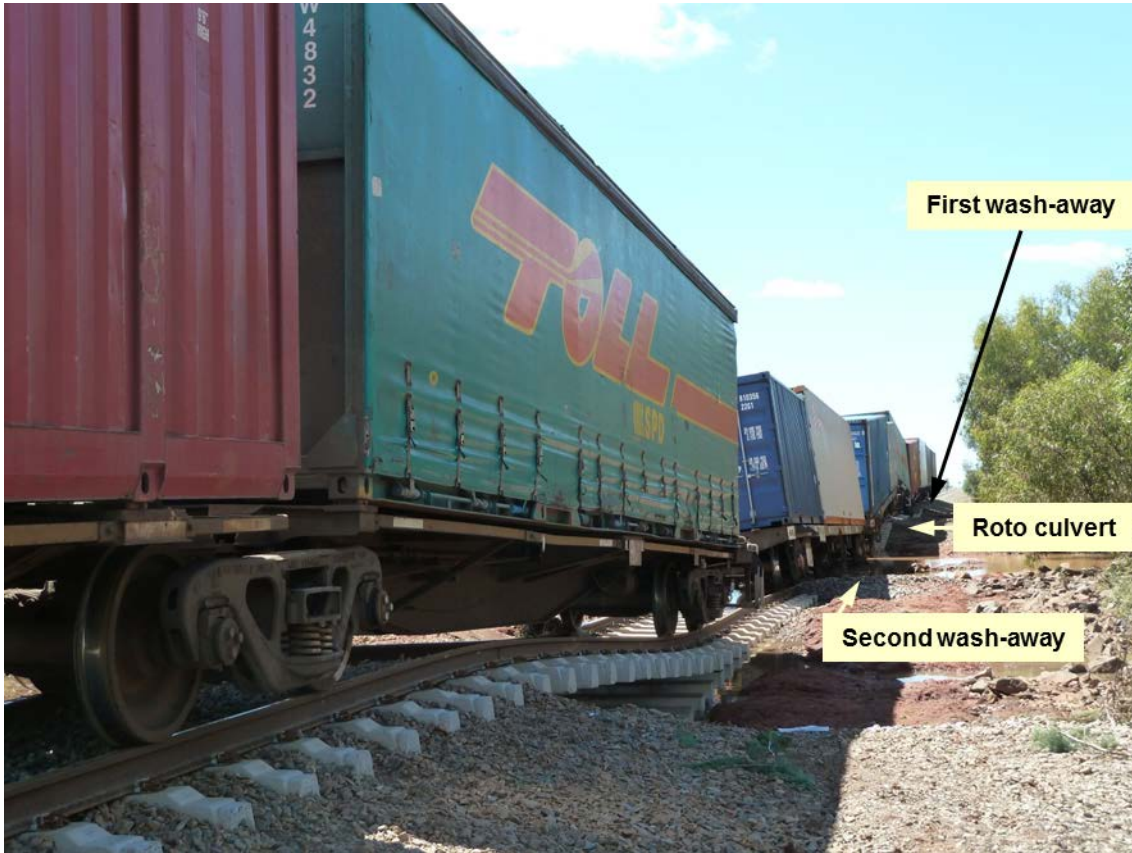
Figure 5: Wash-away damage to track formation adjacent Roto culvert, viewed toward Roto (note the same perspective to Figure 4)

The ATSB determined that runoff from the heavy rain that had fallen in the catchment area adjacent to Roto the morning of 4 March 2012 caused a flash flood event. The volume of floodwater exceeded the capacity of a drainage culvert, which resulted in water overtopping the track formation with ballast and sub-grade scouring on either side of the culvert.

The magnitude of the scouring meant that the track could not support the weight of train 7SP3 as it passed over the affected areas. The resulting deformation in the alignment of the track initiated the derailment.

After floodwaters receded, repairs to the locomotives and remaining wagons of train 7SP3 were completed. At about 0750 on Thursday 8 March 2012, PN completed the removal of all rail vehicles from the derailment site. Transfield maintenance personnel undertook repairs to the washed out formation and damaged concrete sleepers (Figure 5). At about 1230 on Friday 9 March 2012, Transfield staff completed repairs and reopened the track.

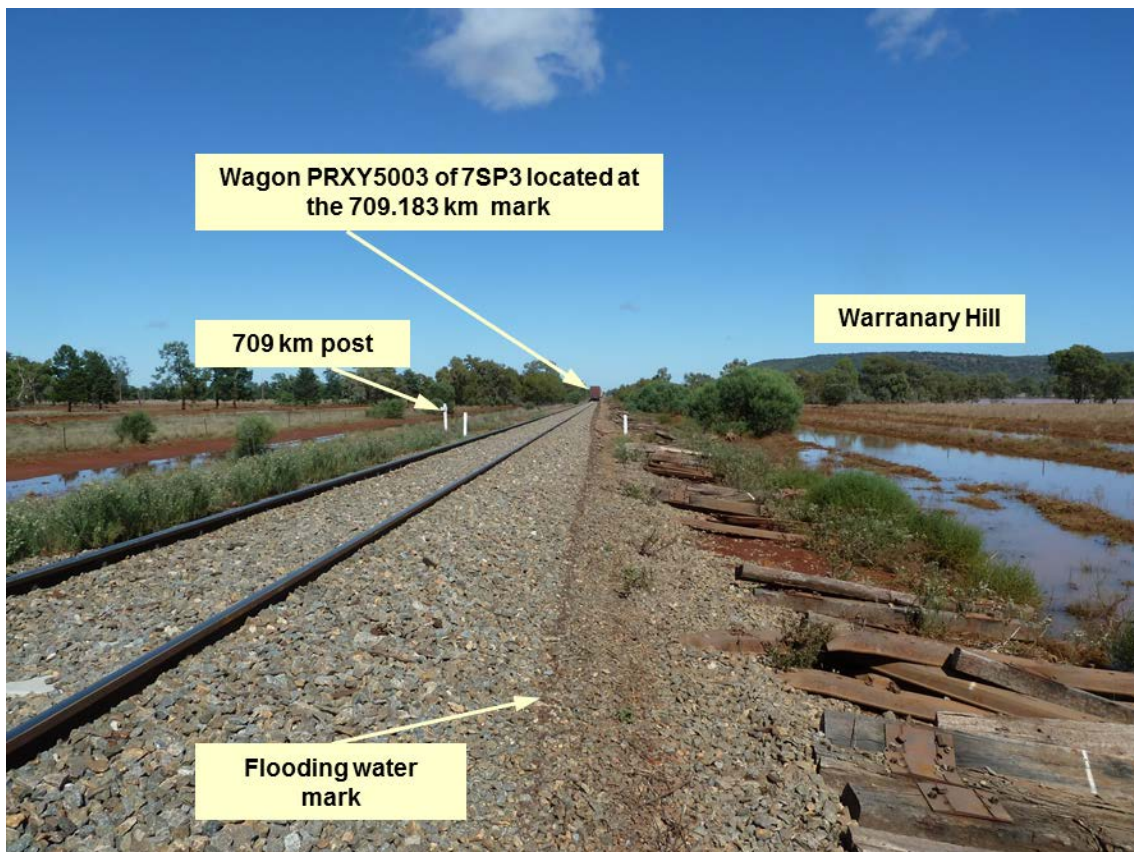
Figure 7: Flooding water mark on northern face of formation, viewed from the east of the wash-away site.

Rainwater runoff resulted in the pooling of water against the track formation at a number of locations between Parkes and Broken Hill. The extent of flooding that occurred near the derailment site at Roto area was evident by the water debris mark on the track formation extending both east and west of the wash-away site (Figure 7).

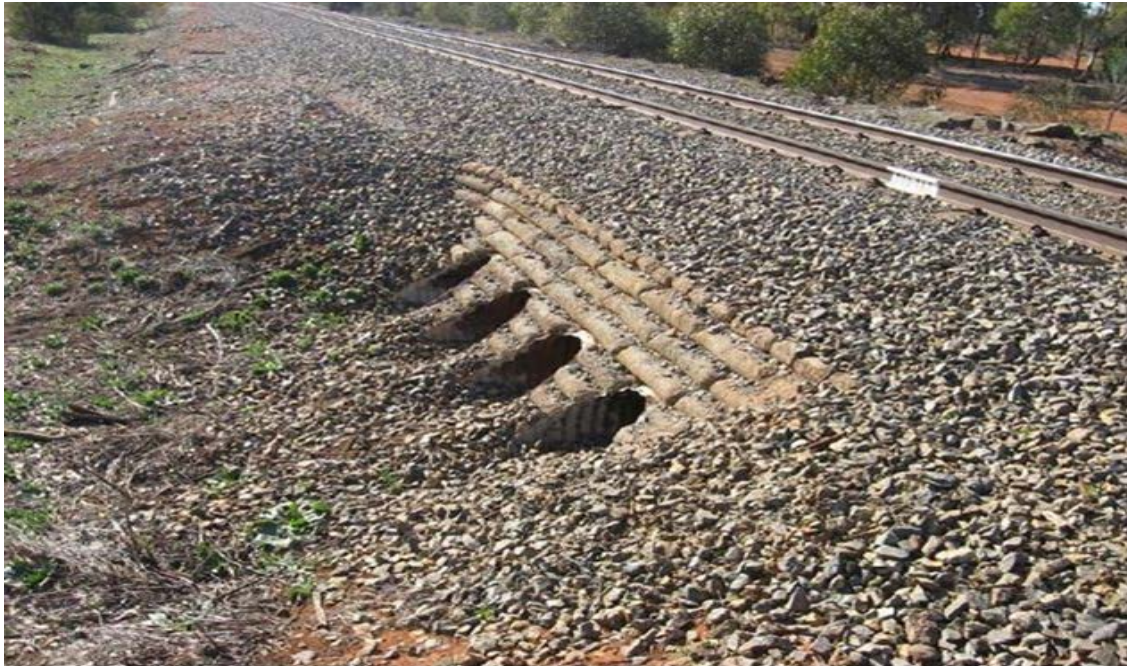
Figure 8: Roto Culvert, northern side view¹²

The drainage system in the Roto area included a series of small under-track culverts installed at intervals along the track to drain the rainwater runoff from the catchment situated to the north of the railway. The culverts each consisted of a group of four 600 mm diameter corrugated metal pipes. The small under-track culvert located at the 709.187 km mark, adjacent to the derailment site, was the only culvert to sustain significant damage because of the runoff of rainwater on the morning of 4 March 2012 (Figure 8).
