**Australian Transport Safety Bureau**

AVIATION SAFETY INVESTIGATION REPORT

200302820

**Model R22 Mariner**

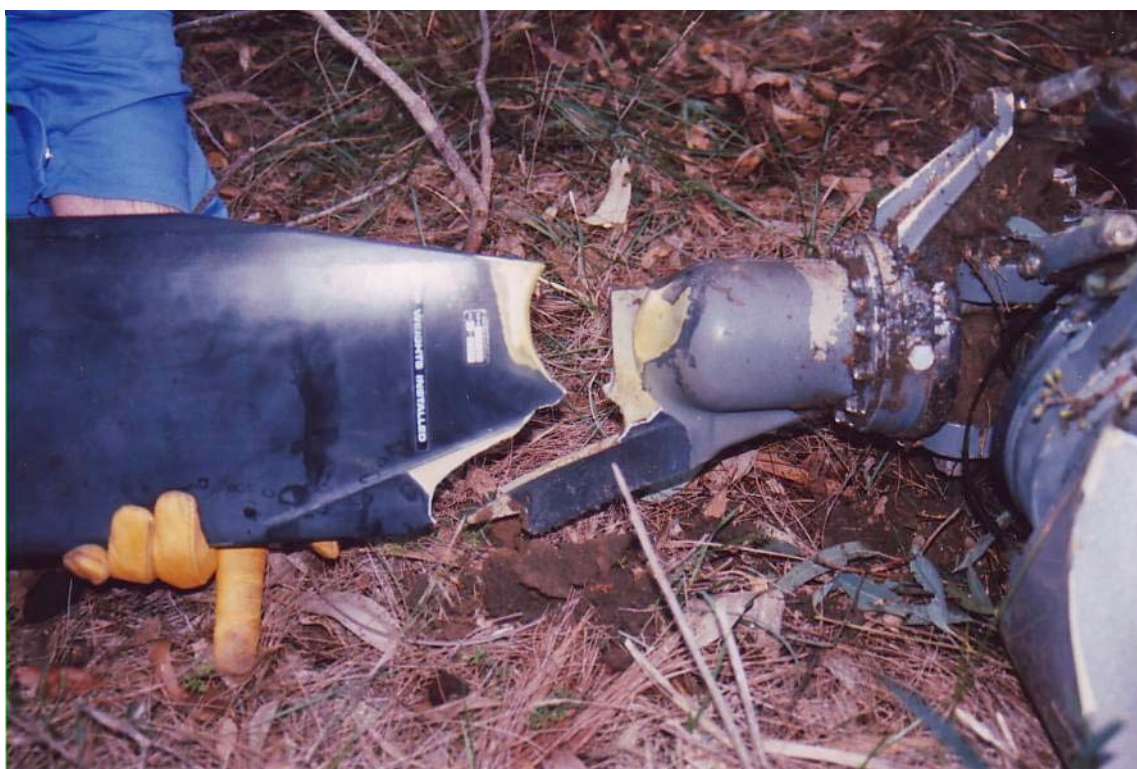
**Figure 2: Failed 'blue' main rotor blade**

The helicopter was destroyed by in-flight break-up and impact forces. Subsequent examination and analysis revealed that the 'blue'<sup>1</sup> main rotor blade, serial number 6249A, had failed in flight (see Figure 2). That failure is further addressed at section 1.16.

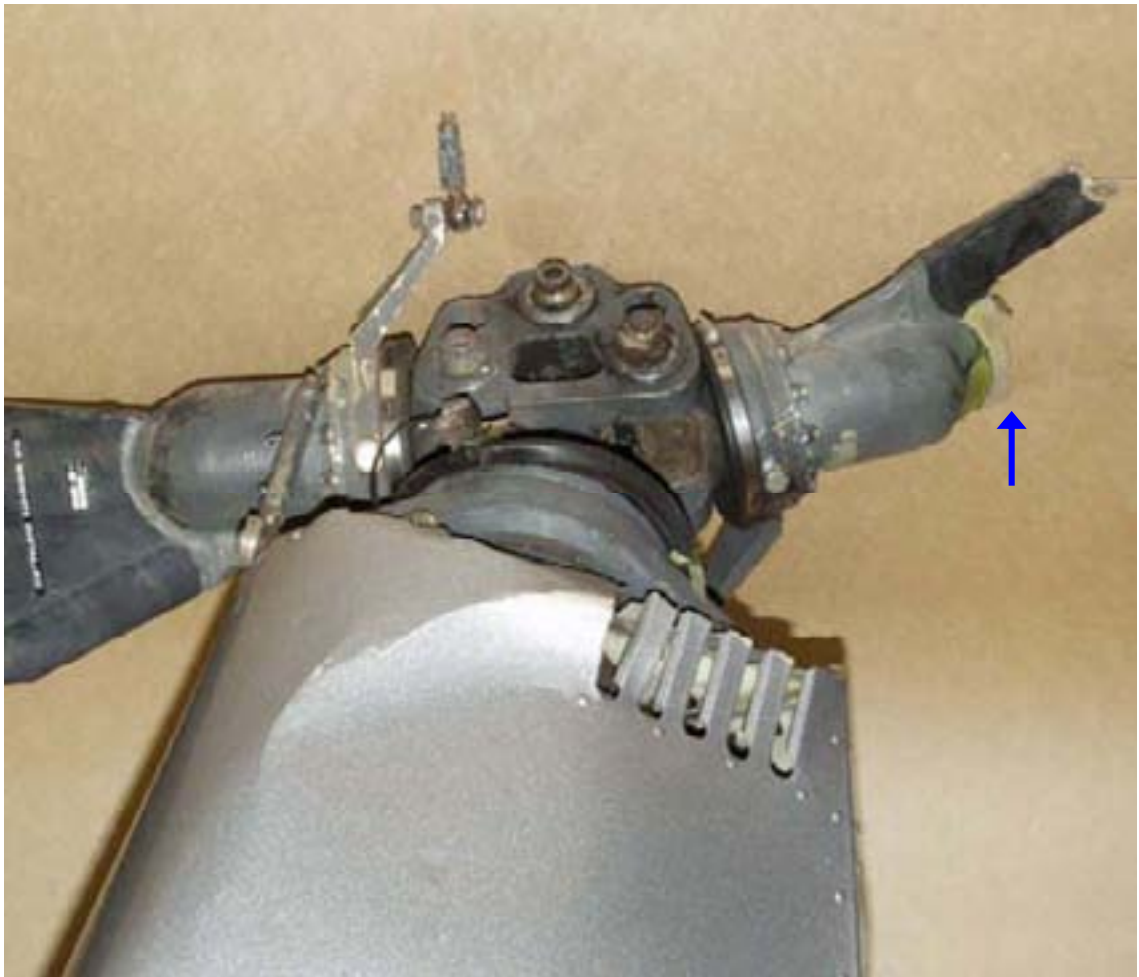
**Figure 1: The recovered main rotor head assembly, VH-OHA**

The fracture location (arrowed) is located at rotor station (RS) 10.35, the location of the inboard bolthole in the fitting to spar joint.

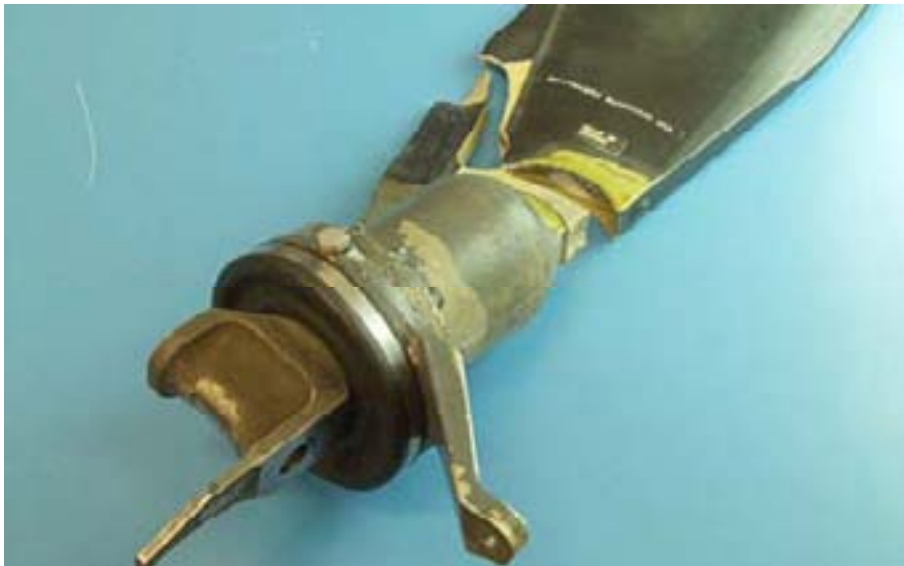
**Figure 2: The fractured main rotor blade, VH-OHA**

The lower surface of the main rotor blade (painted black) is shown in this figure. The upper surface of the blade is painted white.

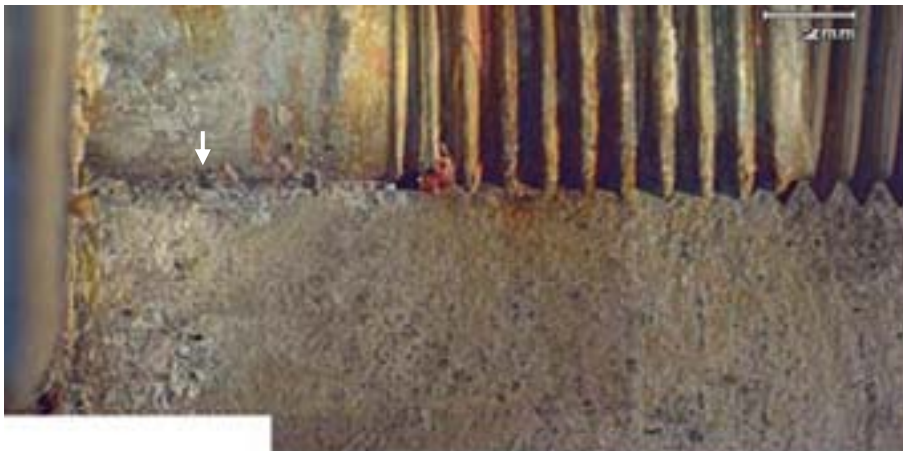
b) Lower side of the bolthole with the bolt in situ. The site of fatigue crack initiation is arrowed

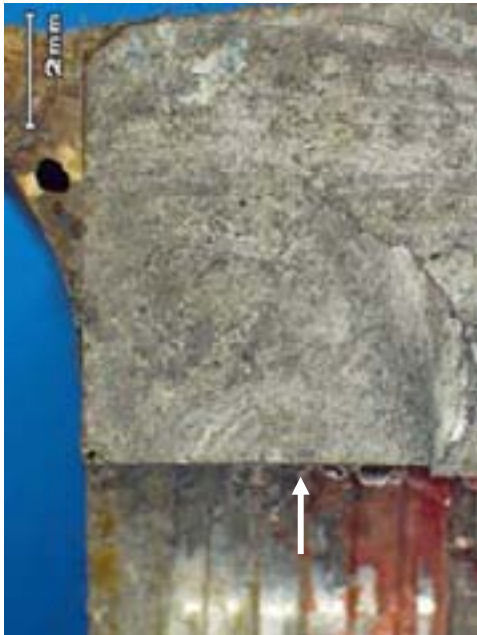
a) Third initiation site, crack growth from this site was influenced by the presence of the crack growing from second initiation site

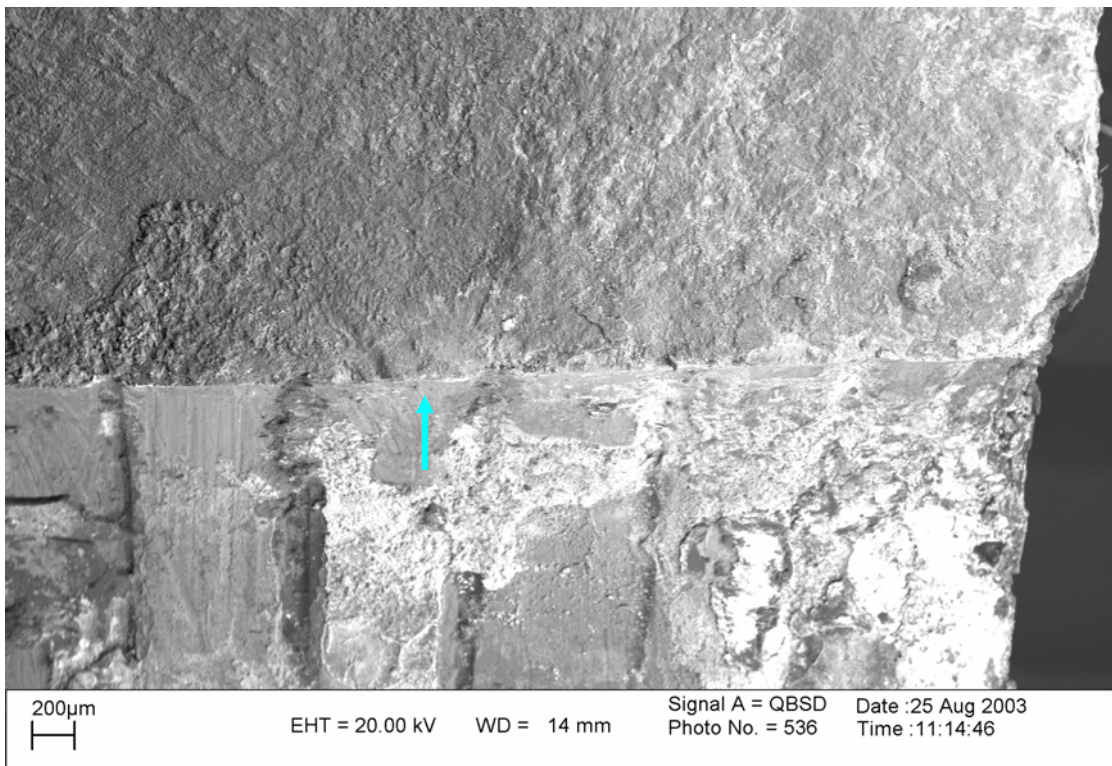
**Figure 8: Scanning electron micrograph of the first initiation site**

Fatigue crack initiation was associated with localised corrosion. It was not associated with the remnant of the thread.

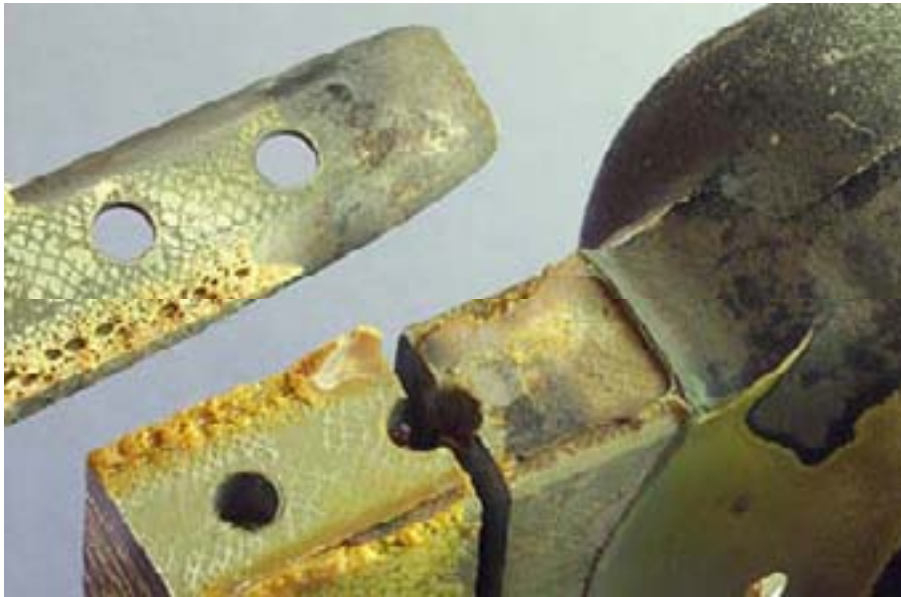
**Figure 12: The extent of disbonding between the spar and root fitting, blade s/n 6249A**

a) The spar and blade skins were removed mechanically from the remnant of the root fitting attached to the blade. Regions of adhesive fractured during this process can be discerned by colour (light cream) and texture (rough) from regions of inservice bond failure (dark honey, generally smooth surface)

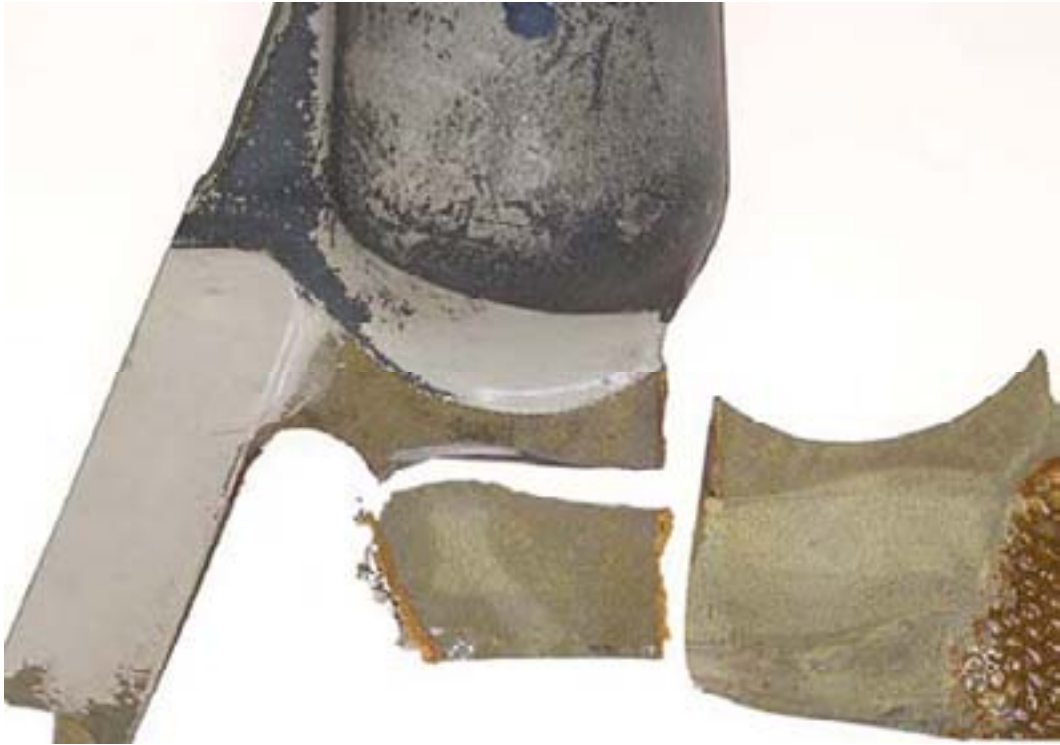
a) Disbonding extends from the inboard edge of the skin to the fracture. The paint film on the root fitting was badly weathered

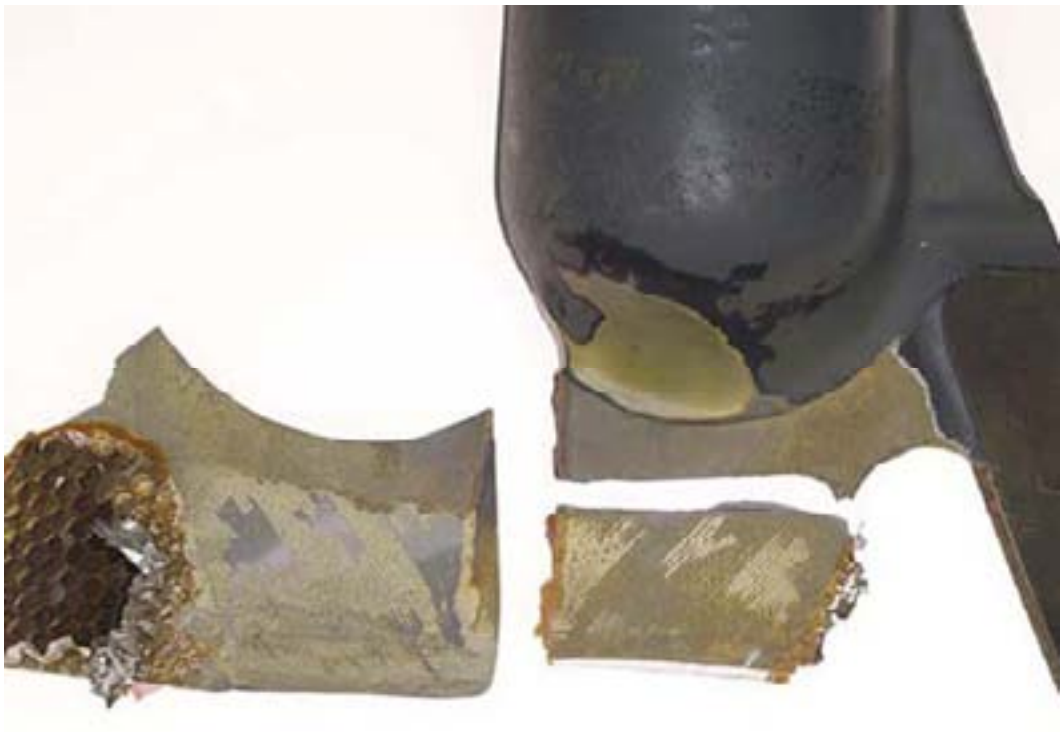
b) Disbonding extends from the inboard edge of the skin to the fracture

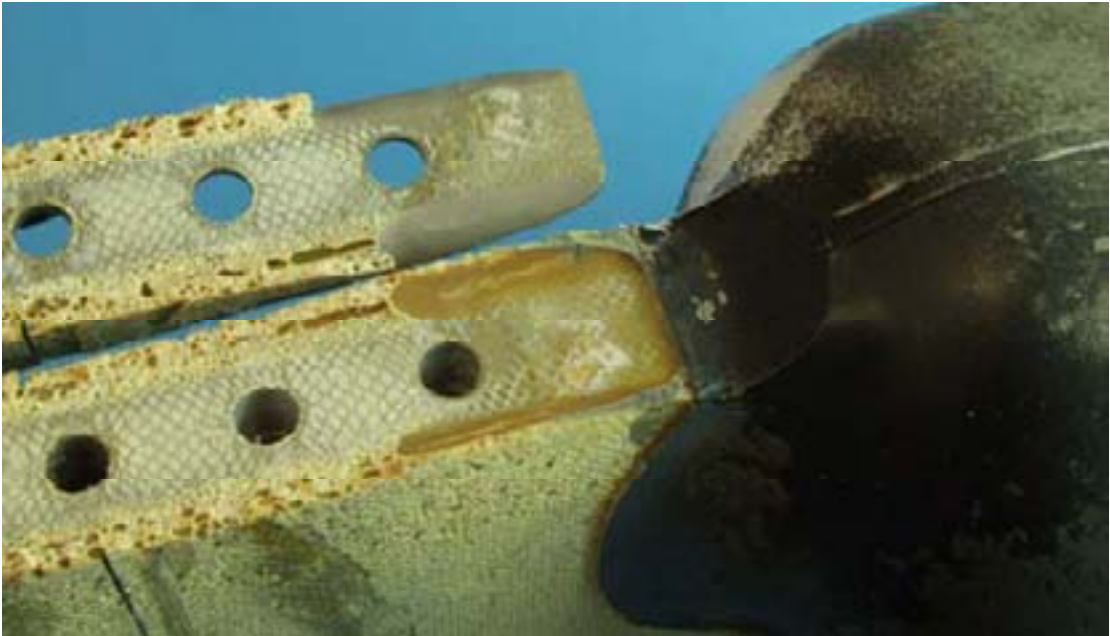
**Figure 14: Extent of adhesive disbond in blade s/n 6283A (VH-OHA)**

a) Disbonding has extended from the end of the spar to the edge of the inboard bolthole

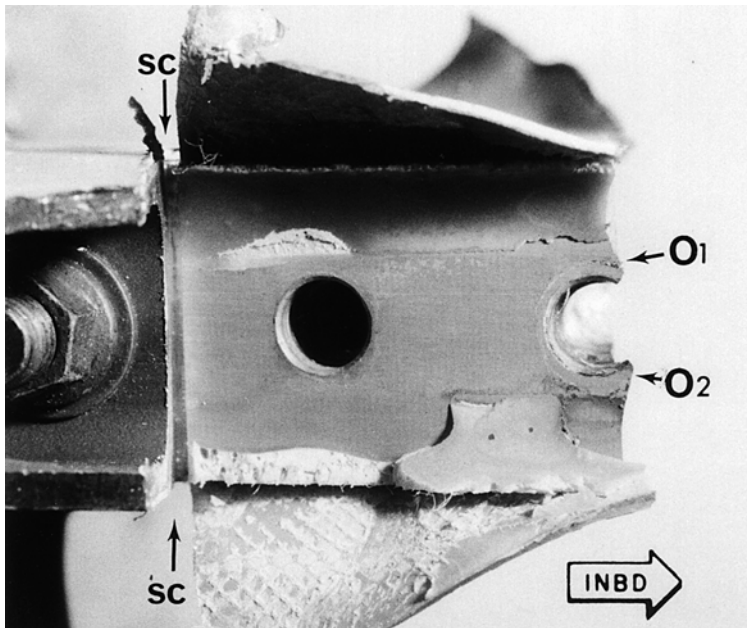
c) The spars of blades manufactured to the configuration of A016-1 were not adhesively bonded to the fitting

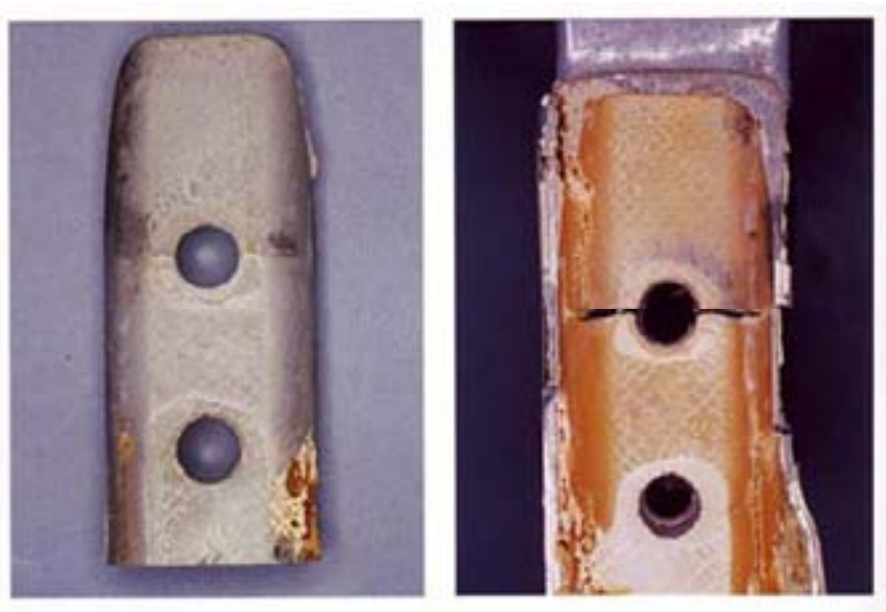
a) Fractured blade 9278B

**Figure 24: Photographs showing the extent of disbonding between the spar and fitting for both blades fitted to the helicopter (VH-LDR)**

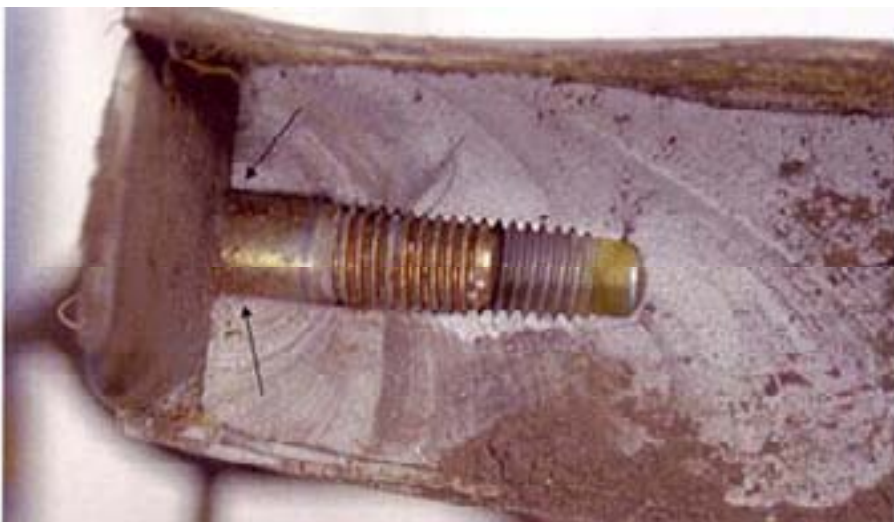
b) "The arrows indicate the location of the fracture origins on both sides of the bolt hole very close to the leading edge"

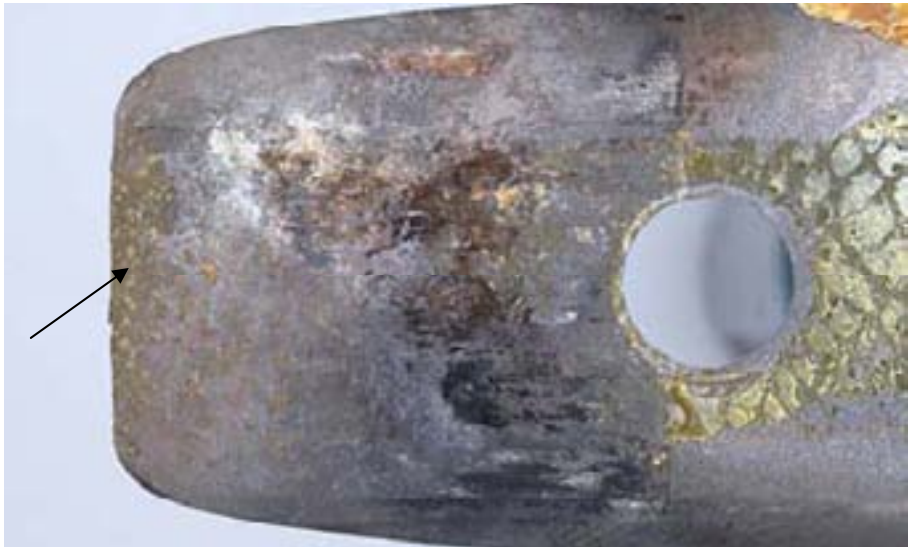
a) VH-OHA fractured blade, adhesive bonded to the spar, at the spar end is arrowed

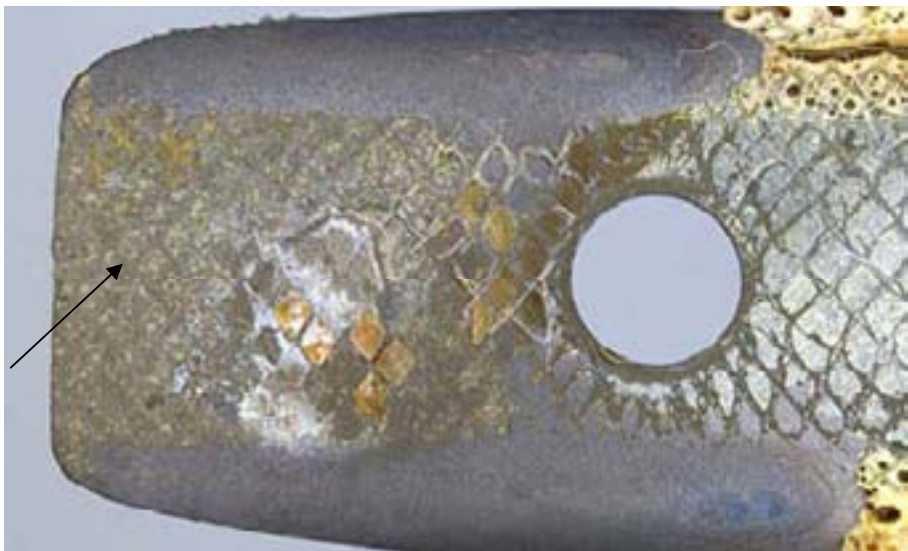
b) VH-OHA intact blade, adhesive bonded to the spar, at the spar end is arrowed

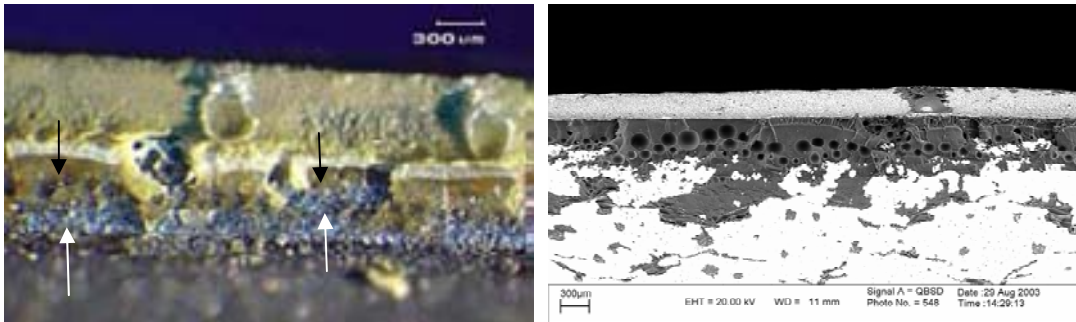
a) VH-HCO, s/n 11277B, the extent of fatigue cracking is arrowed (light micrograph at left, scanning electron micrograph at right)

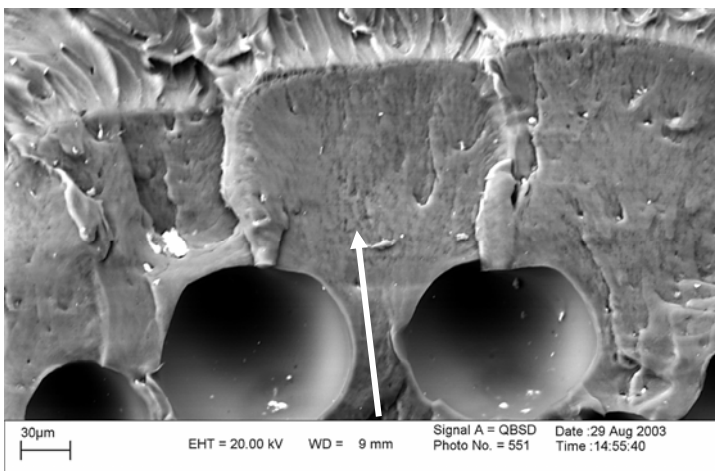
b) VH-HCO, s/n 11277B, the direction of fatigue crack growth is arrowed

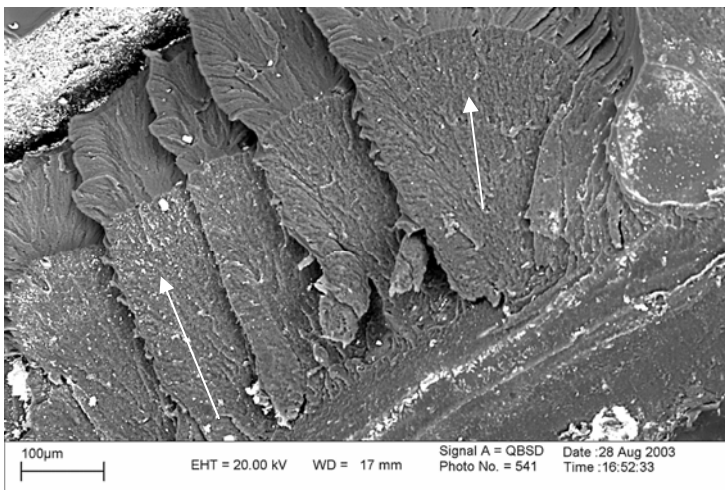
c) VH-LOT, s/n 8411B, the direction of fatigue crack growth is arrowed

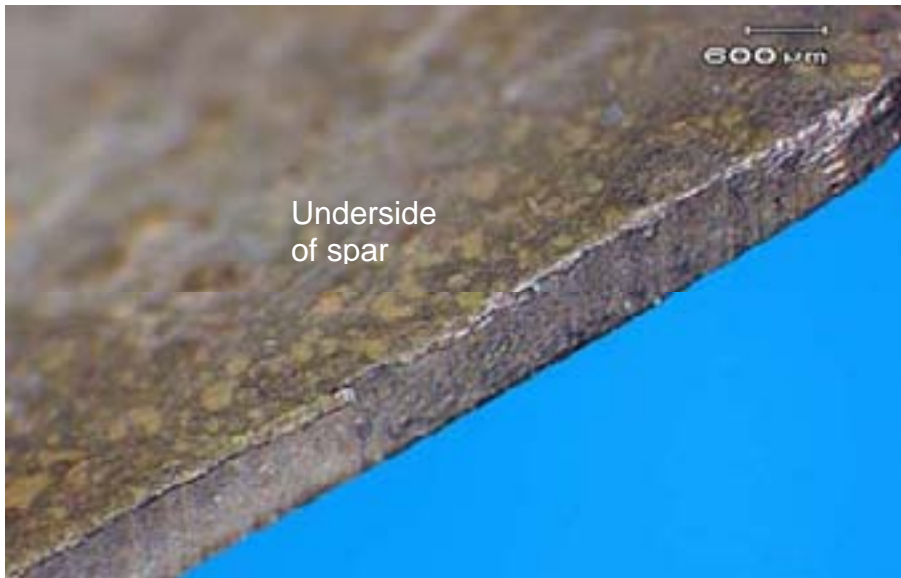
a) VH-OHA, s/n 6249A, fractured blade, showing a sharp corner between the spar end and the bonded surface, and, in addition, minimal surface roughening by grit blasting

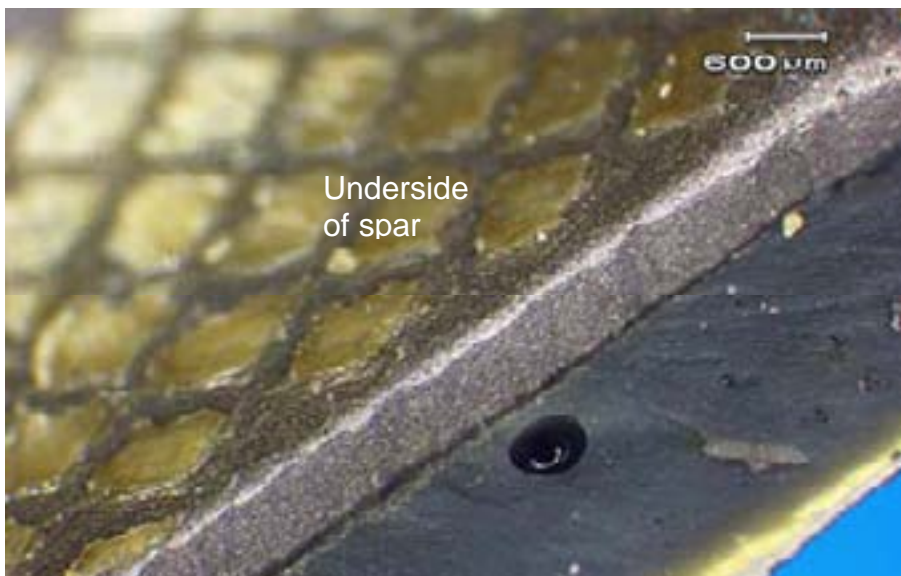
b) Blade s/n 8603B, showing a rounded corner between the spar end and bonded surface, plus surface roughening by grit blasting

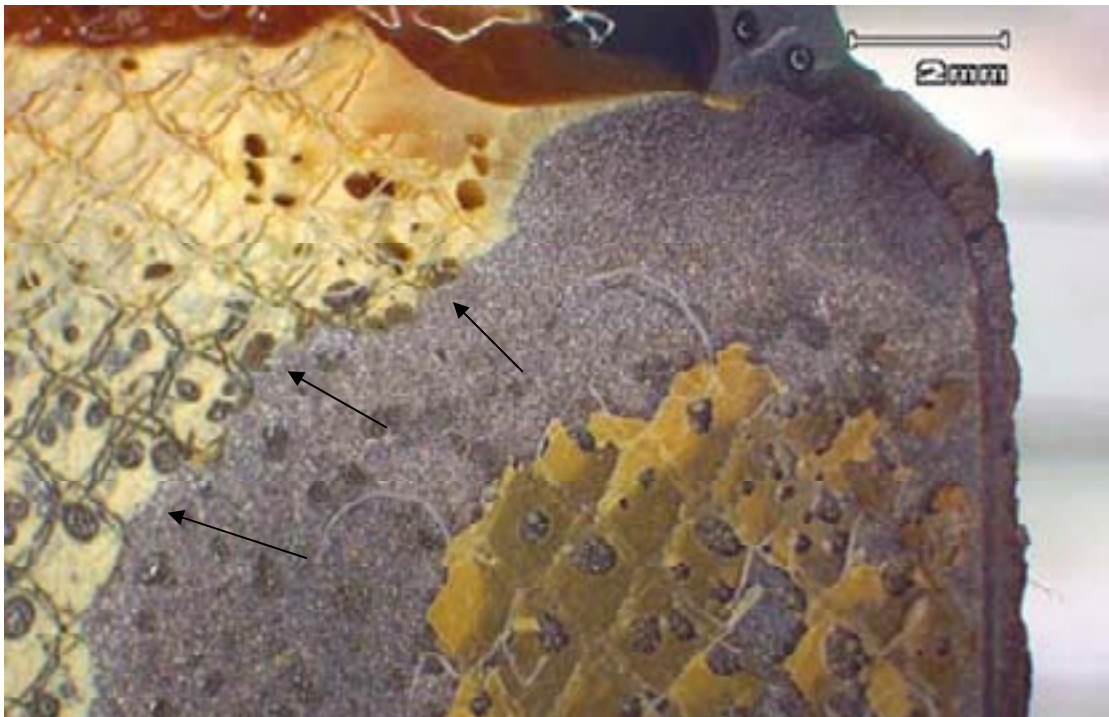
a) The disbond boundary is arrowed.

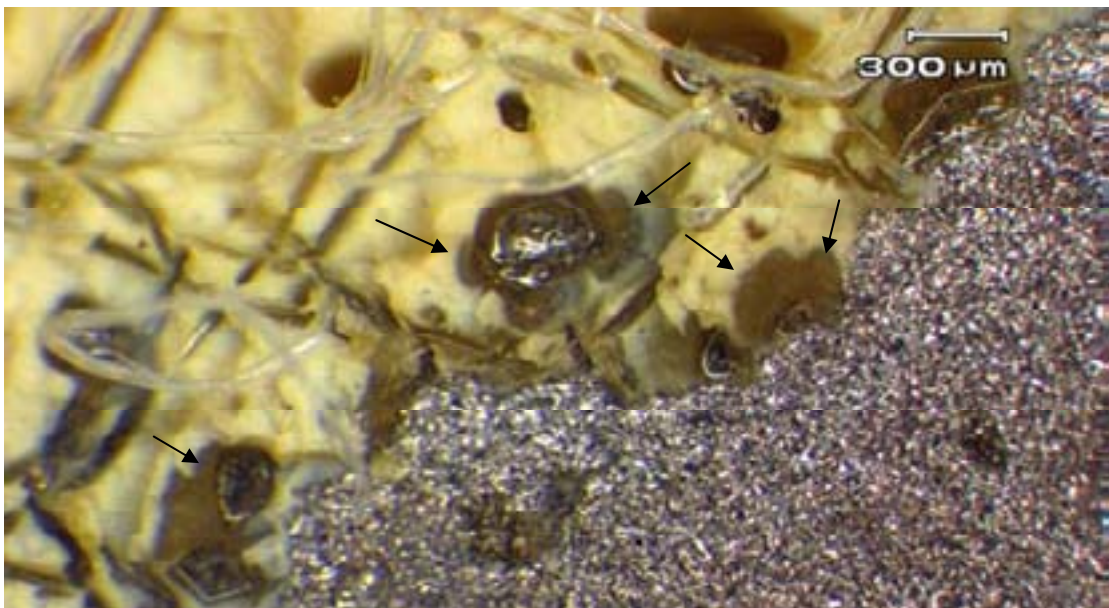
b) Regions of crack growth from voids near the disbond boundary are coloured darker than the region of fracture induced in the adhesive during strip down, examples are arrowed. The clear fibres are from the scrim fabric used in the manufacture of the adhesive film.

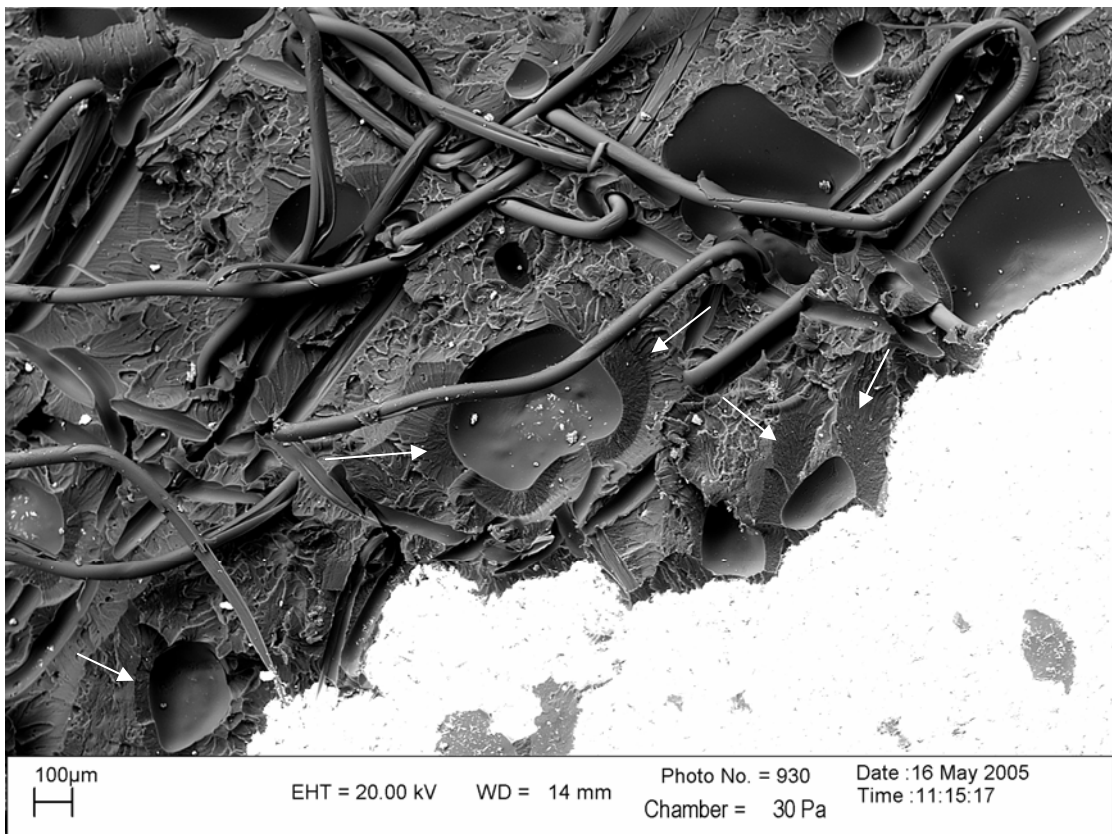
a) Regions of crack growth from voids near the disbond boundary are arrowed

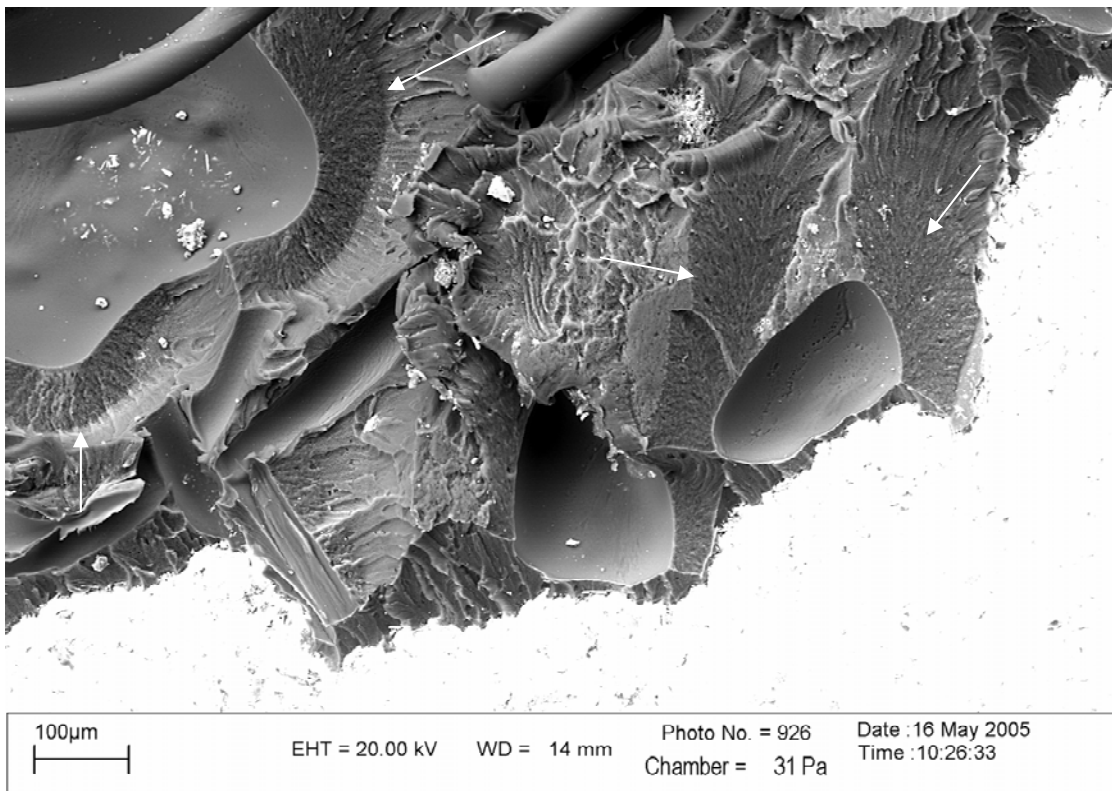
b) Region of Figure 40a at higher magnification, crack growth from voids is arrowed,

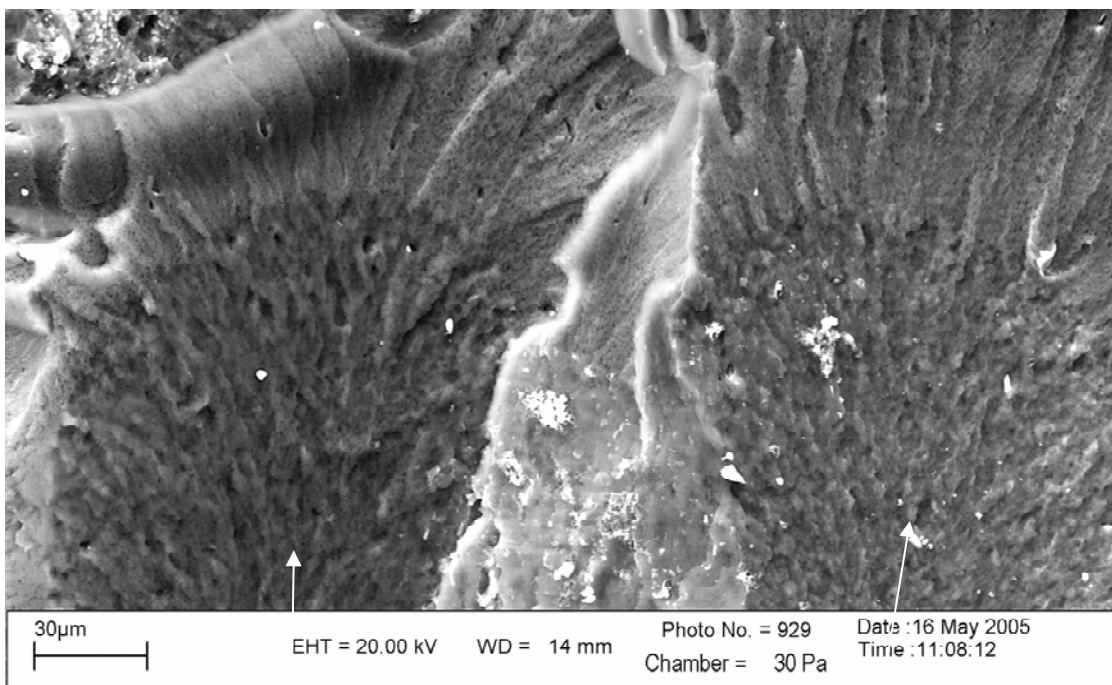
c) The boundary between a region of progressive crack growth (lower half of the micrograph) and induced tearing (upper half of the micrograph), the direction of crack growth is arrowed

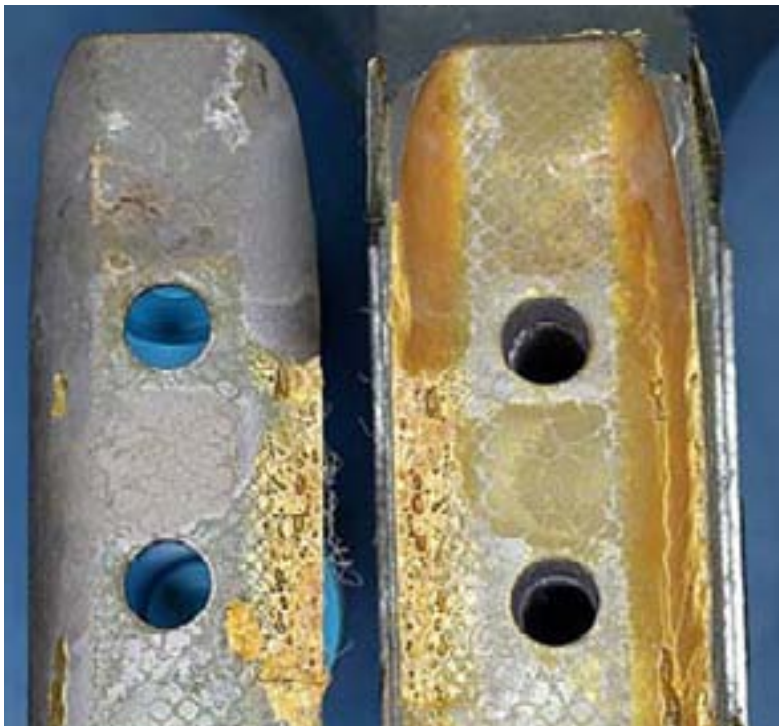
b) VH-LOT, s/n 8414B. Extensive disbonding has occurred, including disbonding between the two boltholes. However disbonding has not extended to the edge of the inboard bolthole.

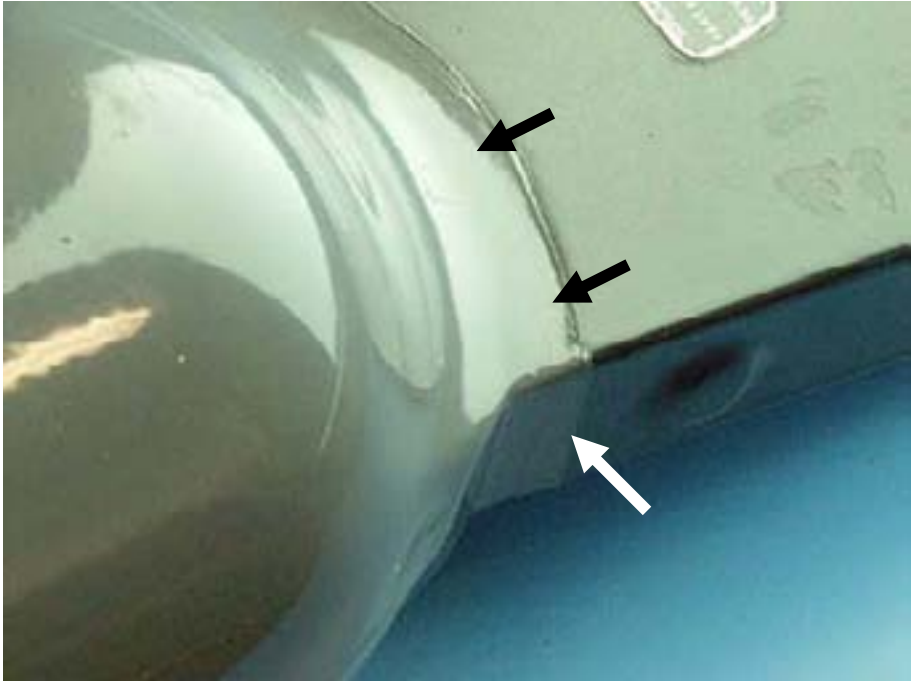
Figure 3. Cracks in filler at the end of the spar and lower skin
