Derailment of freight train 331

Lowdina, Tasmania | 9 April 2013

ATSB Transport Safety Report
Rail Occurrence Investigation
RO-2013-012
Final – 15 October 2013

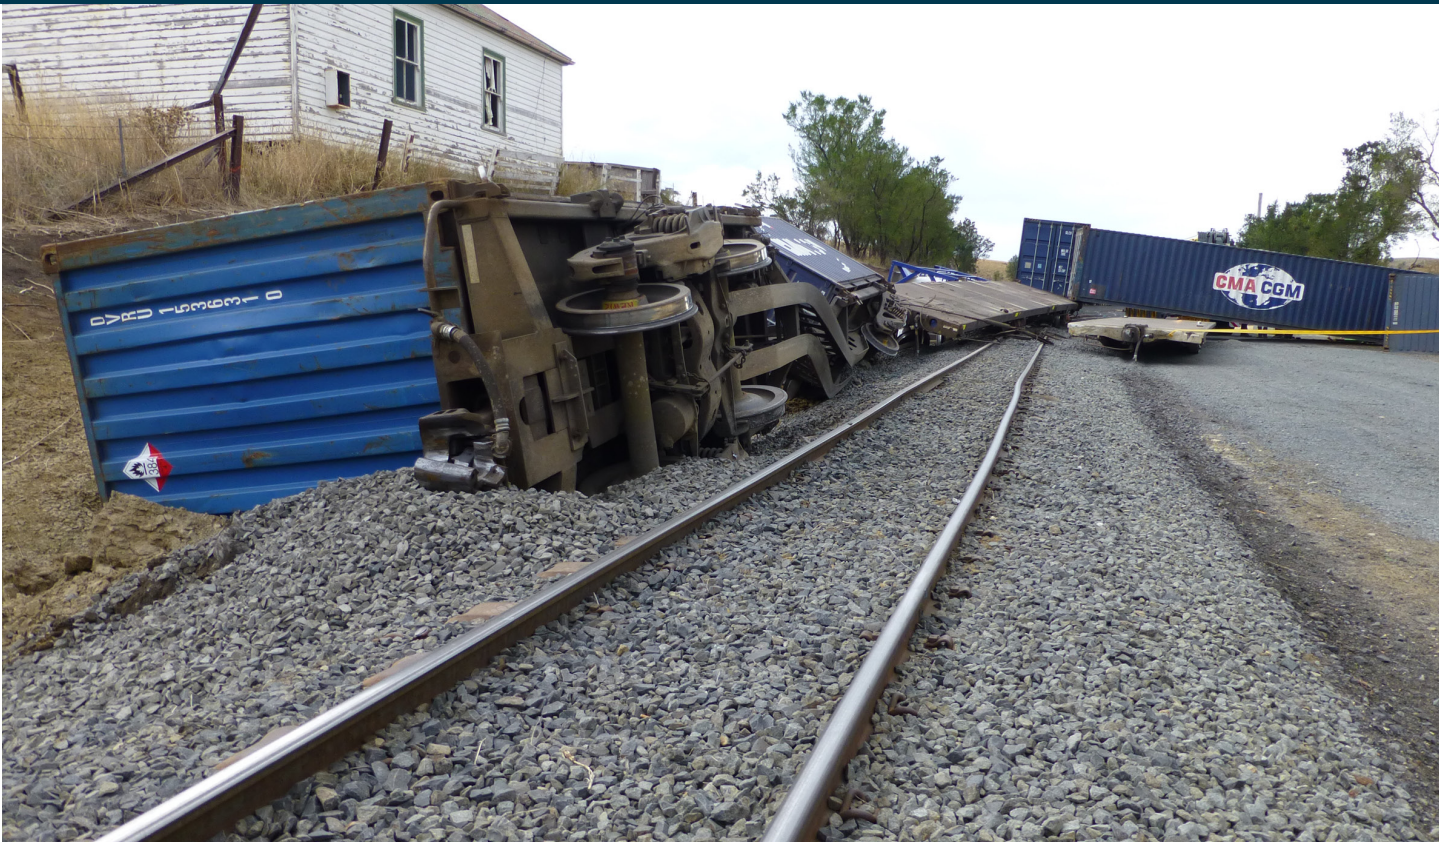
Derailment site at Lowdina

At about 2119 on 9 April 2013, freight train 331 derailed while travelling between Burnie and Boyer in Tasmania. The train travelled for about 2.5 km while derailed and came to a stop at Lowdina, about 48 km north of Hobart.

The ATSB investigation found that a large twist defect in the track near Lowdina caused the leading wheelset of the third wagon's trailing bogie to unload and derail.

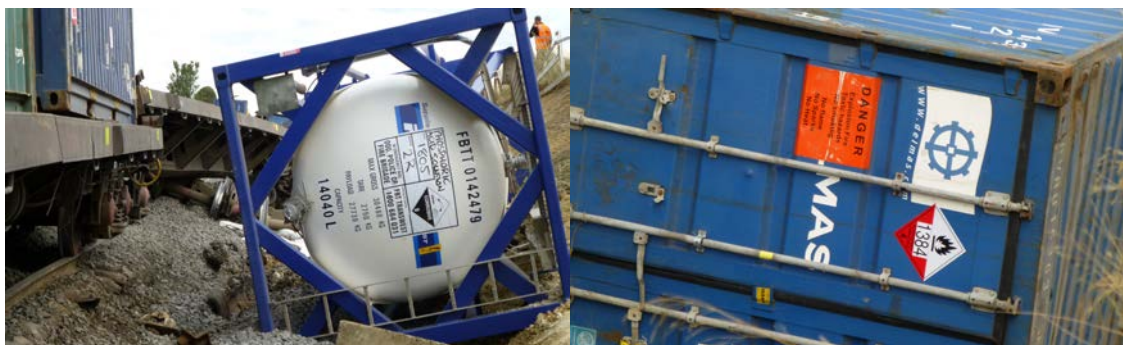
Figure 2: Dangerous goods

A short time later, a number of TasRail employees arrived on site to assist with the incident, one of whom specialised in dangerous goods management. About 2 hours later, phosphoric acid was discovered leaking from the top hatch of the ISO tank. Once it was determined that it was safe to do so, a number of spill kits were deployed to contain the leak.

While wagons QM6F and QS59P were found to be repairable, wagon IB197R was destroyed as a result of the derailment.

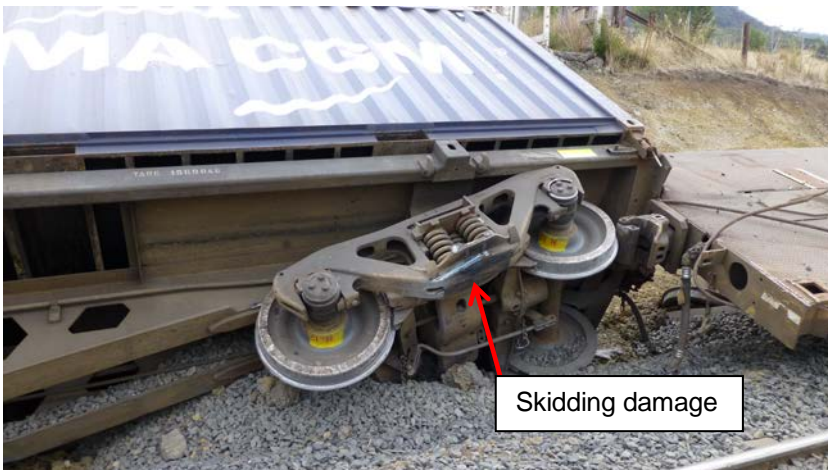
Figure 5: Trailing bogie of wagon IB197R

The trailing bogie on wagon IB179R was identified as the first to derail based on the amount of wheel and bogie damage. This was consistent with travelling in a derailed state for almost 2.5 km (Figure 5).

A post-derailment inspection conducted by TasRail indicated that the wagon was in serviceable condition before the derailment. Its bogies and wheelsets had been recently overhauled and no issues were found that may have contributed to the derailment.

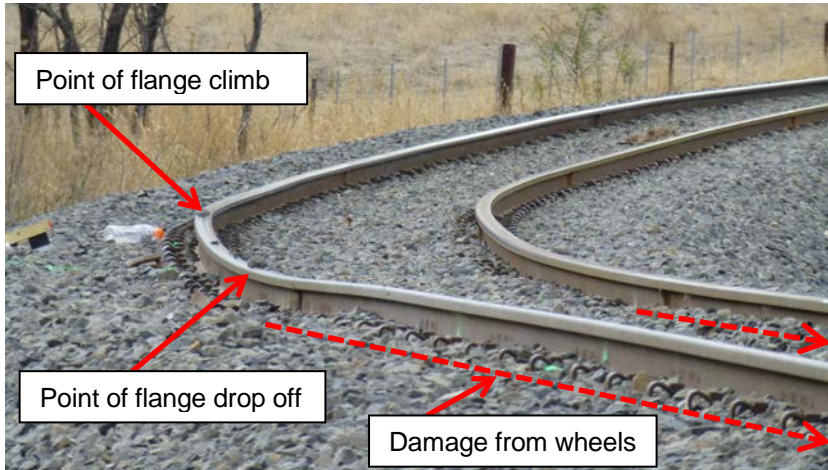
Figure 6: Twist in track at point of derailment

Evidence of flange climb was found on the high rail in a curve exit (Figure 6) at the 50.4847 kps. The flange mark ran across the rail head and dropped off the field side of the high rail about 7 m further along the track.

Based on available evidence, a large twist defect in the track near Lowdina (50.5 kps) caused the leading wheelset of the trailing bogie on wagon IB197R to unload and climb the high rail at 50.48 kps, run along the rail head, and derail on the field side of the high rail. The trailing wheelset derailed shortly thereafter.

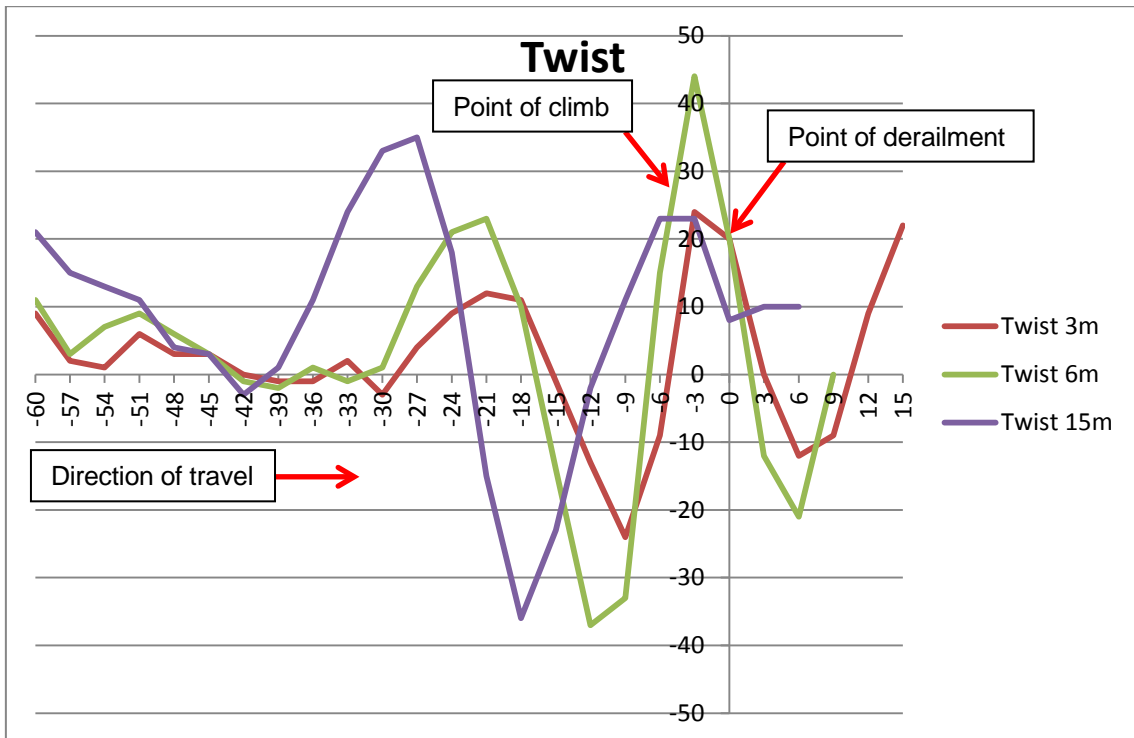
Figure 7: Twist measurements.

TasRail surveyed the site measuring gauge and cant. The results shown in Figure 7 indicate a twist in the track on the high rail side. The twist was in excess of the maximum allowable defect size for 3 m and 6 m lengths, meaning that it was classified⁷ as a large defect and, therefore, required immediate attention prior to the passage of the next rail vehicle. Evidence of minor formation heaving was also noted by TasRail during the survey.
