Serious injury of a crew member on board *Mell Selarang*

Port of Townsville, Queensland | 20 August 2013

ATSB Transport Safety Report
Marine Occurrence Investigation
302-MO-2013-009
Final – 4 November 2013

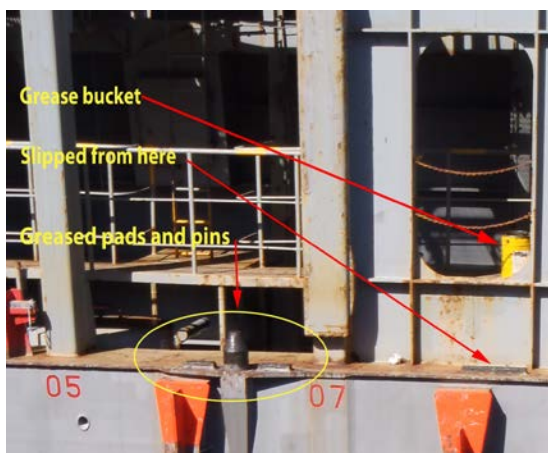
Figure 2: Cargo hatch coaming

Cargo operations continued into 20 August and, at about 0752, the stevedores stopped work for a change of shift. In the quiet period between the two shifts, one of the ship's seamen decided to grease the hatch landing pads (Figure 2) around the open cargo hold. The chief mate and the boatswain (bosun) were not advised of the work and permission had not been obtained.

The hatch landing pads could only be greased when the hatch lid was not in position. Normally, this task was carried out using an extended handle roller, which allowed the work to be performed from the walkway. As a result, the crew were not exposed to the risk of falling from the hatch coamings.

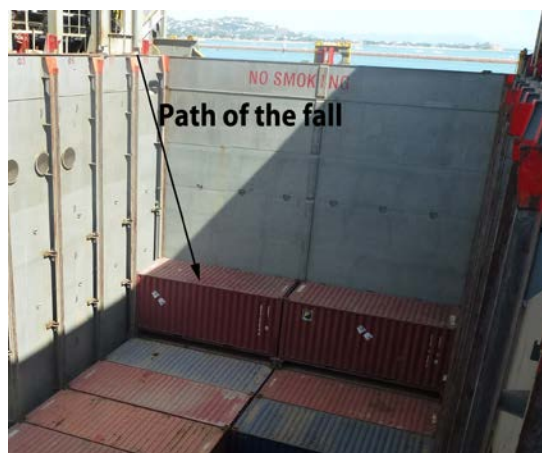
Figure 3: Open cargo hold

At about 0820, the new shift of stevedores boarded the ship and began to make their way into the cargo hold. At this time, the seaman was moving around the hatch coaming greasing the hatch lid landing pads when he slipped and fell, landing about 8.5 m below on the top of a container in the cargo hold (Figure 3).
