Collision of passenger train T842 with station platform

Cleveland, Queensland | 31 January 2013

ATSB Transport Safety Report

RO-2013-005

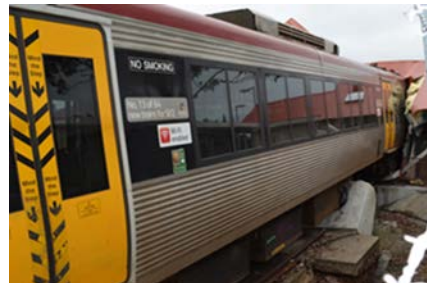
Train T842 at Cleveland station

At about 0940 on 31 January 2013, a Queensland Rail passenger train (T842) failed to stop at the Cleveland station platform and collided with the end-of-line buffer stop, the platform and the station building at a speed of about 31 km/h. There were 19 people on board the train (including the driver and a guard); three people were on the platform and five were in the station building. A number of people were treated for minor injuries and transported to hospital for further examination.

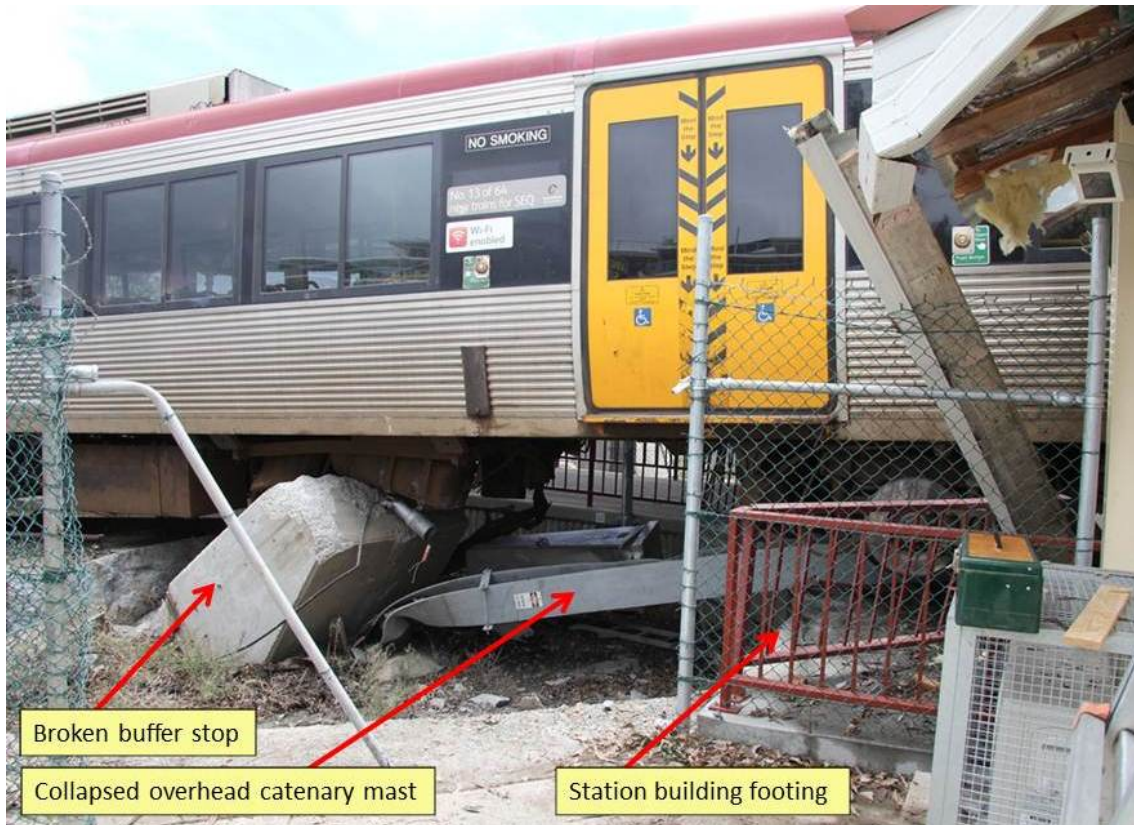
Figure 2: View of lead passenger car bridging the buffer stop and the overhead catenary mast.

At 0940 the train collided with the buffer stop at a speed close to 31 km/h, shearing the buffer stop from its foundation and rotating it onto its side. The train then rode up and over the buffer stop and collided with an overhead power line mast located immediately behind. The impact flattened the mast and brought down the overhead high voltage wiring onto the train and platform. The train continued into the station building where it came to rest (Figure 2).

Train T842 weighed about 256 t and was travelling at about 31 km/h when it collided with the buffer stop. The impact force significantly exceeded the design capability of the concrete buffer stop which was unable to dissipate the train's energy and so failed. This allowed the train to continue into the Cleveland station building.

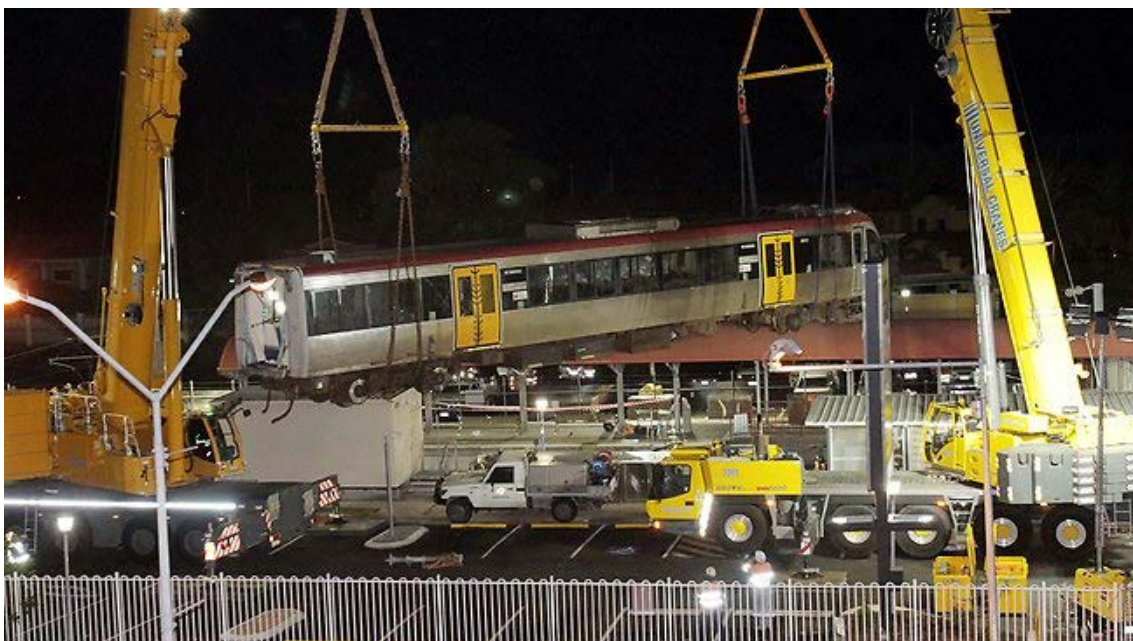
Figure 3: Recovery of car 5173

The two leading cars of train T842 had sustained significant damage and had to be lifted by crane from the site onto low bed loaders to be transported by road (Figure 3).

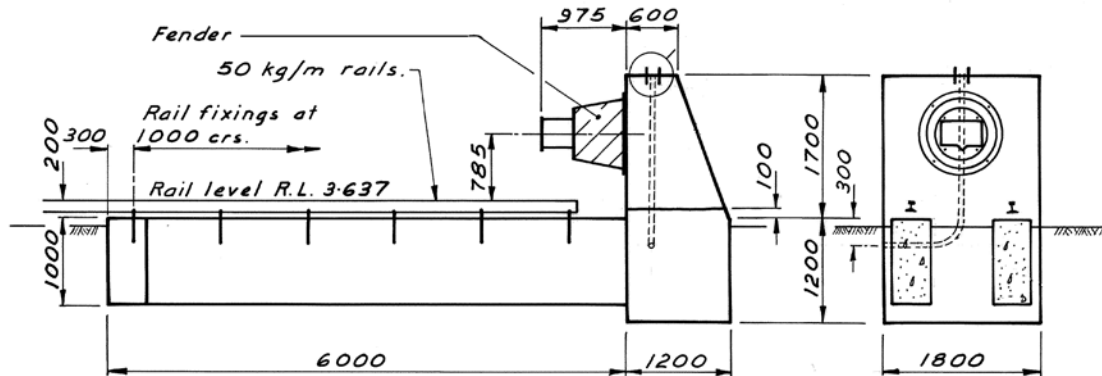
Figure 5: Design of buffer stops installed at Cleveland station

The buffer stops located at the end of the island platform tracks at Cleveland station are rigid reinforced concrete structures with rubber fenders (Figure 5). The buffer stop was constructed of a 2.9 m high concrete block protruding vertically 1.7 m from the ground and attached to a pair of horizontally reinforced concrete beams extending about 5.5 m under each rail.

A rubber fender is attached to the concrete block that also has a contact plate matching the profile of the City Train coupler. Design drawing notes showed the buffer stops at Cleveland station were calculated to arrest a train with a maximum mass of 200 t at a maximum impact speed of 5 km/h. The leading edge of each buffer stop was located about 15 m beyond the train stopping point and the end of the station platform. There was no track laid behind the buffer stop and there was a further 5 m between the buffer stop and the Cleveland station building foundation and pavement that arose about 800 mm above ground level (Figure 2).

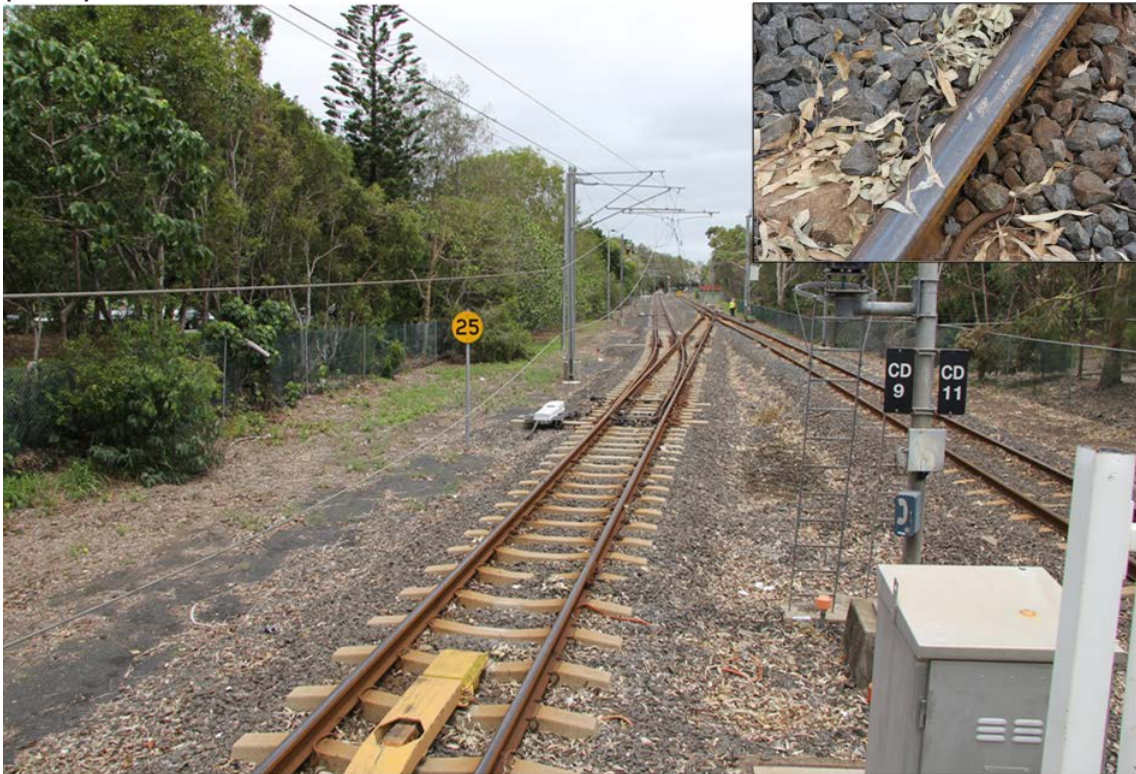
Figure 6: View from Cleveland station platform showing leaf litter about the track and (insert) crushed on the rail head.

When train services resumed on 31 January 2012, the 12 train services before T842 would have crushed and distributed any organic matter on the rail head and also disturbed the leaf litter lying between the rails and beside the track (Figure 6).

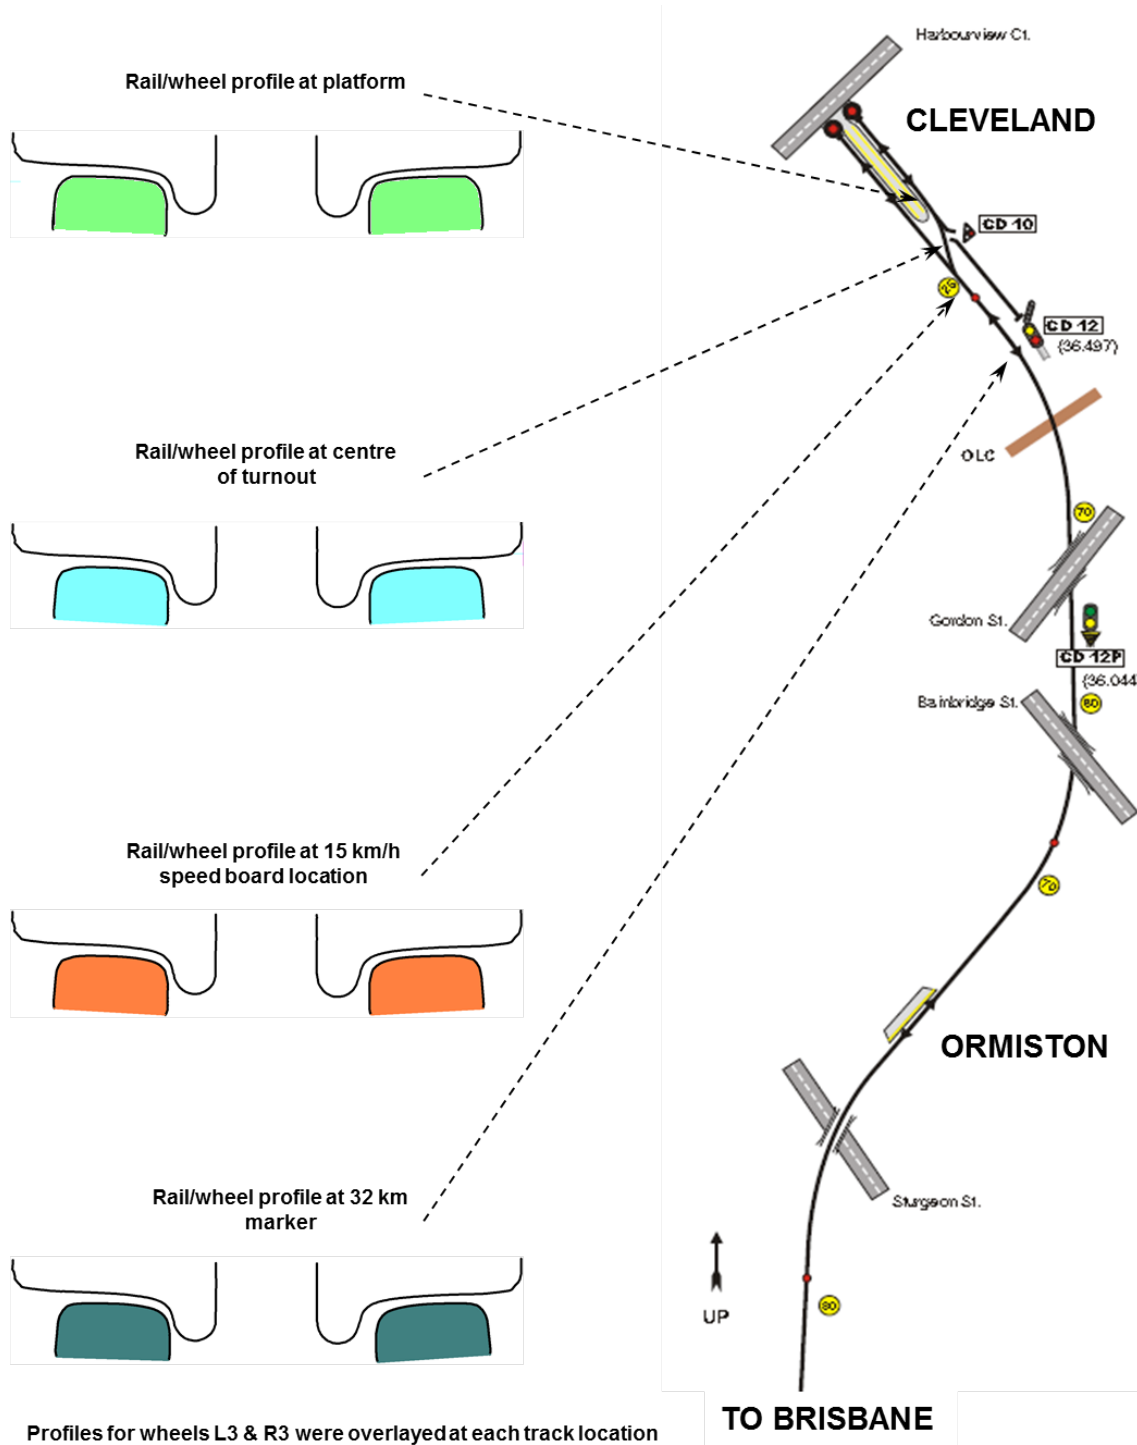
Figure 7: Leading passenger car 5173 wheel profiles and rail profiles at specific locations on approach to Cleveland station

The investigation found that although the rolling stock wheel and rail head profiles showed a very small amount of wear, both were compliant with Queensland Rail engineering standards and specifications. It was concluded that the profile condition of these components and the tracking of the wheels/bogies were unlikely have contributed to the wheel slide experienced by train T842 near Cleveland on 31 January 2013.

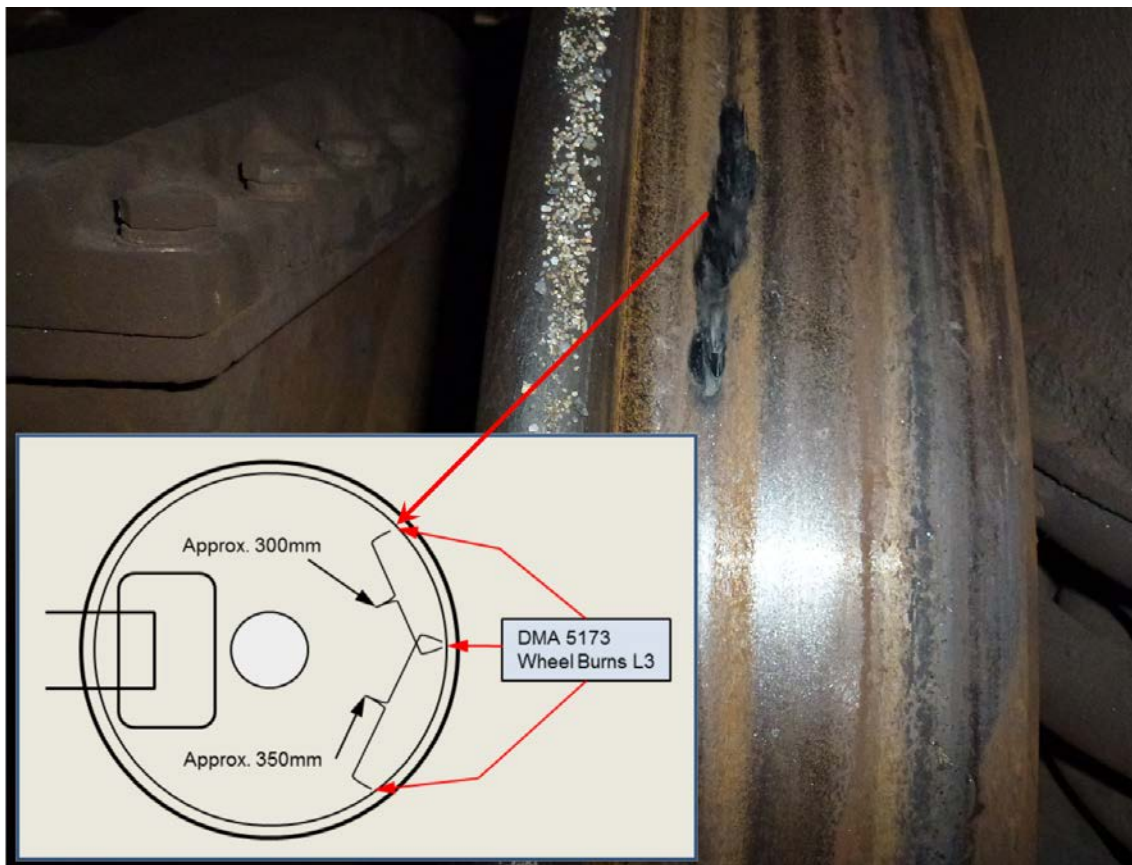
Figure 10: One of three wheel slide burns on car 5173, trailing bogie, wheel L3

Inspections of the wheels for all cars after the collision revealed minor flats¹⁶ at three near equally spaced positions about the tread circumference of an axle on the leading car (5173) and one wheel flat of an axle on the last car (8180). It is possible that the multiple tread flats on one axle of car 5173 indicate that WSP may have briefly been compromised. The equal spacing around the wheel circumference is indicative of the brake activation and release function while WSP was attempting to control the slide (Figure 10).

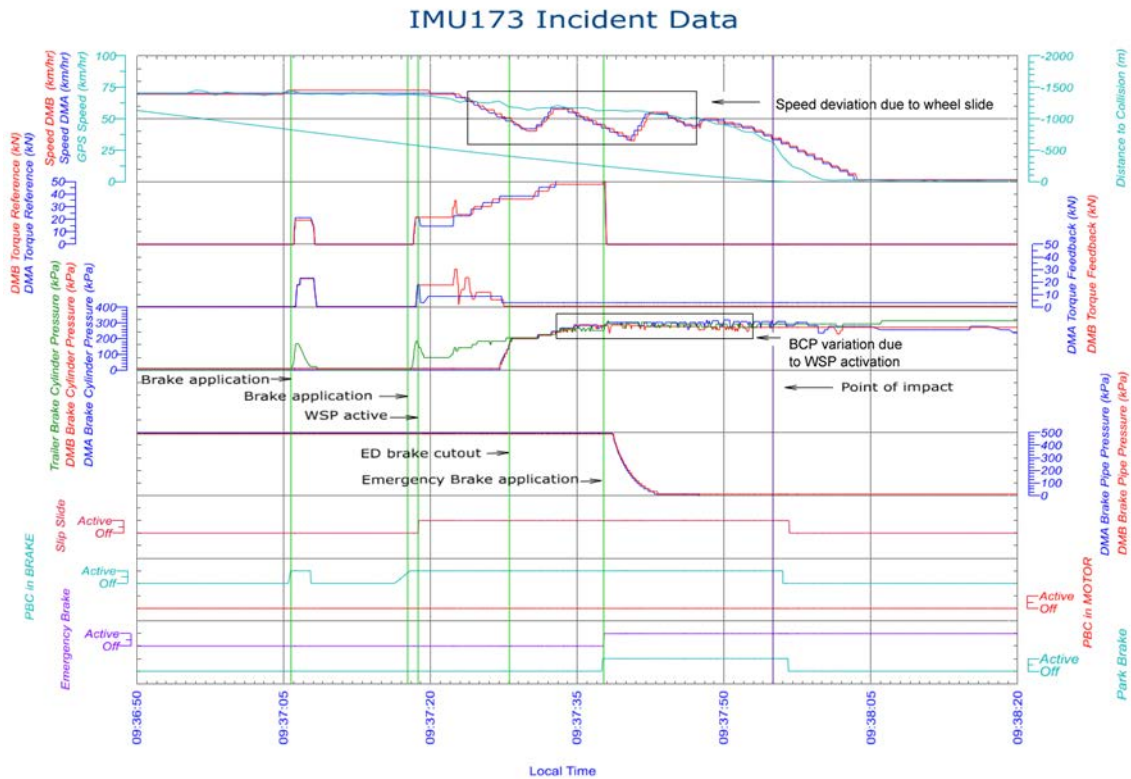
Figure 11: Extract of data log from IMU5173

Analysis of information extracted from car 5173's data logger (Figure 11) shows the train was travelling about 69 km/h (0937.18) when the driver made the service brake application to slow the train about 590 m from the Cleveland station. Less than one second later, the WSP system detected slide. Brake cylinder pressures, particularly after the application of the emergency brake at 56 km/h, display numerous fluctuations as the WSP system intervened to apply and release the brakes in attempting to control the slide. Fluctuations in speed were also recorded where the WSP system remained active throughout the service brake and emergency brake applications until the point of impact.

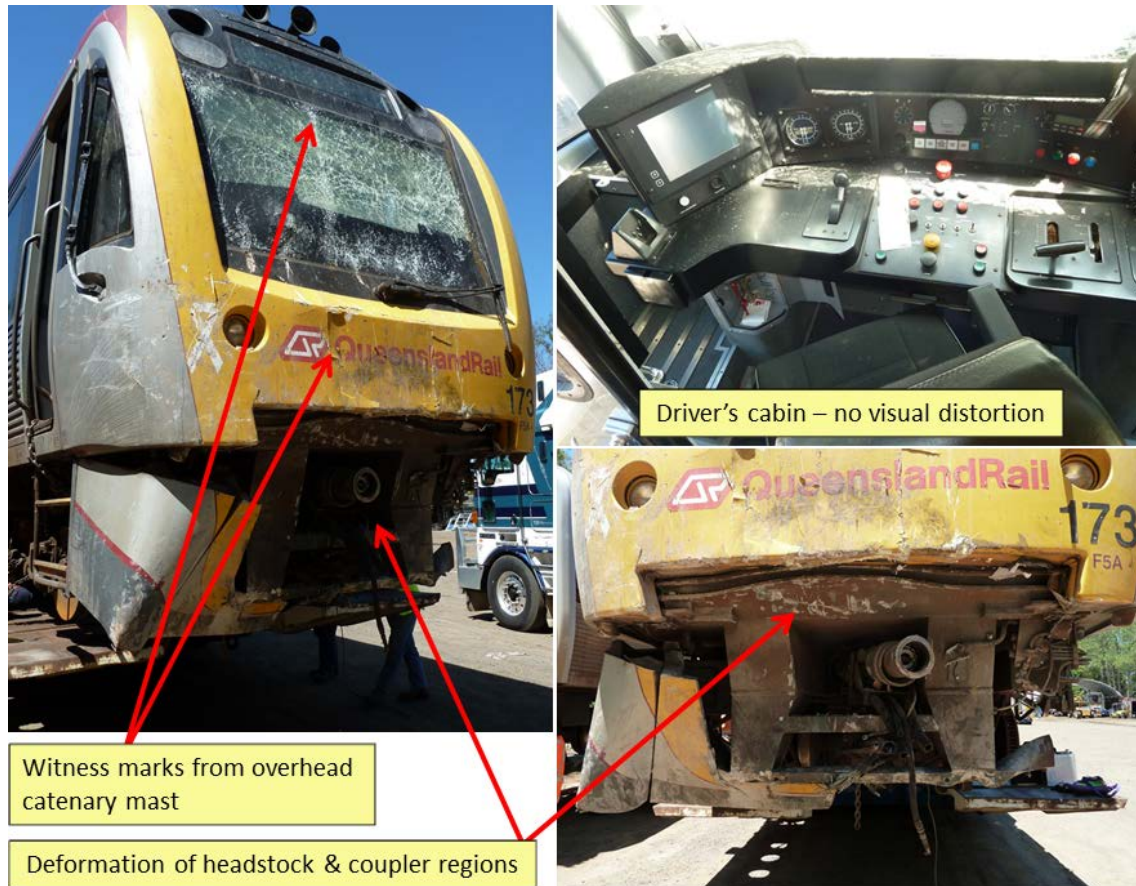
Figure 15: Resultant damage to the front of car 5173 after colliding with buffer stop, overhead electrical catenary mast and station building.

The leading vehicle on train T842, car 5173, was travelling at about 31 km/h when it struck the Cleveland station buffer stop, fracturing it from its foundation before colliding with and collapsing the overhead catenary mast and demolishing part of the station building (Figure 2). The average deceleration force applied to train T842 during the collision sequence (between initial impact and vehicles stationary) was calculated at about 700 kN, about 27% of the force applied during crashworthiness analysis (2600 kN). Post-accident inspections of car 5173 showed the vehicle structure had resisted the impacts and external debris from the collision had not intruded into the driver’s cabin and workspace. Small fragments of glass from the single-piece laminated windscreen had separated from the inside layer and lodged on the forward section of the driver’s console and fractures of the fibre reinforced plastic driver’s desk were visible on the right-hand lower corner adjacent to the train radio and intercom handsets. There was minimal deformation across the headstock section of the train and minor damage to the windscreen and driver’s cabin roof that resulted from the collision with the overhead catenary mast. (Figure 15)

The structural integrity of other body elements of car 5173 remained intact however there were noticeable distortions in the stainless steel lower exterior side-walls located between the driver’s cabin door and the first passenger entry/exit doorway on the ‘A’ end. Extensive distortion of the underfloor structural members and sheeting occurred when the lead bogie was forced upward as car 5173 rode over the broken buffer stop before impacting the station building. An inspection of the passenger saloon floor centrally above the lead bogie displayed a visible hump that had risen about 25 mm over an area of about two square metres. There were no protrusions of metal or visible tears in the floor covering. There were two passengers in this region who were seated near the windows against the bulkhead behind the train driver’s cabin and electrical compartments but no passengers were standing on or near the impacted floor section at the time of the collision.

The investigation found that the IMU160 class of vehicles that made up train T842 had resisted and absorbed the significant forces resulting from the frontal collision with the end of line buffer stop, overhead power line catenary pole and station building structures with minimal intrusion into the driver's cabin and passenger saloon areas. It was also considered that the rising intrusion of the interior floor into the passenger saloon would have had a negligible effect on passengers that could have been standing in this region at the time of the collision.
