# Loss of separation involving CASA C212-CC, VH-MQD, operating in the Richmond parachuting area and Boeing 737-7BX, VH VBP

near Richmond Aerodrome, NSW | 5 November 2011

**ATSB Transport Safety Report**  
Aviation Occurrence Investigation  
AO-2011-142  
Final – 16 December 2013

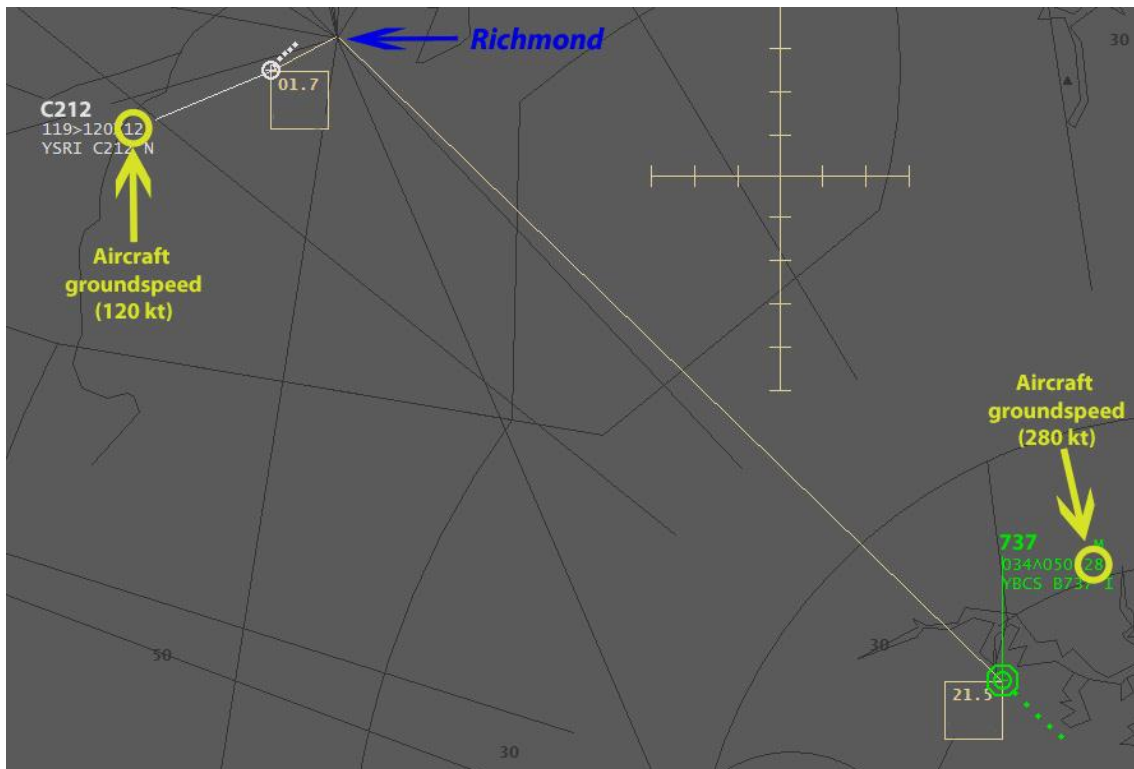
**Figure 2: Aircraft positions at 1439:15**

At 1439:15, the SDS trainee assigned the 737 a climb to 10,000 ft. At that time, the 737 was 21.5 NM (39.8 km) to the south-east of Richmond, passing through 3,400 ft with a groundspeed<sup>8</sup> of 280 kt. The C212 was 1.7 NM (3.1 km) to the south-west of Richmond, maintaining 12,000 ft,<sup>9</sup> with a groundspeed of 120 kt (Figure 2).

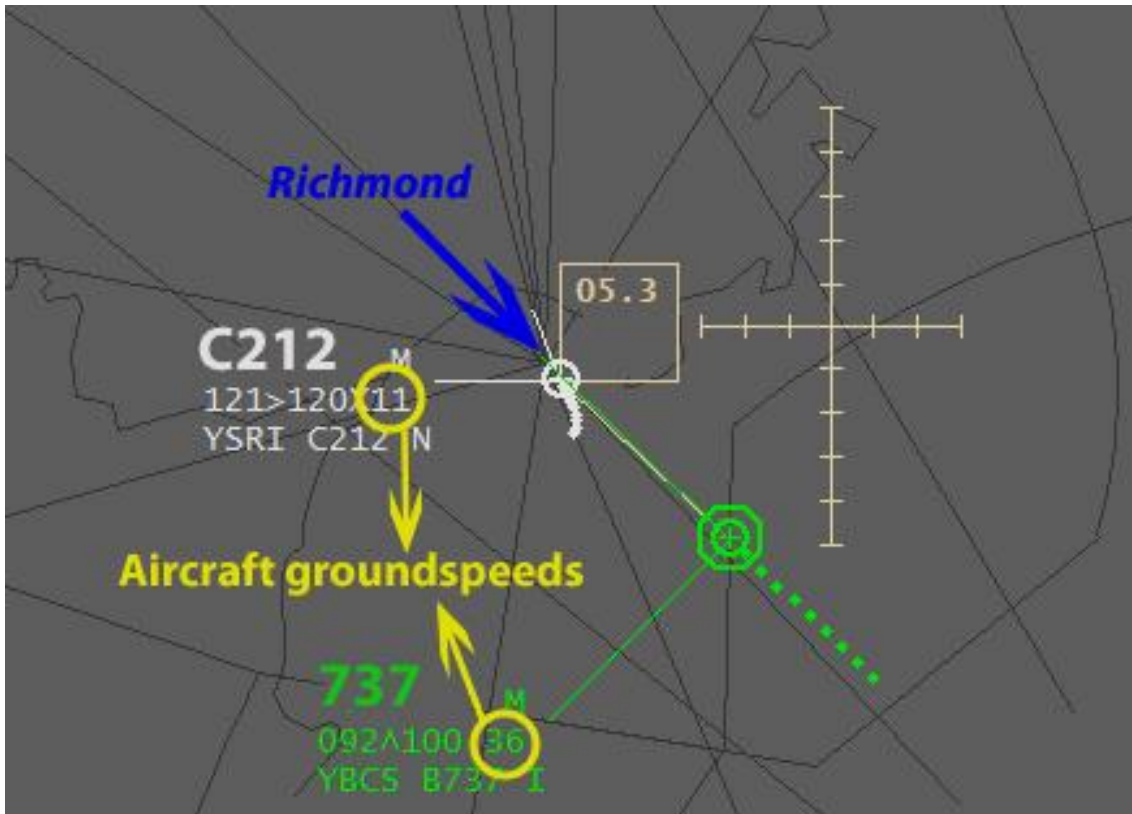
**Figure 3: Aircraft positions at 1442:05**

The SDS trainee instructed the 737 flight crew to contact the SAW controller at 1441:28, following that controller’s system acceptance of the aircraft. The 737 flight crew first contacted the SAW controller at 1442:05, and was instructed by the SAW controller to stand by. At the time, the 737 was climbing through 9,200 ft, at a groundspeed of 360 kt, and 5.3 NM (9.8 km) from the C212. The C212 was maintaining 12,000 ft at a groundspeed of 110 kt and about 1 NM (1.85 km) south of Richmond tracking north-westerly (Figure 3).

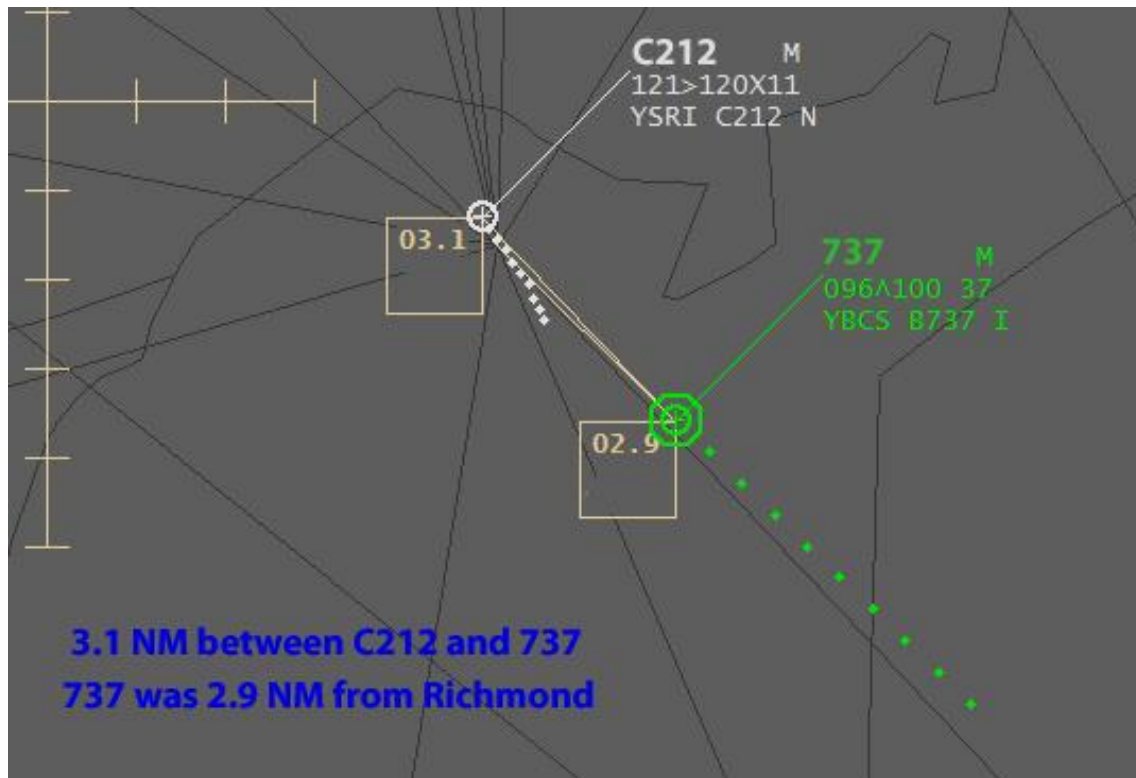
**Figure 4: Aircraft positions at 1442:35**

The SAW controller then asked the C212 flight crew for the ‘status of the chutes’. Seven seconds later, after no response from the C212 flight crew, the SAW controller called again, to which the flight crew asked for the controller to repeat their request. The SAW controller again asked for a report on the ‘status of the chutes’, to which the flight crew responded with another request for the controller to repeat their query. The controller then asked ‘are the chutes in the air?’ to which the flight crew reported that the paratroopers were exiting the aircraft. At that time (1442:35), the 737 was 2.9 NM (5.4 km) to the south-east of Richmond, passing 9,600 ft on climb, with a groundspeed of 370 kt. The C212 was maintaining 12,000 ft, with a groundspeed of 110 kt, just to the north-west of Richmond and 3.1 NM (5.7 km) from the 737 (Figure 4).

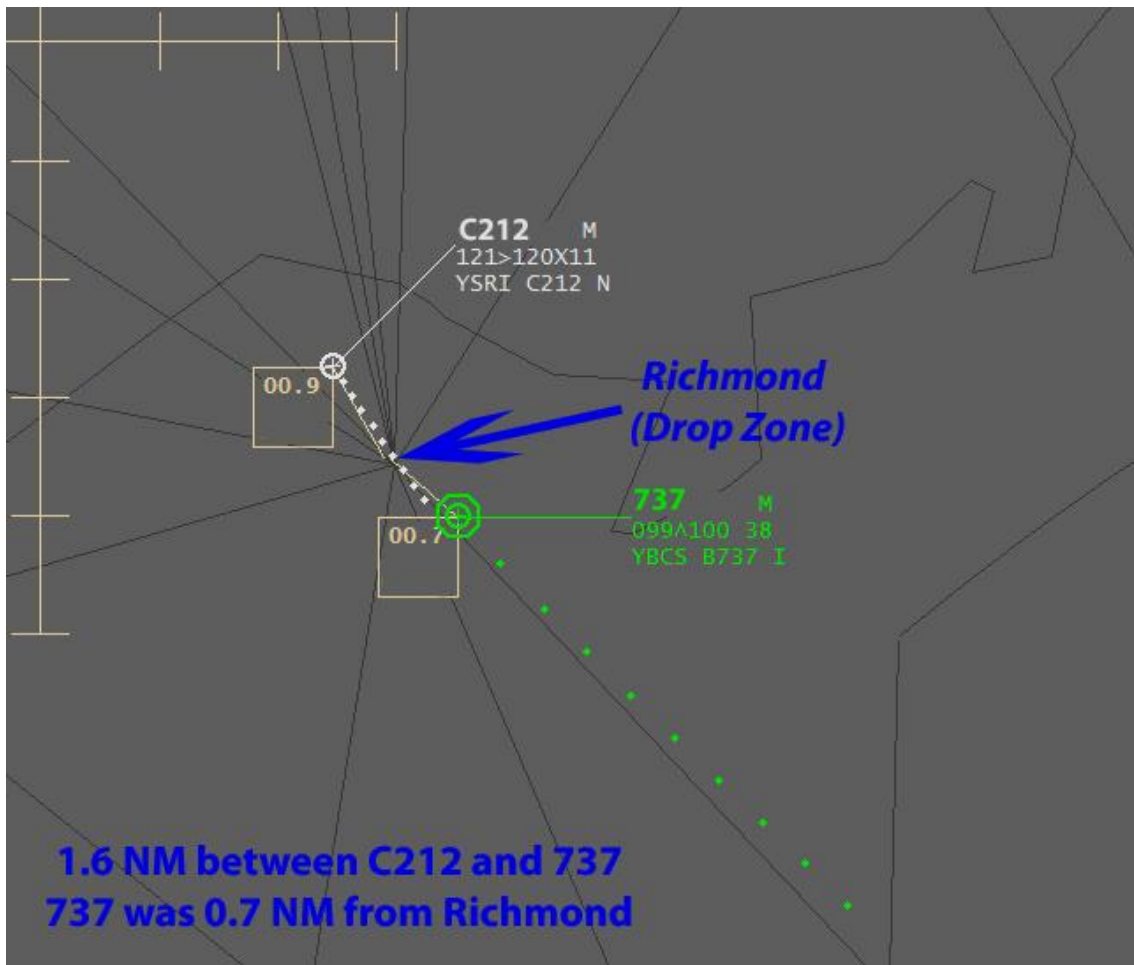
Figure 5: Aircraft positions at 1442:59

Directly after, at 1442:59, the SAW controller issued a traffic alert to the 737 flight crew that advised the C212's call sign and that 'chutes [were] in the air'. At that time, the C212 was maintaining 12,000 ft, with a groundspeed of 110 kt, 0.9 NM (1.7 km) north-west of Richmond and 1.6 NM (3.0 km) ahead of the 737. The 737 was 0.7 NM (1.3 km) south-east of Richmond (the 'drop zone'), passing 9,900 ft in the climb, at a groundspeed of 380 kt (Figure 5).

There was a LOS between the 737 and the Richmond parachute operations area (and paratroopers). The requisite separation standard was for controllers to apply a separation buffer of 1 NM (1.85 km) around a declared parachute operations area, which itself was defined as an area within 1 NM (1.85 km) radius of the dropdown zone or target (see the section titled *Air traffic control information – ATC parachuting procedures*). In this instance, the target was within Richmond and for the period that the 737 operated within 2 NM (3.7 km) of Richmond, there was a loss of separation.

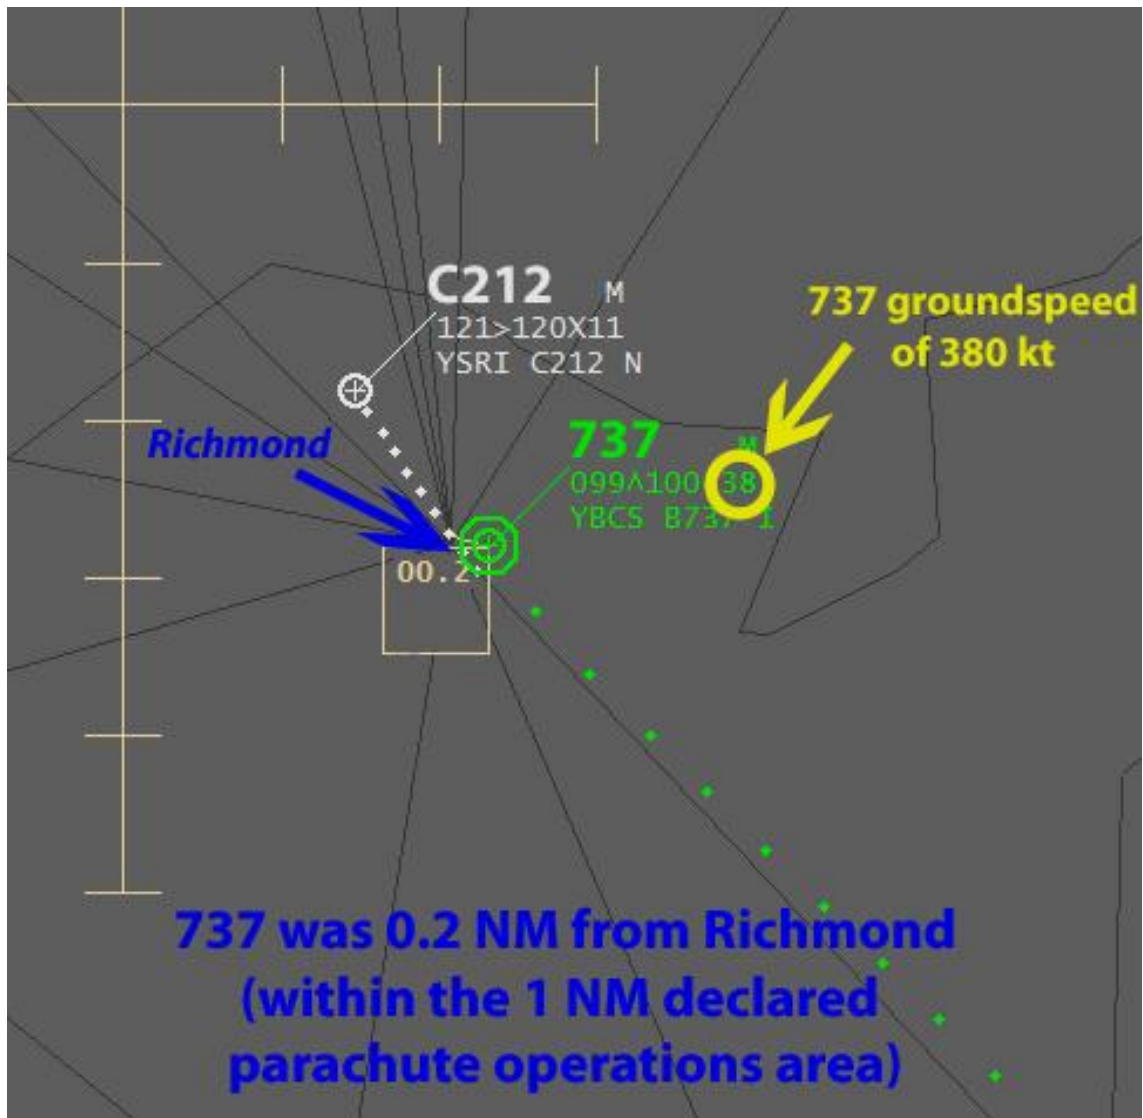
Figure 6: Aircraft positions at 1443:02

Separation between the 737 and the declared drop zone reduced to 0.2 NM (0.4 km) before the right turn that was initiated by the 737 flight crew took effect (Figure 6). At that time, the groundspeed of the 737 was 380 kt.

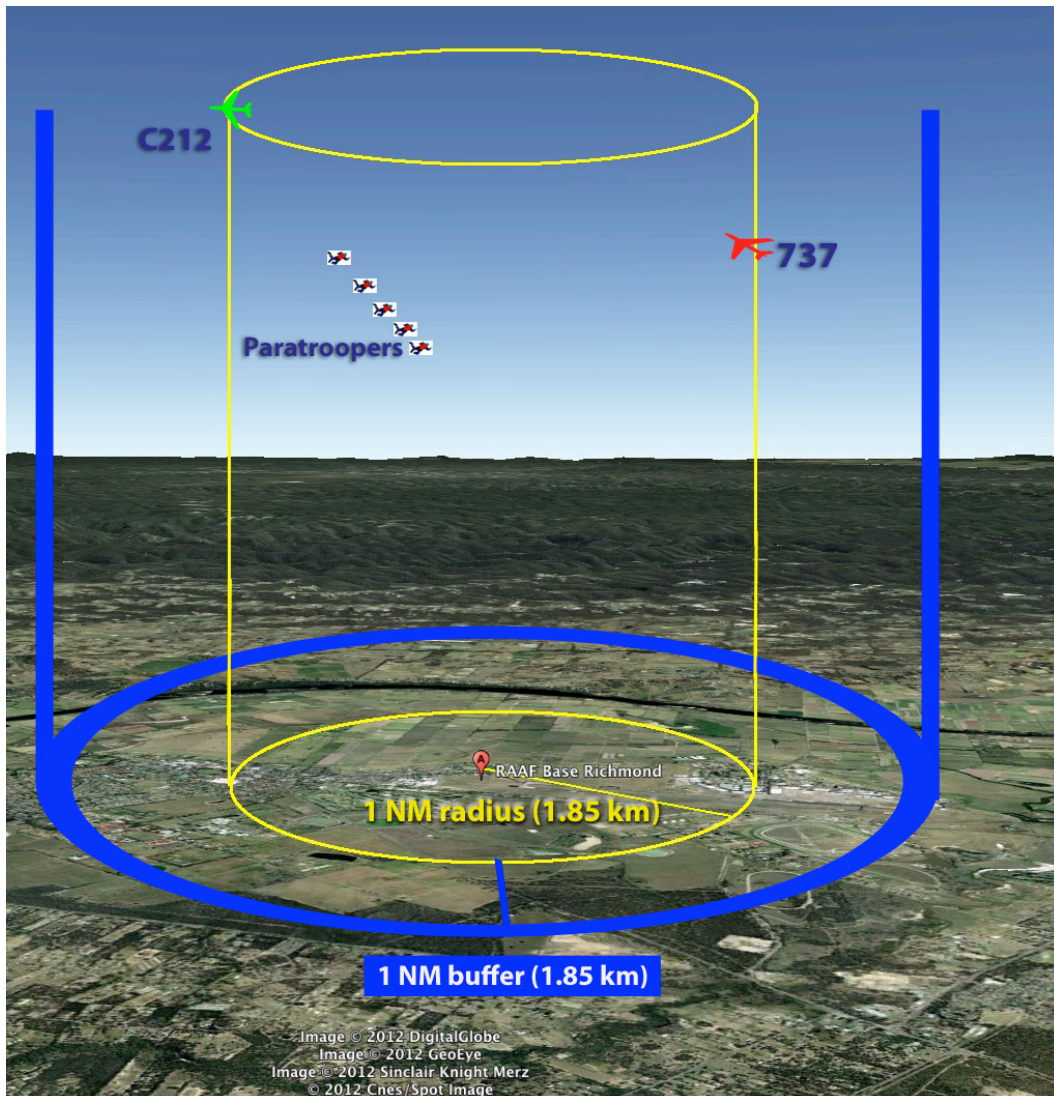
Figure 9: Illustration of the loss of separation

As defined in the Manual of Air Traffic Services (MATS), it was an air traffic control (ATC) responsibility to separate aircraft from the declared parachute drop area of 1 NM (1.85 km) radius from Richmond until receipt of advice that the drop was completed. That declared parachute drop area was from the altitude of the C212 to the ground. ATC were required to apply a 1 NM (1.85 km) buffer to that defined area (shown in blue in Figure 9). Should any aircraft have entered the 1 NM buffer, and then the column of reserved airspace below the C212 before a parachute drop had been completed, there was a loss of separation (LOS). This was the case when the 737 entered the 1 NM buffer zones, as ATC had not separated the aircraft from that area (Figure 9).
