Aviation Short Investigation Bulletin

Issue 26

ATSB Transport Safety Report
Aviation Short Investigations
AB-2014-005
Final – 25 February 2014

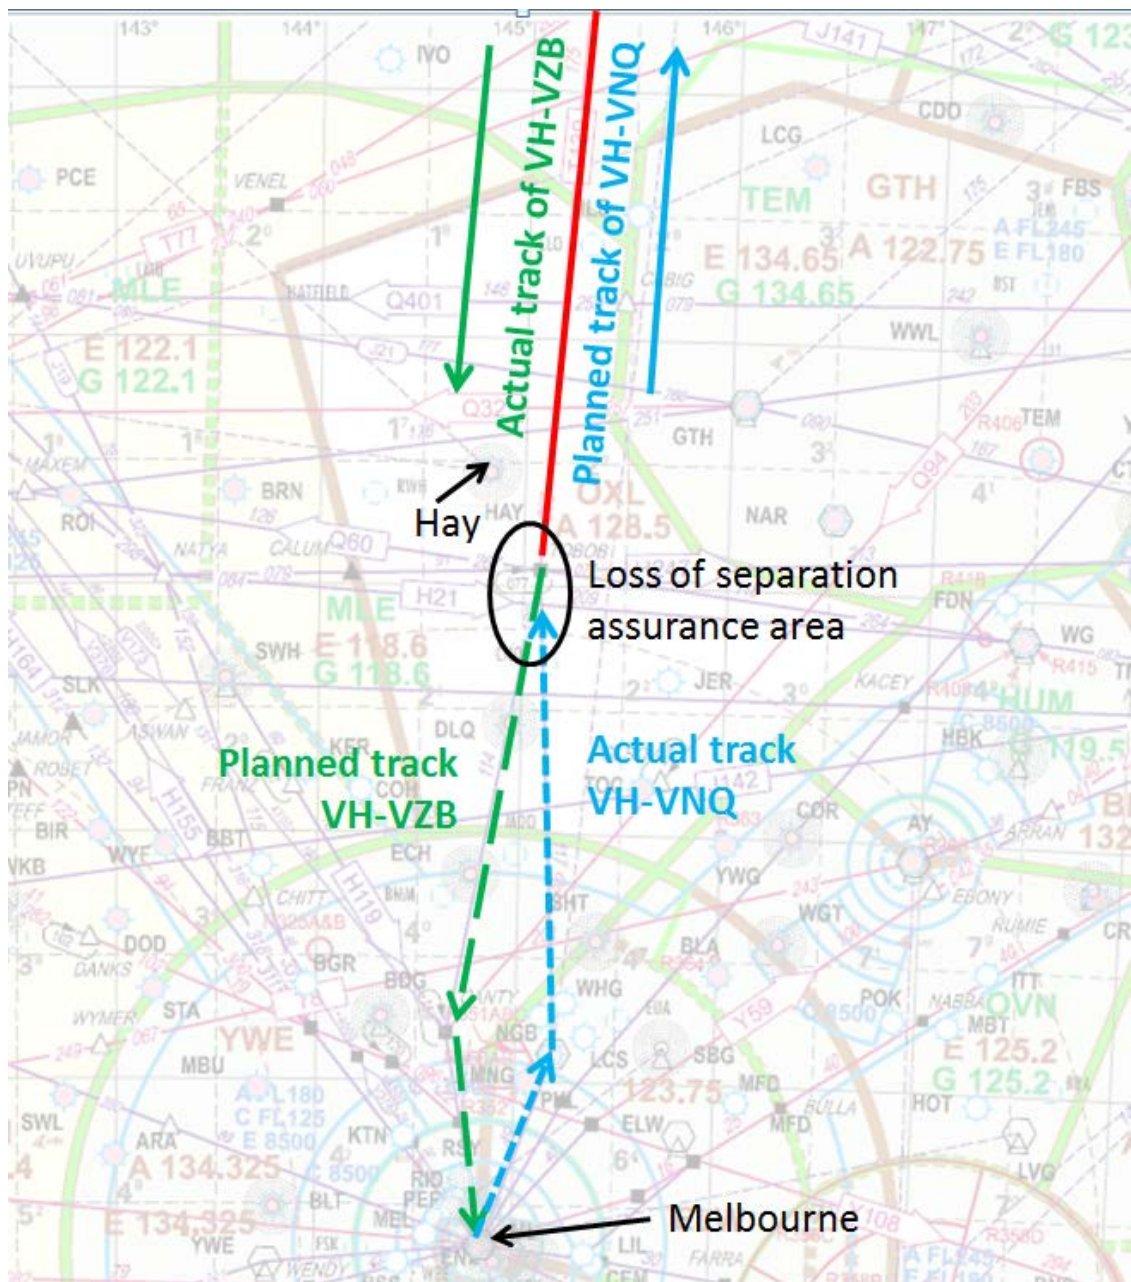
Figure 2: Airspace map overlaid with aircraft tracks and the LOSA area

The Airservices investigation into the LOSA found that Controller 1 correctly utilised compromised separation techniques by issuing safety alerts, turning the aircraft away from each other, descending VZB and passing traffic information. The report also found that an adjustment to the STCA warning distance parameter eight months prior to the incident provided an additional five seconds alert time. The additional time may have assisted Controller 1 to initiate recovery action prior to the separation standard being infringed.

The report noted that the Melbourne to Cairns route structure had not undergone a review following an increase in traffic. Further, the report noted that the Manual of Air Traffic Services (MATS) stated that ATC may assign non-conforming cruising levels only when traffic or other operational circumstances require and to return aircraft to conforming levels when traffic and workload allows.

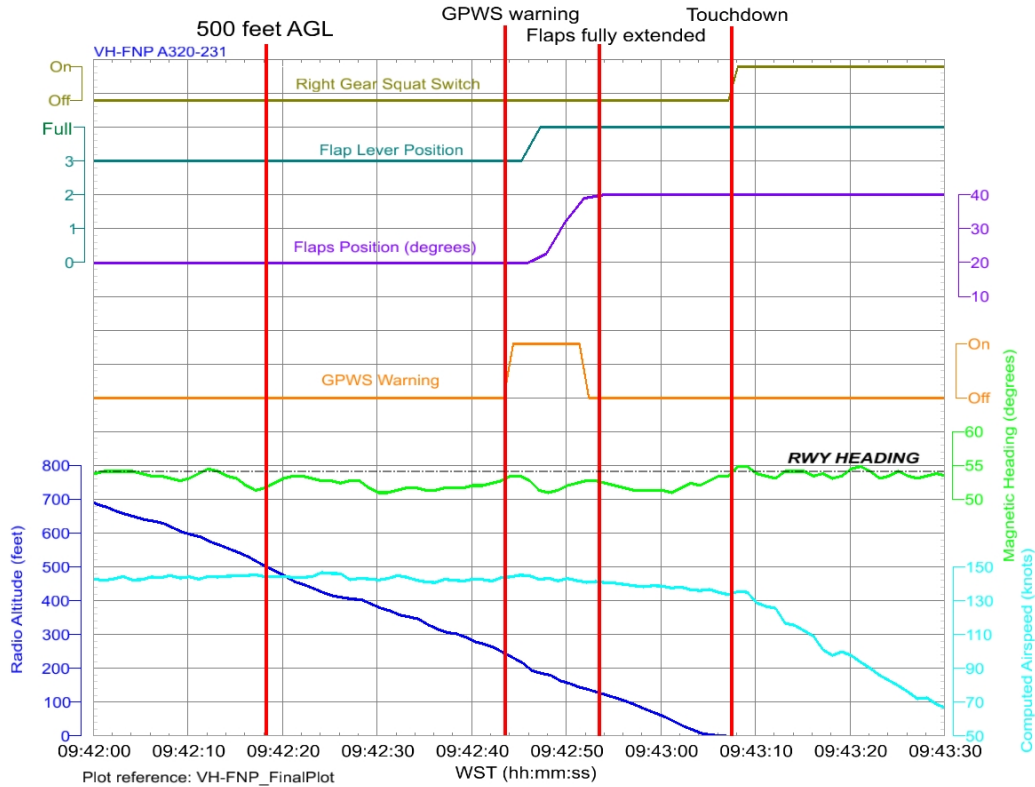
Figure 1: Summary of flight data

- Full flap was selected at 185 ft
- The flaps were fully extended at approximately 144 ft

- The approach was considered unstable as the aircraft was not in the desired landing configuration by 500 ft AGL, in visual meteorological conditions, as ‘Flap Full’ had not been selected.
- While the crew did not conduct a go-around as per the company stable approach policy, the captain believed that the safest option was to land.
- The both engines operating missed approach or go-around in daytime visual meteorological conditions should be conducted on runway track, provided obstacle clearance is assured.
- Based on the aircraft’s maximum landing weight, a ‘Flap 3’ landing with autobrake ‘low’ selected would have required a landing distance in excess of the landing distance available.⁵ However, if ‘medium’ autobrake was selected or manual braking was used, there would have been sufficient landing distance available with ‘Flap 3’ selected.

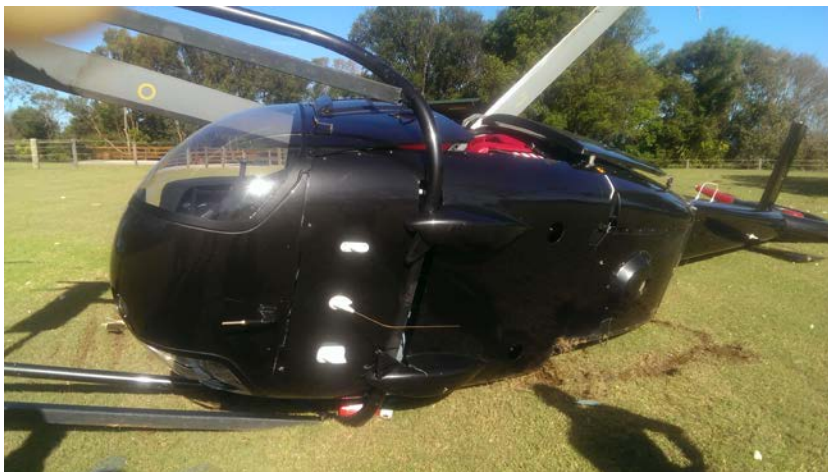
Figure 1: VH-VMT

The pilot believed that a combination of main rotor downwash and a wind gust contributed to a loss of tail rotor effectiveness (LTE).

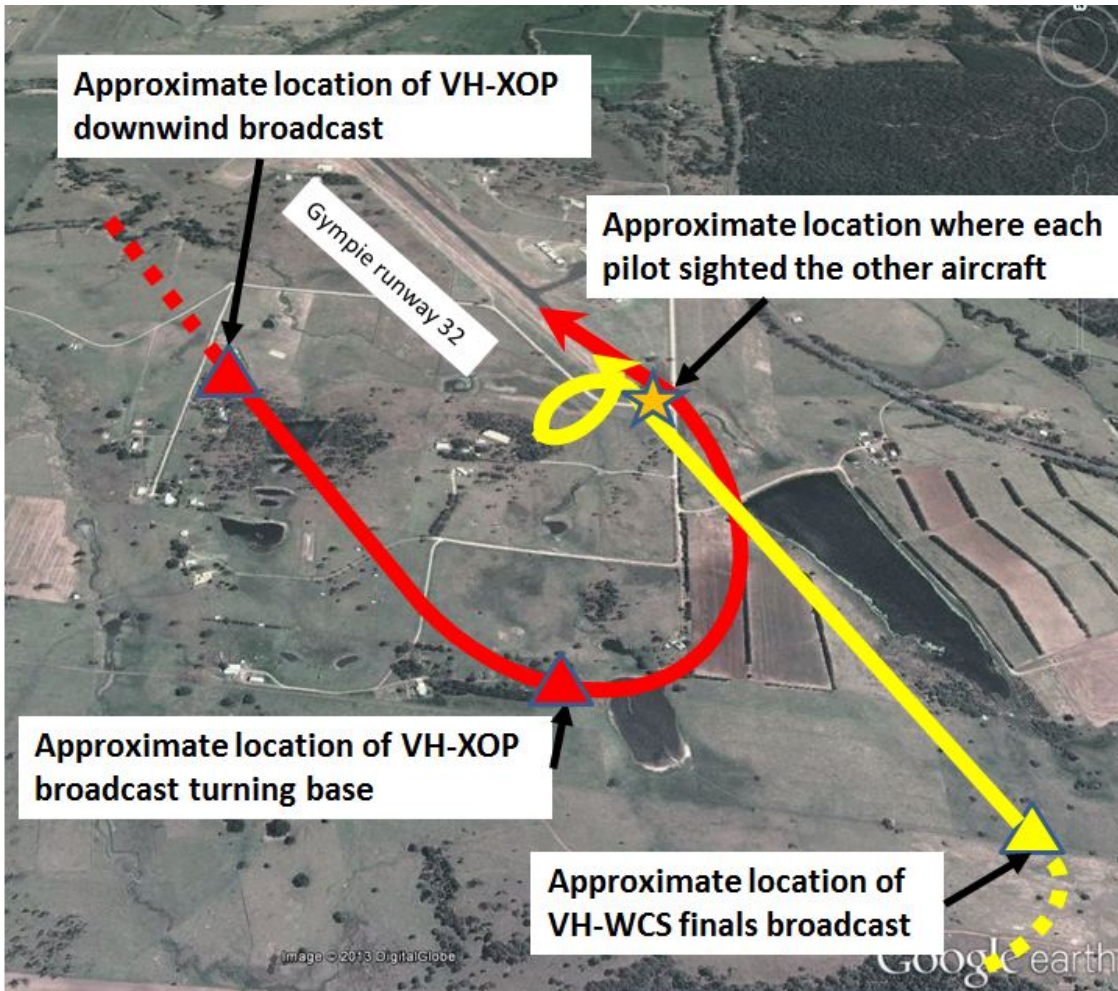
Figure 1: Approximate aircraft flight paths and broadcast locations

About 90 seconds later, the instructor of WCS sighted the glider to his right, at about the same height and about 10 m away. The pilot of XOP also observed the helicopter to his left and slightly above. In response, he lowered the nose of the glider to increase the airspeed to 60 kt to stay below the helicopter. The glider then landed on the grass to the left of the runway.

The Gliding Federation of Australia reported that the helicopter may have been in the glider pilot's blind spot during the diagonal base leg and turn onto final. If the glider turned onto final above, and in front of the helicopter, the pilots of each aircraft would not have been able to sight the other. The glider pilot had then applied the airbrakes, steepening the approach path.
