Runway incursion between a Cessna 206, VH-LHX and a Cessna 210, VH-HGZ

Gove Airport, Northern Territory, 13 August 2013

ATSB Transport Safety Report
Aviation Occurrence Investigation
AO-2013-162
Final – 10 December 2013

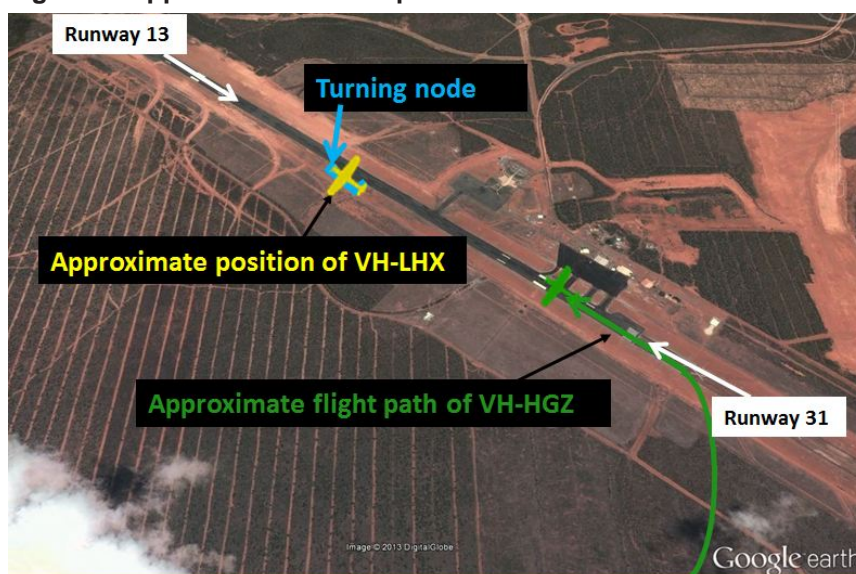
Figure 1: Approximate aircraft positions

HGZ landed on runway 31 and vacated the runway. At the time, LHX was positioned at the turning node, but the runway was still occupied. LHX subsequently departed from runway 13.
