Runway event involving a Beech 1900C, VH-VNV

Darwin Airport, Northern Territory, 1 October 2013

ATSB Transport Safety Report
Aviation Occurrence Investigation
AO-2013-169
Final – 20 January 2014

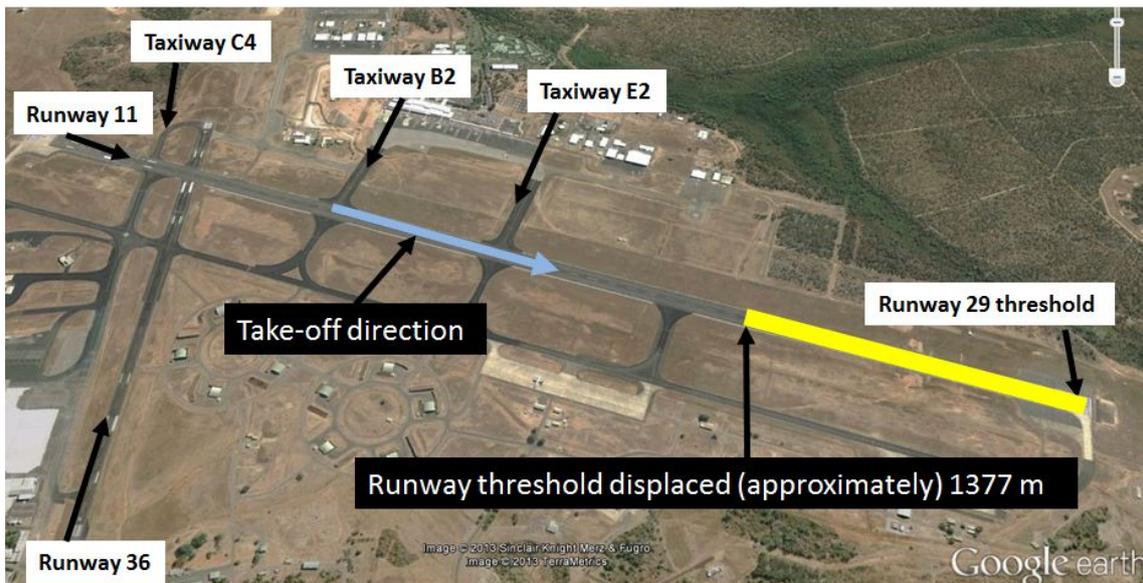
Figure 1: Darwin Airport

At about 0900, the first officer (FO) requested a clearance from Darwin air traffic control (ATC) to taxi to taxiway 'Echo 2' (E2) for runway 11 (Figure 1). Air traffic control advised the crew that a reduced runway operating length was in effect. The FO then requested and obtained a clearance to taxi to taxiway 'Bravo 2' (B2).

When at the B2 holding point, the captain observed an aircraft on final approach to runway 11. Air traffic control then cleared the crew of VNV to line up on runway 11, ahead of the approaching aircraft, and asked them to confirm that they were aware of the displaced threshold to the east of taxiway 'Echo' (E). The FO replied that he understood.

The crew reported that when they were lined up on runway 11, they could see the tops of vehicles conducting the runway works, but due to a rise in the runway, were unable to see the start of the displaced threshold.
