Pilot incapacitation event involving a Cessna 210, VH-JMG

56 km N of Sydney, New South Wales, 1 September, 2013

ATSB Transport Safety Report
Aviation Occurrence Investigation
AO-2013-155
Final – 20 January 2014

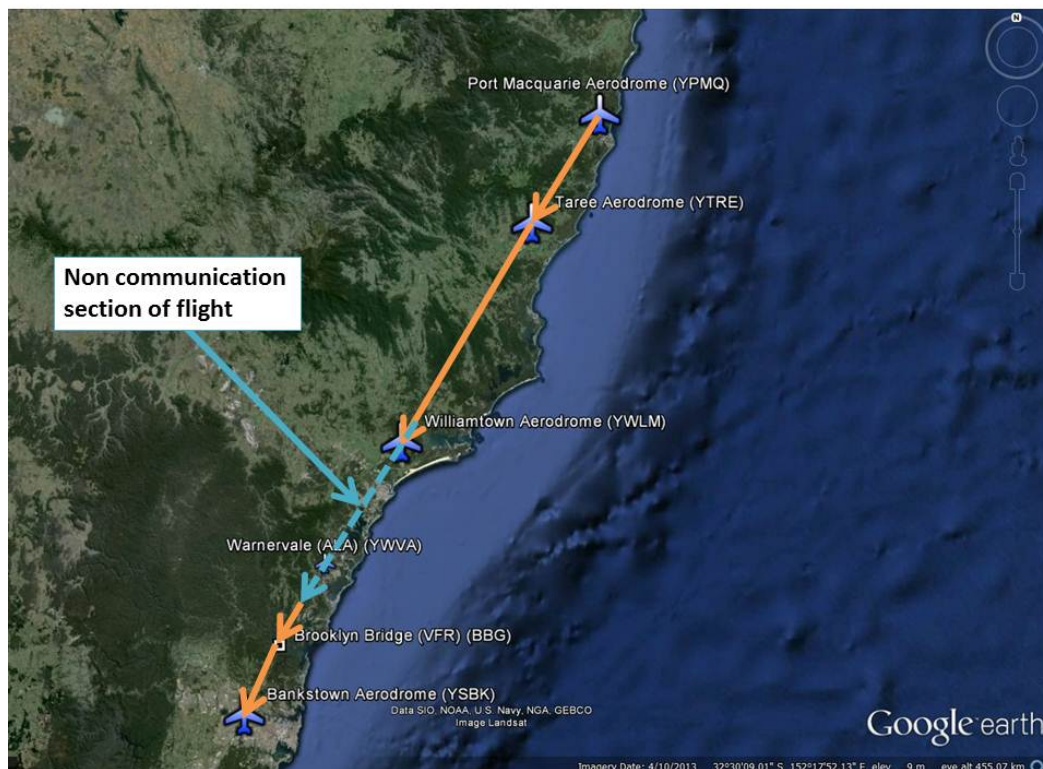
Figure 1: Flight planned track

The pilot reported feeling a little tired and unwell. He elected to depart Port Macquarie earlier than usual at about 1510 Eastern Standard Time.¹ The planned route was from Port Macquarie to overhead Taree, Williamtown, then on descent from controlled airspace to Brooklyn Bridge, and via the lane of entry (LOE) to Bankstown Airport (Figure 1).

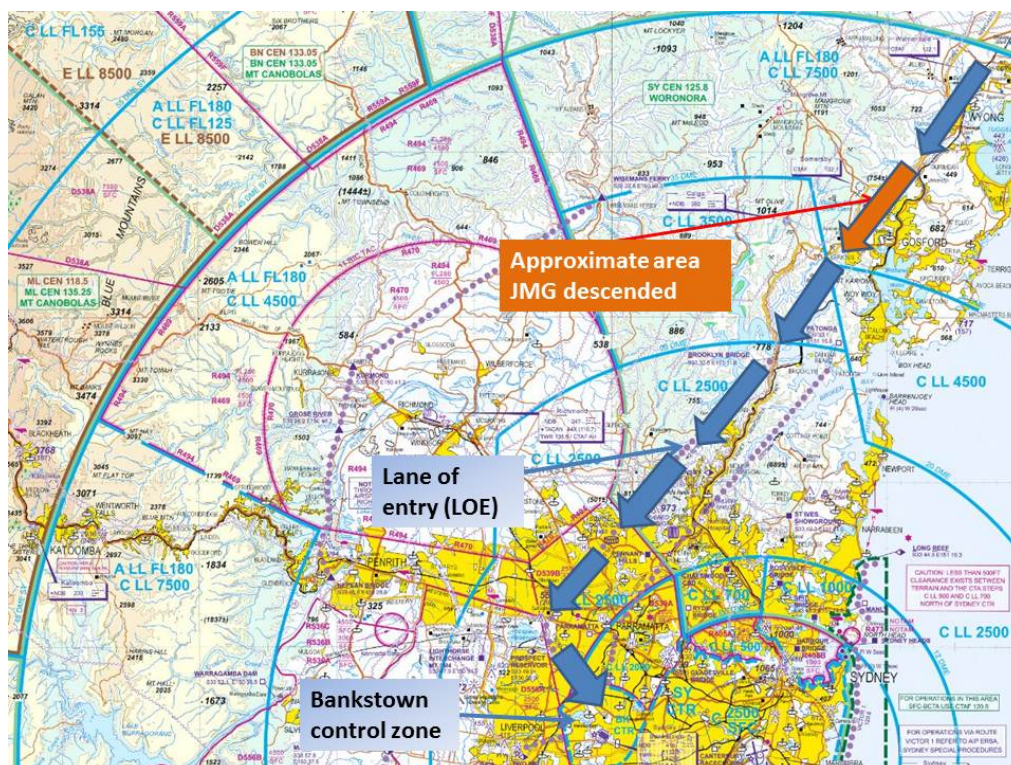
Figure 2: Flight path of VH-JMG

At about 1601, as JMG passed overhead Williamstown, ATC called the pilot of JMG to advise that control services were terminated, but no response was received. The aircraft subsequently entered Class E airspace³. At about 1620, the aircraft was observed to re-enter Class C airspace, without an ATC clearance, maintaining 8,500 ft.

About 20 minutes after entering Williamstown airspace, the pilot recalled waking up. Realising he must have fallen asleep, he gathered his thoughts, checked the aircraft's instruments and then realised that he was now in Class C airspace, about 12-15 NM north of Brooklyn Bridge (Figure 2).
