Level crossing collision between passenger train 7MA8 and a dual cab utility

Inverleigh, Vic | 31 August 2013

ATSB Transport Safety Report
Rail Occurrence Investigation
RO-2013-023
Final – 5 February 2014

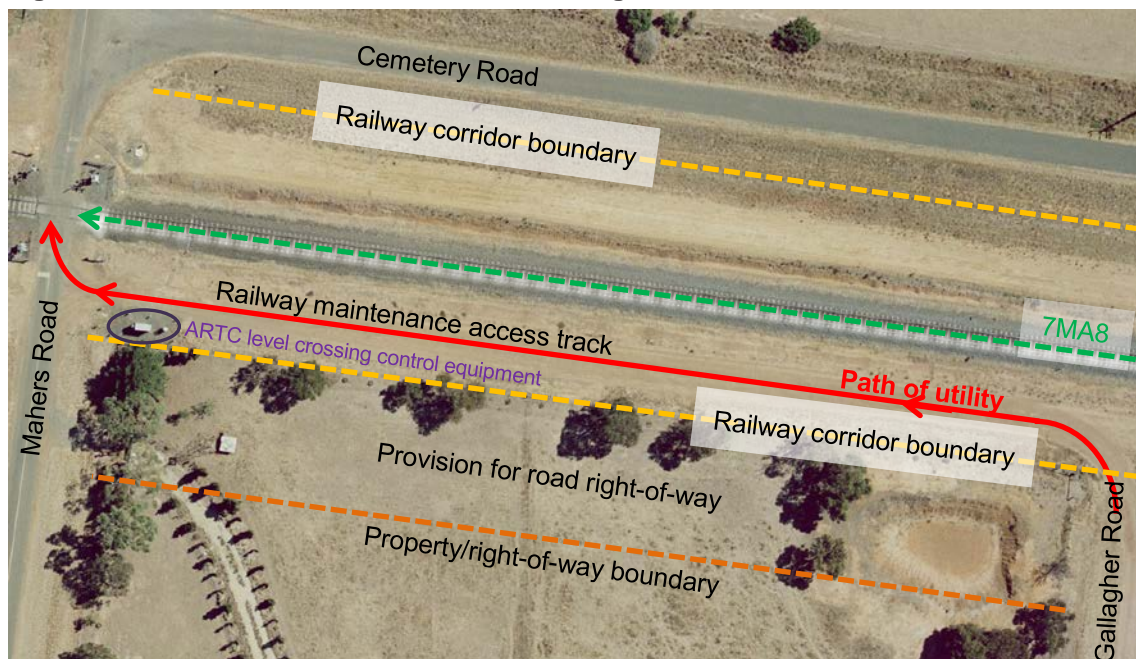
Figure 1: Aerial view Mahers Road level crossing

As the train approached the level crossing, the train crew observed a Holden Rodeo dual cab utility (utility) travelling west along the unsealed maintenance access track adjacent to the railway (Figure 1).

Gallagher Road is a local unsealed road located about 140 m east of, and running parallel to, Mahers Road. According to the Department of Planning and Community Development Victoria map of land titles, the road terminates at the railway property boundary. There was provision for a nearby road right-of-way between Gallagher Road and Mahers Road to the south of the railway corridor boundary (Figure 1). However, a road had not been constructed on the right-of-way.

The road used by the utility, known locally as the 'Gallagher Road Extension' (Figure 1) was, in fact, a railway maintenance access track located entirely within the railway corridor on land leased by the Australian Rail Track Corporation (ARTC). Nevertheless, many commercial mapping providers, including VicRoads, had incorrectly identified the maintenance access track as a road.

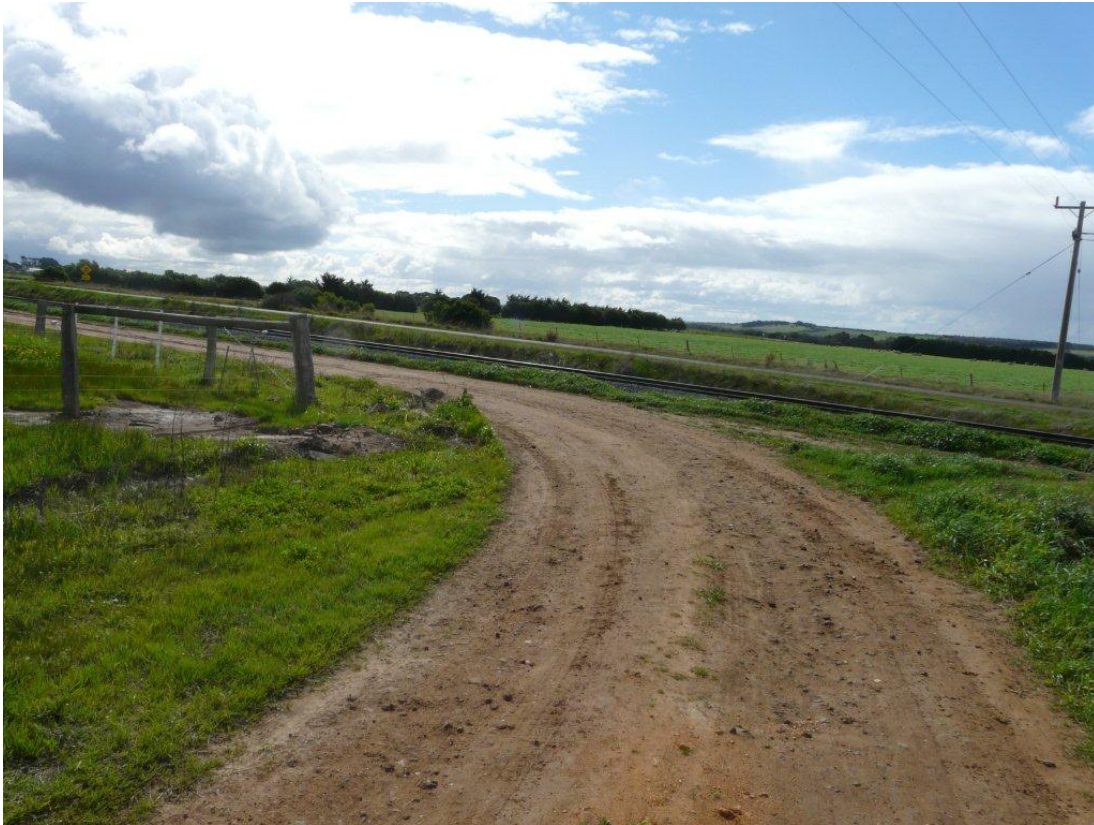
Figure 2: Intersection of Gallagher Road and the access track

Examination of the site after the collision established that although the maintenance access track was not a public road it was regularly used by local traffic to gain access between Gallagher Road and Mahers Road (Figure 2 and Figure 3).

Examination of the site after the collision established that, at some time in the past, the fence at the Gallagher Road/railway property boundary had been removed, thereby providing vehicle access along the railway maintenance track. As a result, over time and with regular use, the false perception that the maintenance track was part of Gallagher Road was created and reinforced.

The Australian Rail Track Corporation will commit to work with the Golden Plains Shire Council, as the relevant road authority and adjoining land owner to achieve the permanent closure of the section of Gallagher Road, which is located on the rail corridor. The safe and permanent closure of the roadway at the surveyed boundary requires signage to be installed on the main part of Gallagher Road; hence the safe and effective permanent closure is seen to be a joint project.

The Golden Plains Shire Council has recently updated its Road Management Plan and intends to revise its Register of Public Roads for the purpose of clarifying the status of roads currently classed as Unmade Roads. The revision will result in roads currently included on the register as a public road and classed as an unmade road, being removed from the register. The council will jointly work with the ARTC to isolate the rail reserve from the road reservation.

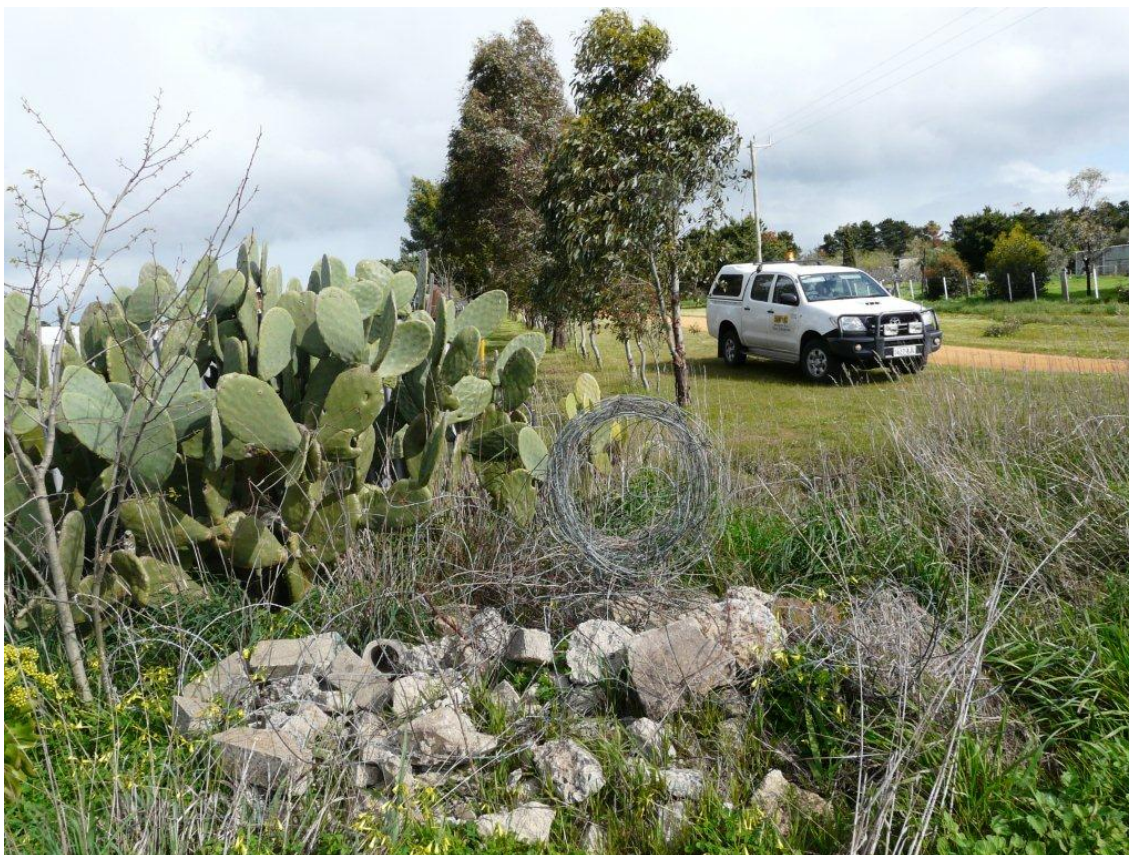
Figure 4: Discarded fencing

There were also coils of fencing wire and remnants of concrete posts found near the junction of Gallagher Road and the railway property boundary (Figure 4). This indicates that the railway corridor had at some point in time been fenced off to prevent access to the railway corridor and the maintenance access track. The investigation could not determine when the boundary fence was removed.

The boundary fence between the railway maintenance access track and Gallagher Road had been removed. As a result, over time and with regular use, the false perception that the maintenance access track was part of Gallagher Road was created and reinforced.

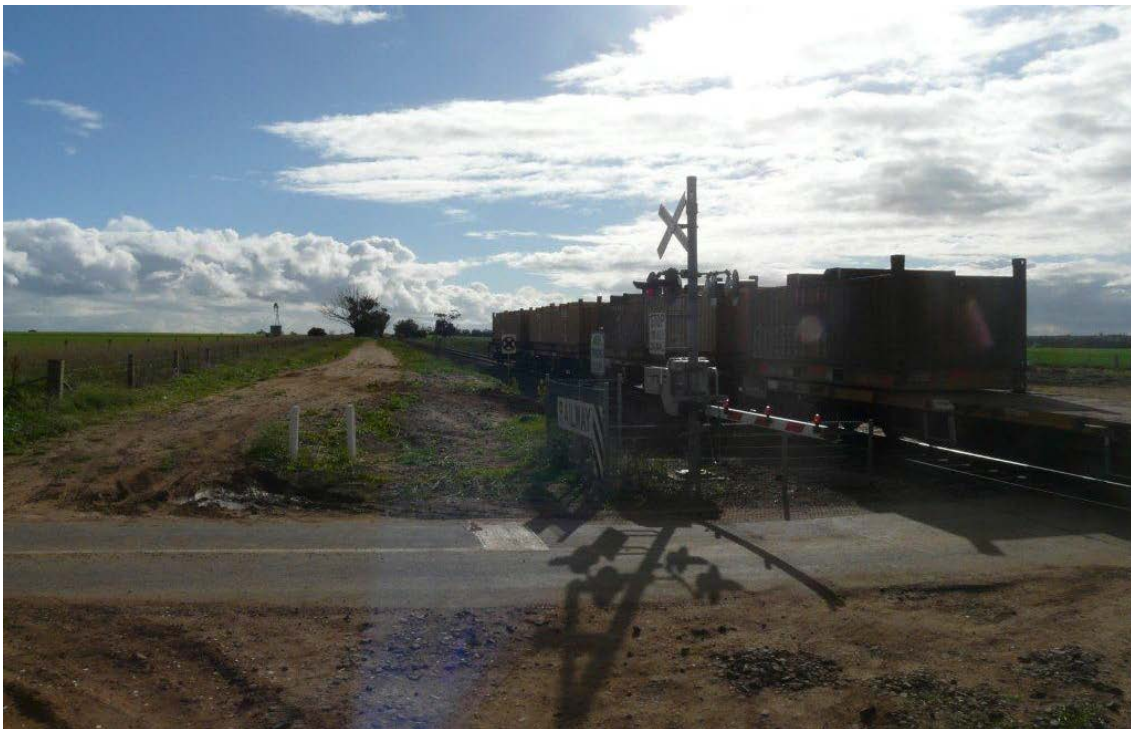
Figure 5: Approaching level crossing from access track

As the driver was approaching the intersection, the flashing signal and boom barrier assembly were at 90 degrees to his direction of travel and almost directly in front of the vehicle (Figure 5). Consequently, the boom barrier (when lowered) would have been pointing almost directly at the driver rather than being orientated across the driver's intended path. Similarly, the flashing lights were directed along Mahers Road rather than the maintenance track.

With the orientation of the traffic control devices set for Mahers Road, it is likely that the driver did not detect the lights or barrier and was unaware of the train approaching from behind. As the vehicle was turned onto Mahers Road and struck the tip of the boom barrier, the driver stopped. However, the vehicle was fouling the railway line and did not clear it in time to avoid the collision.
