Turbulence event involving a Boeing 767, VH-OGU

near Sydney Airport, New South Wales, 8 November 2013

ATSB Transport Safety Report
Aviation Occurrence Investigation
AO-2013-209
Final – 25 February 2014

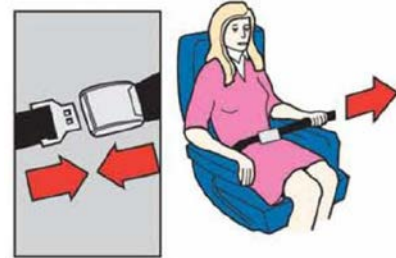
Keep your seatbelt fastened

This incident serves as a timely reminder to passengers to safely stow any carry-on baggage, laptops, iPads and other items in the overhead locker or under the seat in front of you, particularly when the seatbelt light is turned ON. These items can become projectiles during turbulence if not properly secured.
