Descent below segment minimum safe altitudes involving Airbus A320-232 VH-VQA

near Queenstown, New Zealand | 16 July 2012

ATSB Transport Safety Report
Aviation Occurrence Investigation
AO-2012-103
Final – 13 March 2014

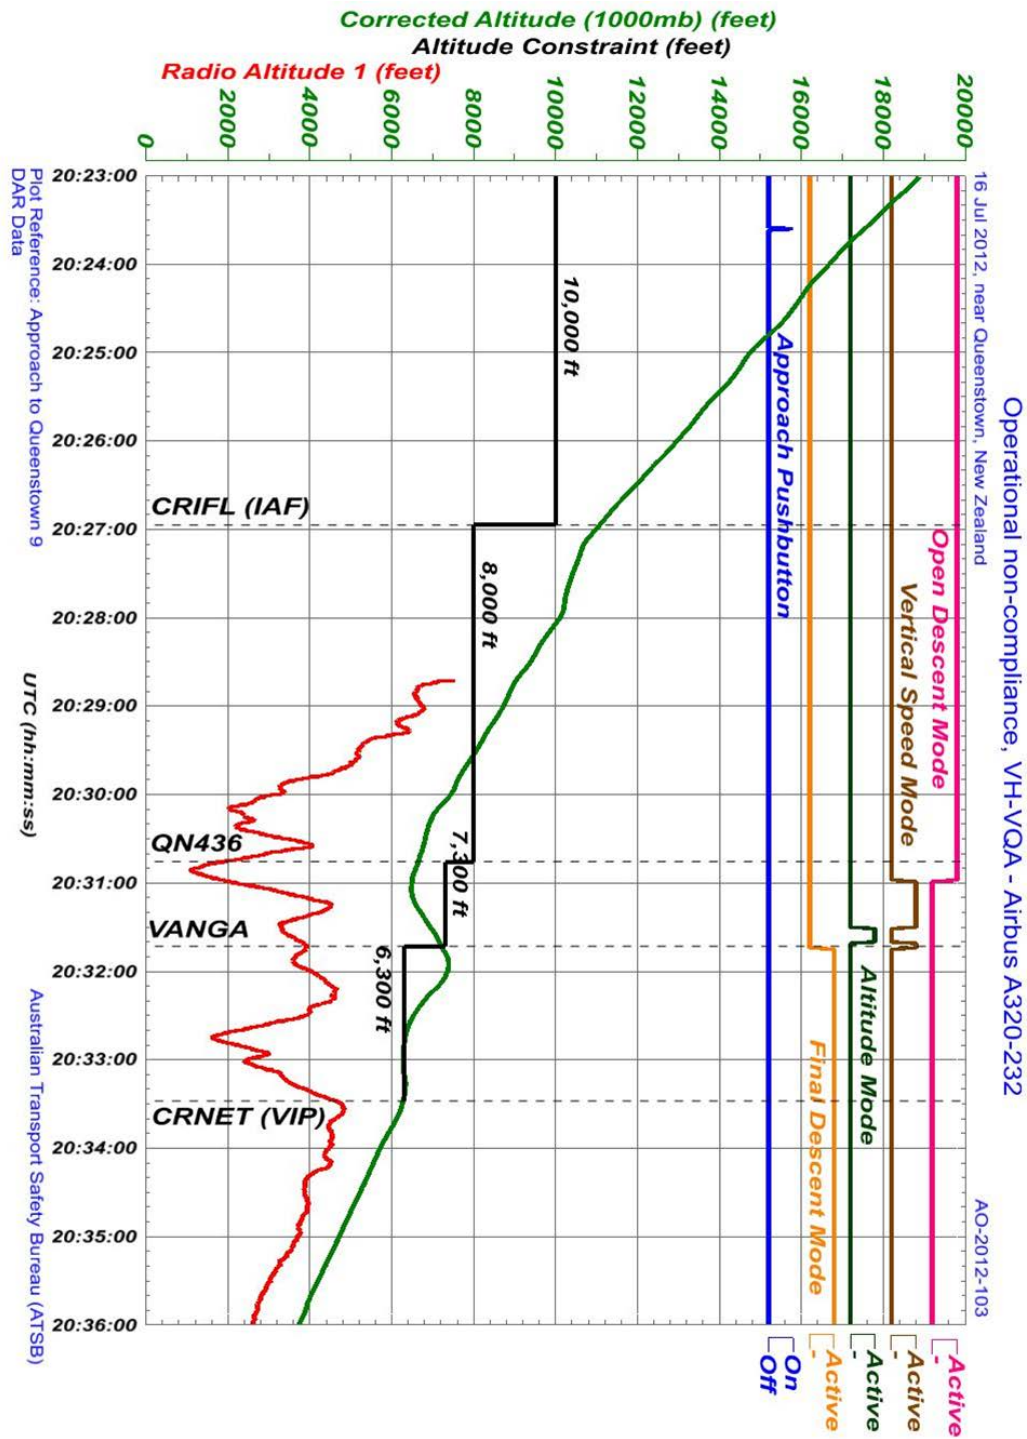
Figure 2: Descent profile and auto-flight descent modes¹⁰

In open descent mode, the aircraft was in an unrestricted descent to 6,300 ft to intercept the final approach path, tracking laterally via the waypoints defined on the instrument approach procedure. Just before 0830, the aircraft infringed the 8,000 ft segment minimum safe altitude between waypoints CRIFL and QN436, and continued descent beneath the 7,300 ft segment minimum safe altitude between waypoints QN436 and VANGA (Figure 1).

At about 0831 and nearing 6,300 ft above mean sea level, the first officer was alerted by a sensation they described as 'going too fast'. They noticed the radio altimeter⁷ indicating about 2,300 ft above ground level and a rate of descent at that moment of around 2,100 ft per minute, and alerted the captain accordingly. The captain checked the altimeter, realised the problem and commenced a climb using the auto-flight vertical speed mode.⁸ The aircraft climbed to 7,300 ft above mean sea level near waypoint VANGA, which was the applicable minimum altitude at that

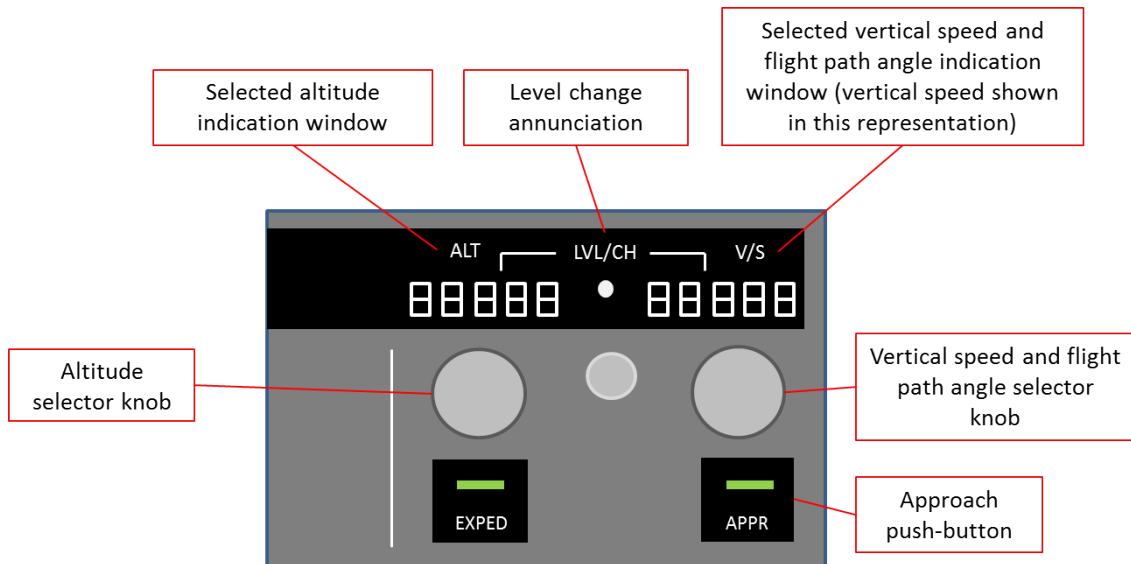
Figure 3: Representation of FCU vertical mode management panel

Open descent mode is engaged by pulling the altitude selector knob on the FCU. The switch from open descent mode to managed descent mode is made by pushing the altitude selector knob. Figure 3 provides a representation of the vertical mode management panel of the FCU.

- The white level change (LVL/CH) dot on the FCU illuminates when the auto-flight system is in managed descent mode to a selected altitude (Figure 3). In open descent mode, this dot is extinguished.

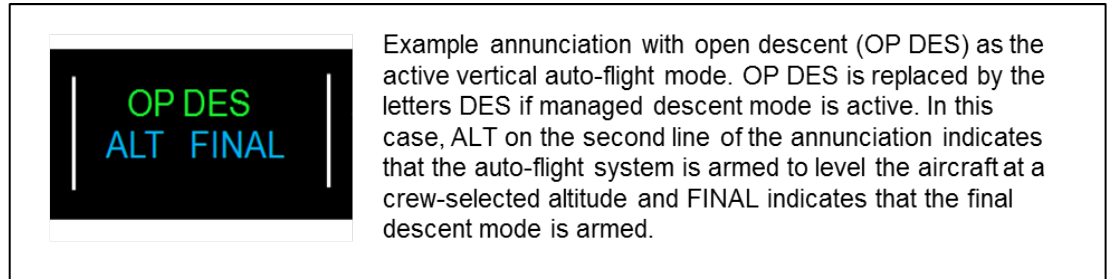
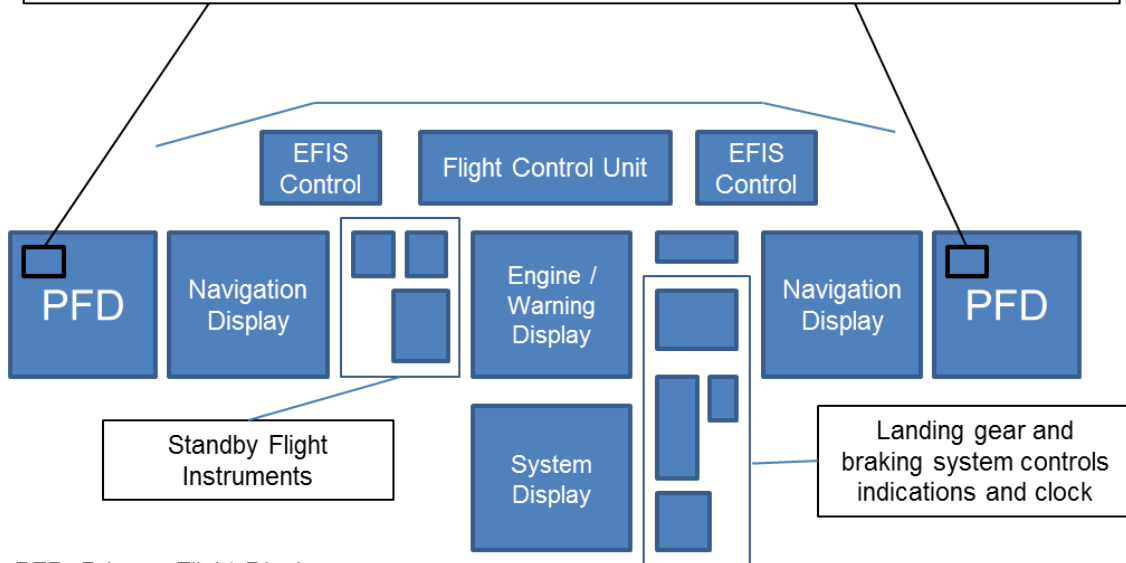
Figure 4: Representation of relevant flight deck displays and example FMA annunciation

on the right by the auto-flight lateral mode. Managed descent mode is annunciated by 'DES' and open descent mode is annunciated by 'OP DES'. The armed mode is annunciated on the second line of the FMA to inform the crew of the mode to which the auto-flight system will next sequence. A white box is displayed around new annunciations for 10 seconds when the FMA changes. Figure 4 shows the location of the FMA and an example FMA vertical mode annunciation.
