Loss of separation between a Schweizer 269C, VH-HYD and a Piper PA-31, VH-IBI

Moorabbin Airport, Victoria, 22 October 2013

ATSB Transport Safety Report
Aviation Occurrence Investigation
AO-2013-189
Final – 27 March 2014

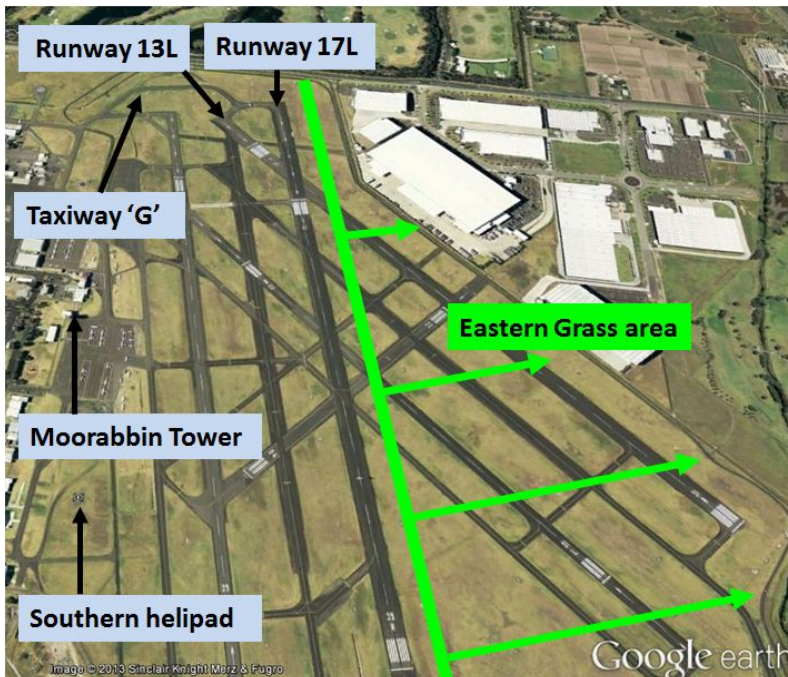
Figure 1: Moorabbin Airport

Runway 17 Left (17L) was the designated runway in use¹ at the time. The helicopter circuit area was the 'Eastern Grass', defined as the area extending from 20 m east of, and parallel to, runway 17L to the perimeter fence. When operating in this area, helicopter pilots were required to broadcast prior to becoming airborne for each circuit, but were otherwise not controlled by air traffic control (ATC) (Figure 1).²

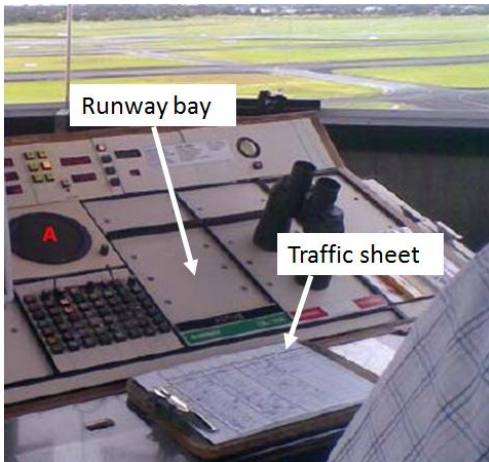
Figure 2: Aerodrome controller – east console

in use. He was seated between ADCE and SMC, from where he was able to sight the aerodrome. ADCE had the runway strip for runway 17L on the runway bay on the console (Figures 2 and 3).

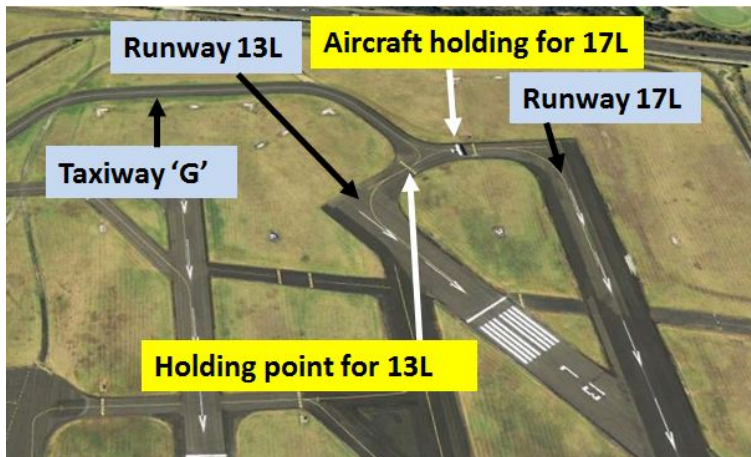
Figure 6: Holding points for runways 13L and 17L

To facilitate re-sequencing of the aircraft, ADCE opted to change the departure runway for IBI from runway 17L to runway 13L. As IBI was already on taxiway 'G' and the aircraft ready for circuits was at the holding point for runway 17L, there was limited time to obtain coordination with SMC for the use of runway 13L and then alert the pilot of IBI to turn right towards the holding point for 13L, instead of left towards 17L prior to IBI reaching the intersection. ADCE also had to ensure adequate runway separation for the aircraft on base for runway 17L (Figure 6).

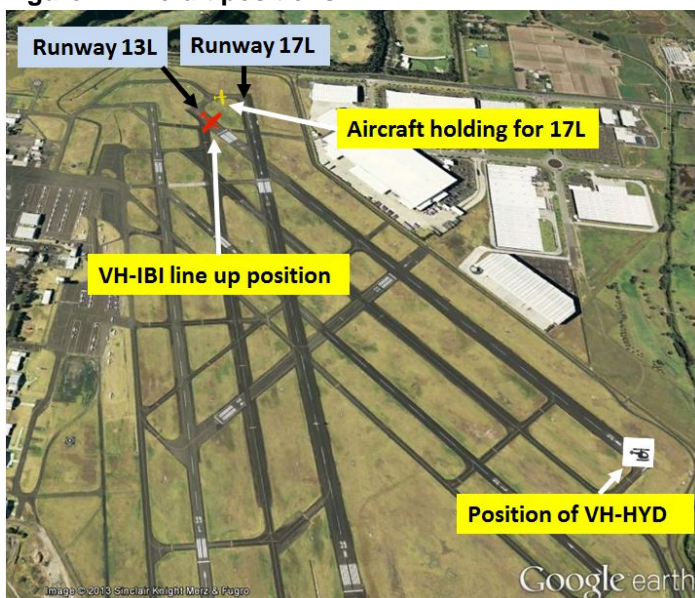
Figure 7: Aircraft positions

At this time, the helicopter, HYD, was on the runway 31 Right threshold at the far end of runway 13L, however ADCE did not see the helicopter when conducting a scan of the runway prior to clearing IBI for take-off. ADCE reported that the 'Helicopters' strip on the console was not effective in alerting the controller to the presence of the helicopter (Figure 7).

At about 0918, ADCE cleared IBI for take-off from runway 13L. The pilot of IBI sighted the helicopter ahead, on the runway centreline, when about two-thirds of the way along the runway. As the aircraft had already exceeded the minimum rotate speed, the pilot continued the take-off, increased the aircraft's angle of climb, and IBI passed about 100-200 ft above HYD.

As a result of this occurrence, the Moorabbin Tower Manager advised the ATSB that they have changed the colour of the 'Helicopters' strip from yellow to bright orange to make it more visible.

- Amend local procedures at Moorabbin associated with helicopter operations including the Eastern Grass training area as follows: ADC to request release of helicopter training areas from the SMC; SMC to display a helicopter training area reminder strip underneath the runway jurisdiction strip/s when helicopter training areas are active; and SMC to indicate active helicopter areas on the reminder strip. Coordination will be required between ADC and SMC for activation of the training areas and the SMC and ADC will display a helicopter reminder strip.
