Near collision between a Piper PA-25, VH-MLS, and an AMS-Flight DG-303, VH-DGA

Bunyan (ALA), New South Wales, 8 February 2014

ATSB Transport Safety Report
Aviation Occurrence Investigation
AO-2014-022
Final – 27 March 2014

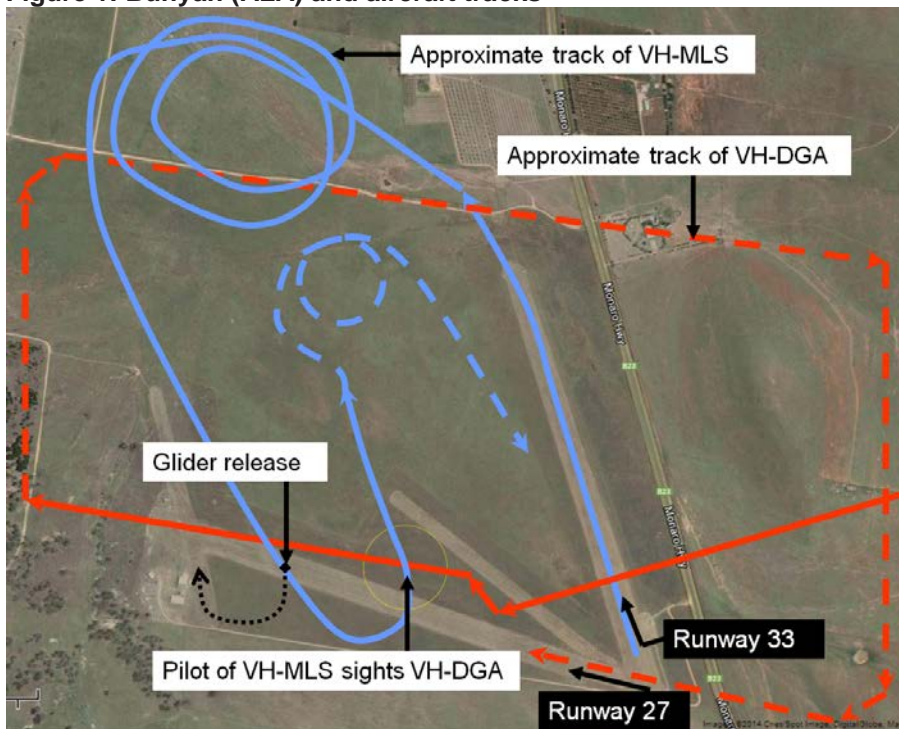
Figure 1: Bunyan (ALA) and aircraft tracks

About 10 minutes later, the pilot of a Piper PA-25, registered VH-MLS (MLS), broadcast a lining up and rolling call and took off from runway 33 at Bunyan to launch a glider from overhead the aerodrome (Figure 1).

At about 1515, when at about 4,000 ft AMSL, in anticipation of the glider pilot releasing the tow cable, the pilot of MLS turned to look behind the aircraft. He confirmed that the glider had released successfully and, in accordance with standard operating procedures, he then commenced a descending turn to the left.

The pilot of DGA sighted MLS release the glider and commence the turn. The two aircraft were at about the same altitude and he then observed MLS with the wings level, he assumed the aircraft would then track straight ahead. He commenced a right turn to increase separation between them, and to track towards the joining point for a right downwind for runway 27. He reported that he assumed the pilot of MLS had sighted DGA at that time, and that he did not see MLS again until it was on downwind.

As the pilot of MLS rolled the aircraft's wings level from the turn, he saw DGA as a white flash passing about 30 ft below him, and reported that he could see the rivets on the glider's airbrakes.
