Australian Government
Australian Transport Safety Bureau

Aviation Short Investigations Bulletin

Issue 29

ATSB Transport Safety Report
Aviation Short Investigations
AB-2014-046
Final – 8 April 2014

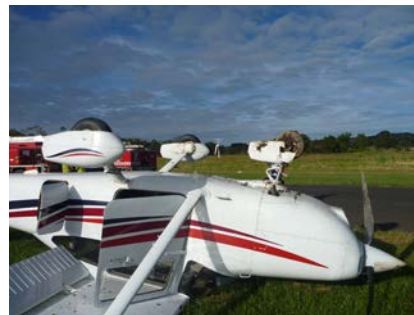
VH-LMA damage

When the aircraft had slowed to about 50 knots, he began to apply the brakes. At about the same time, a gust of wind pushed the aircraft to the left. The pilot applied right rudder in an attempt to steer the aircraft back to the centreline, but stated the aircraft pulled to the left and felt like the left brake had locked. The grass verge next the runway was wet due to recent heavy rain. The aircraft rapidly decelerated, and continued along a path through the wet grass a few metres to the left of the sealed runway. As it stopped, the aircraft nosed forward, and then tipped over onto its back (Figure 2).

The pilot and his passenger were hanging upside down, and due to their weight on the straps, were unable to release the seatbelts. Fortunately, a person had been waiting for the aircraft to arrive, and quickly rendered assistance. The young passenger was able to slip through the harness and was carried a safe distance from the aircraft by the assistant. The pilot then instructed the assistant to find the pocketknife which he kept in a bin between the two front seats, while he reached to shut off the fuel and master switch. The pocketknife was located on the now upside down aircraft ceiling and was used to cut the seatbelt and free the pilot. Both the pilot and his passenger received minor injuries and the aircraft was substantially damaged.

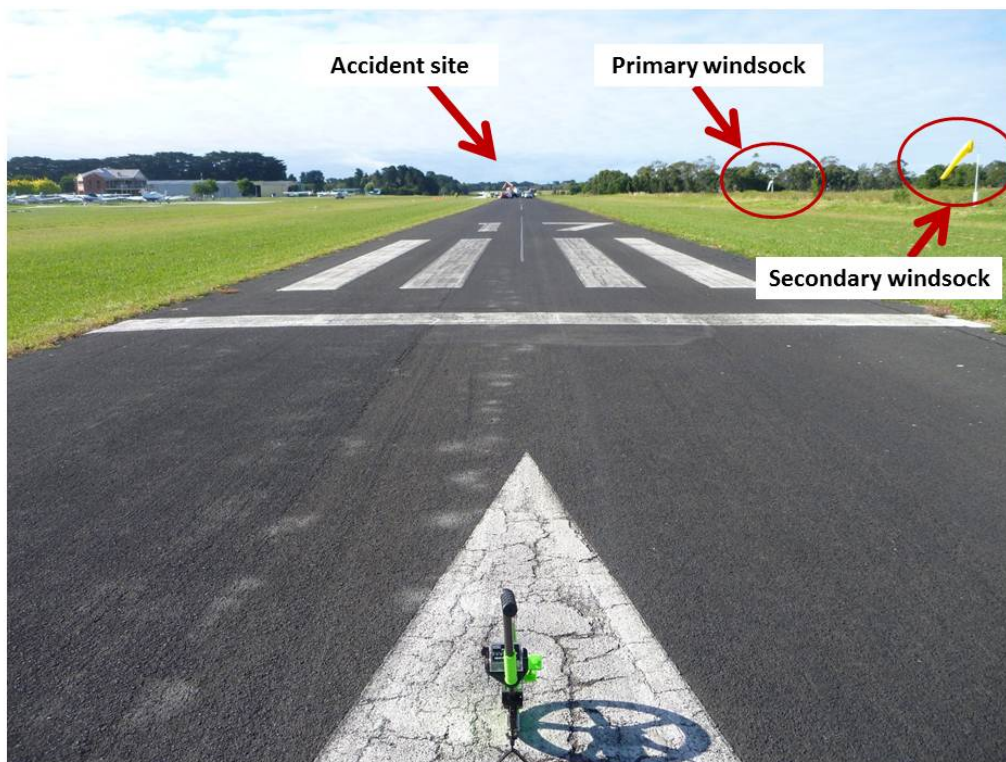
Figure 1: Approach to runway 17 at Tyabb ALA

During the base leg, he again broadcast on the CTAF, then completed the pre-landing checks, except for selecting the final stage of flap. When on final approach, he checked the secondary windsock (Figure 1) and noted the wind was predominantly crosswind from the right, gusting around 5-10 knots. With the final stage of flap selected, the aircraft touched down on the main wheels about 20-30 metres past the runway threshold, close to the centreline. The pilot estimated that the aircraft touchdown speed was about 65 knots. During the landing roll, he applied a small amount of right aileron to counter the crosswind.

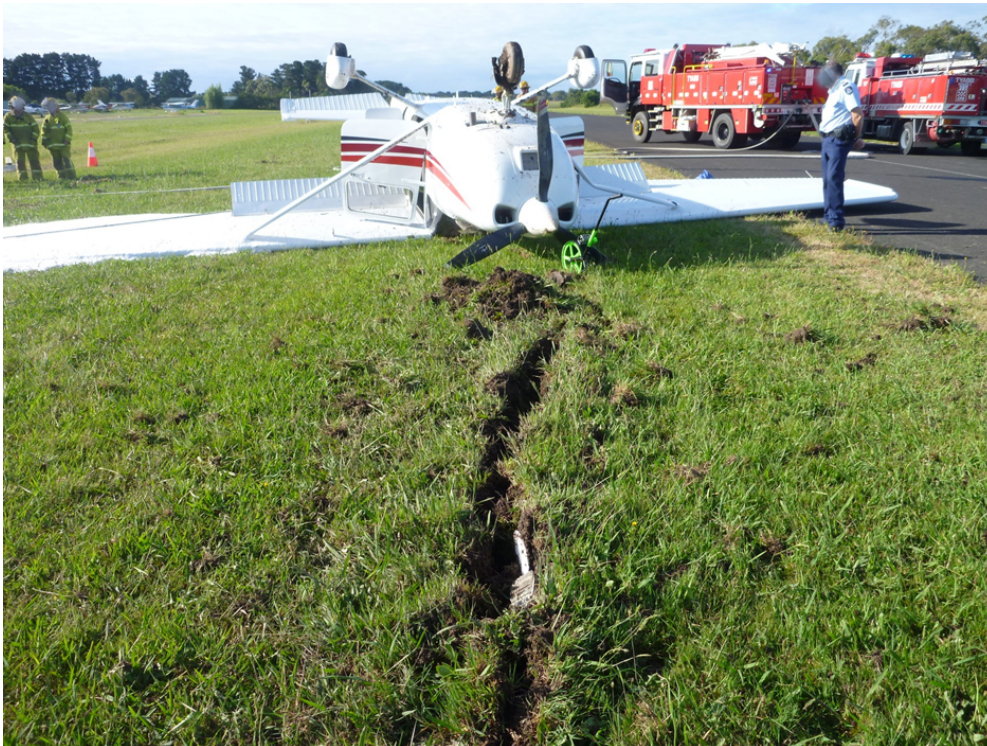
Figure 2: VH-LMA showing path through the grass verge

Also, in hindsight, the pilot felt that if he had applied right rudder a little earlier during the landing roll, this may have prevented the aircraft leaving the sealed runway, and onto the sodden grass verge.

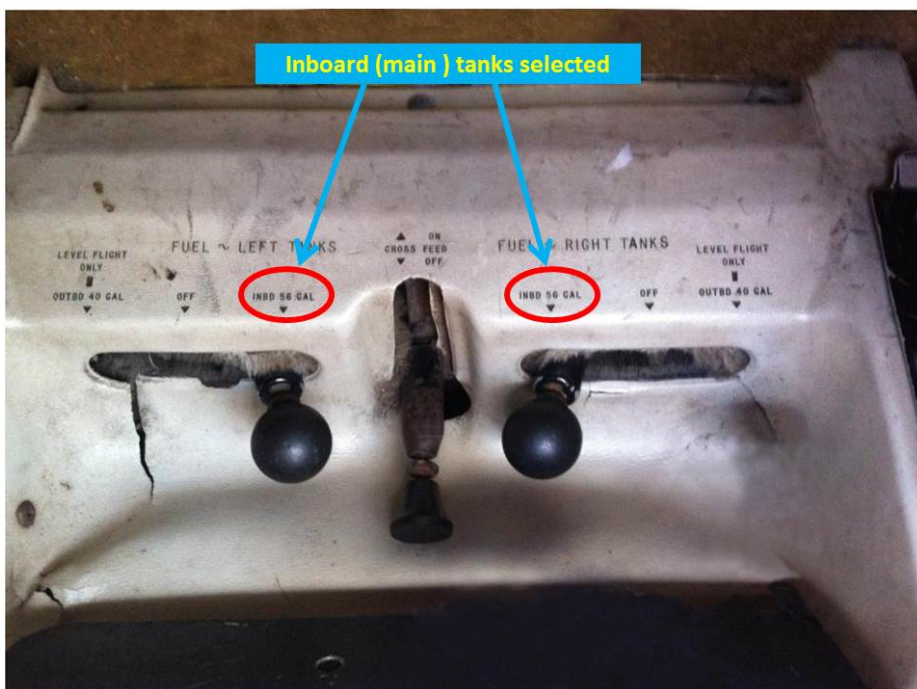
Figure 1: PA 31 fuel selectors on inboard (main) tanks

The PA31 Navajo fuel system consists of four flexible fuel cells, two in each wing. Two electric fuel quantity gauges are mounted in the overhead switch pane. The right fuel quantity gauge indicates the quantity of fuel in the selected right fuel system tank (right main or right auxiliary), and the left fuel quantity gauge indicates the quantity of fuel in the selected left fuel system tanks. There are also engine-driven fuel pumps, and emergency fuel pumps. Emergency fuel pumps are installed to provide fuel pressure in the event an engine driven pump fails. These pumps are also used under normal conditions for priming the engines, take-off, and landing. The fuel selectors are required to be set on the main tanks for take-off.

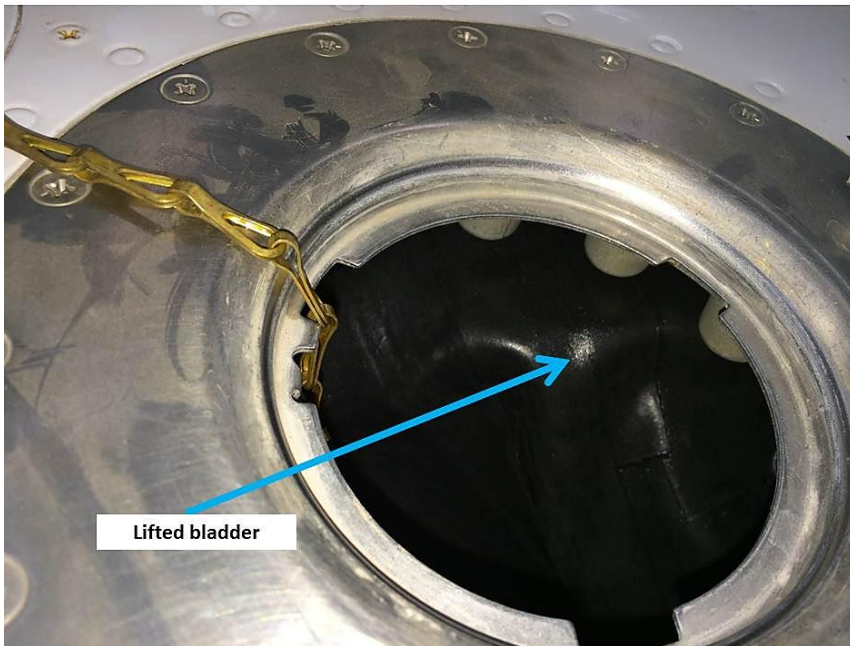
Figure 3: Lifted bladder, VH-OFF left auxiliary tank

A post-accident engineering report found all four fuel tanks were operational. When selected, the auxiliary tanks were almost empty. The left and right auxiliary tank fuel samples indicated about 0.5 ml of water was present. The left auxiliary fuel tank bladder was found to be lifted inside the tank (Figure 3). The engineer noted that in its extremities, the bladder can lift the fuel sender float, which gives a false indication that there is more fuel in the tank than available. Fuel pressure was tested and was normal.

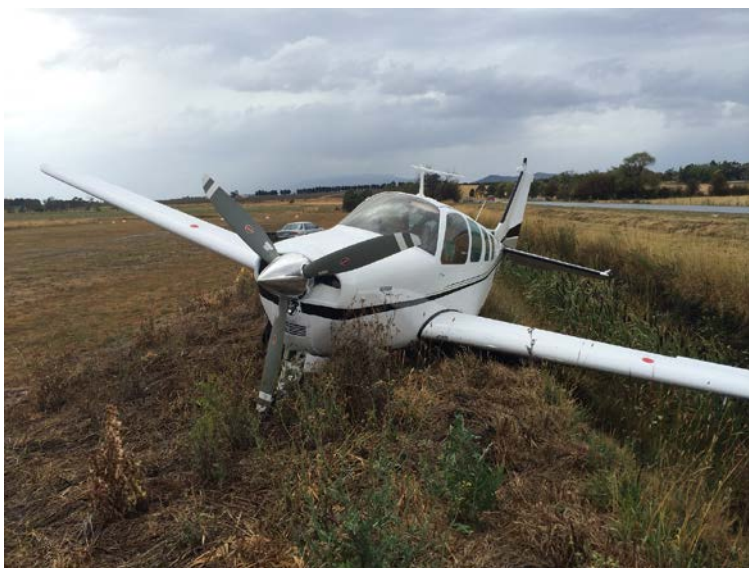
Figure 1: VH-EUB

After exiting the aircraft, the instructor observed that the wind had veered and was then about 10 kt from 340° and assessed that a tailwind may have contributed to the incident.

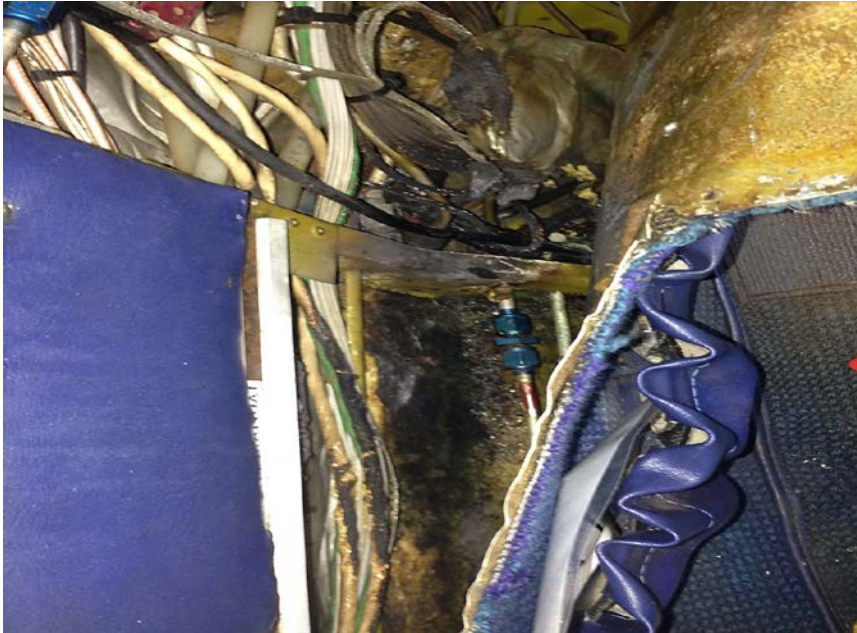
Figure 1: Fire damage behind the left internal panel of VH-SBS

An engineering inspection found that exhaust gas temperature (EGT) wiring had penetrated through the heater supply fuel line causing it to arc out and burn a hole in the fuel line. With an ignition source and fuel, the fire in the cabin was started. Engineers disconnected and capped the heater fuel line and reconnected the vacuum line.

The engineer also reported that the wires had been bundled together and were rubbing on the fuel line. Inspection of the wires prior to the flight would have required the internal panel to be removed, and was not a routine inspection item.

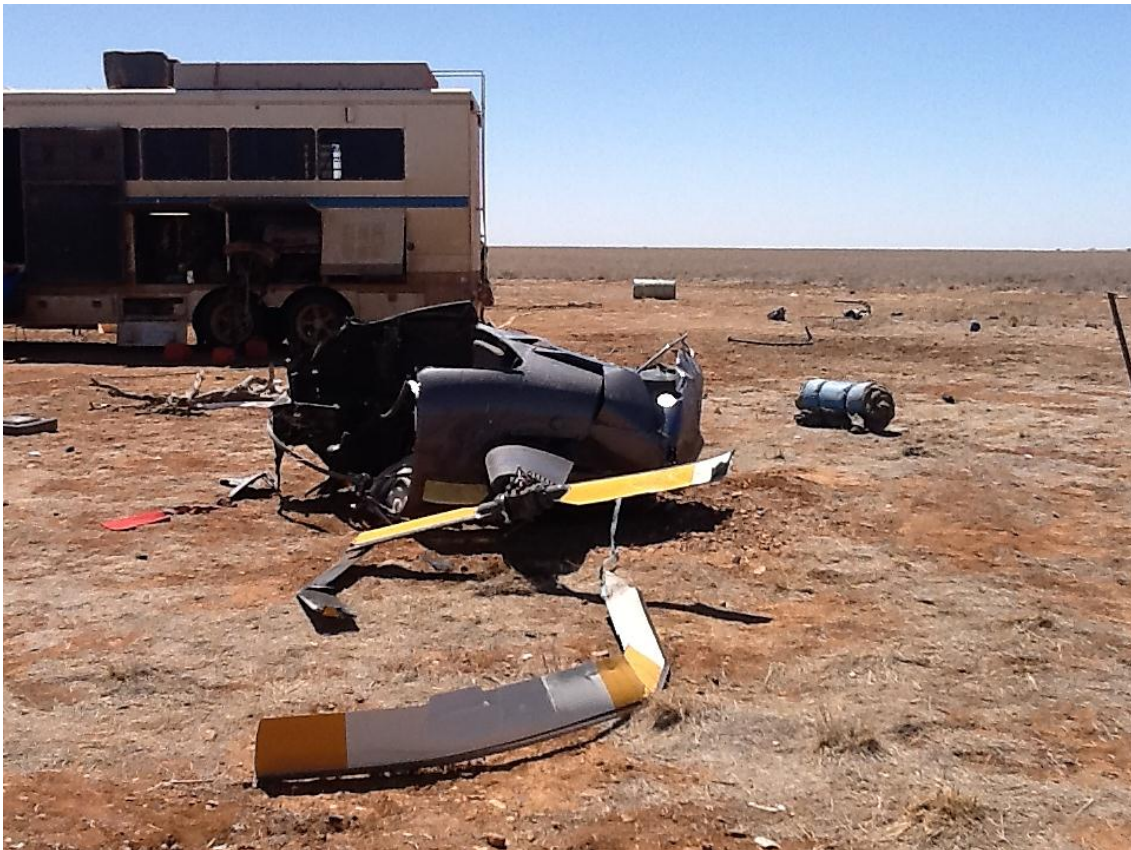
Figure 1: Damage to VH-HVW

Shortly after take-off, the helicopter was observed by witnesses at the stock camp to commence a steep climbing left turn. As the helicopter turned into a downwind position, a number of the witnesses reported that the wind appeared to affect the controllability of the aircraft. It appeared that the pilot attempted to respond to the situation, however, there was insufficient altitude to recover. The helicopter skids contacted the ground and became separated. The helicopter slid along the ground and then flipped over a number of times before coming to rest near the stock camp. During the accident sequence, the pilot was ejected from the helicopter and sustained serious injuries; the helicopter was destroyed (Figure 1).

The aircraft owner attended the accident site, and based on his observations and that of the witnesses, believed that when the helicopter was in a downwind position, a negative G¹ situation may have occurred. During the subsequent attempted recovery, the pilot appeared to have pushed the nose of the helicopter forward in an attempt to regain airspeed; however, the helicopter contacted the ground.

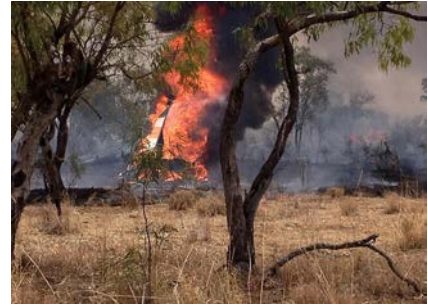
VH-TZE - Intensity of the fire

An uncommanded change in engine noise prompted the pilot to increase engine power a small amount in order to improve engine performance. While doing this, he checked the gauges and noticed that the engine revolutions per minute (RPM) had dropped significantly and the rotor RPM was decaying toward zero. He then saw the technician waving his arms in an attempt to gain his attention. The pilot looked toward the rear of the helicopter and saw a fire underneath, which was spreading into the engine bay. The pilot exited the helicopter and notified the landholders via phone so they could construct fire breaks to contain the ensuing grass fire. The helicopter was not equipped with a portable fire extinguisher. The occupants were uninjured; however, the helicopter was destroyed by the fire (Figure 1).

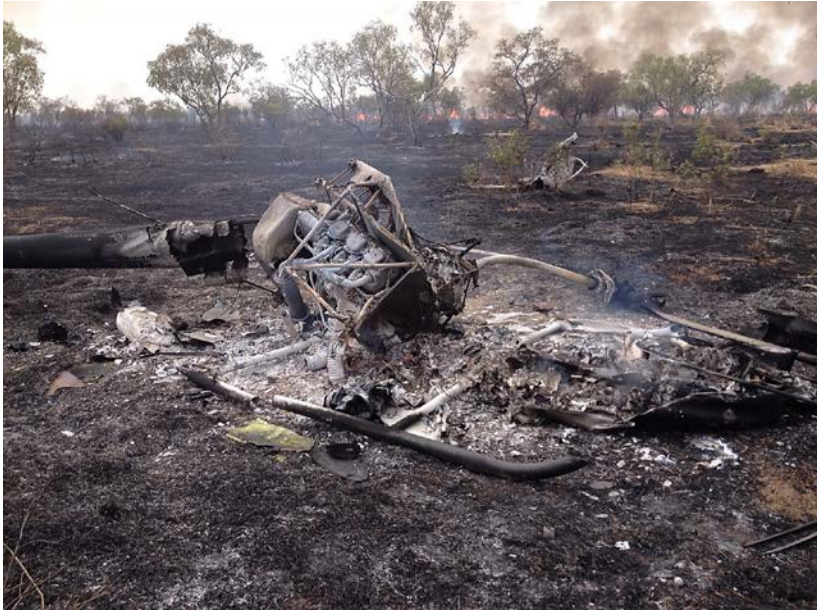
Figure 1: Fire damage to VH-TZE and surrounding bush

TZE had a serial number of 1333, indicating that the helicopter had been fitted with aluminium exhaust collector and tailpipe shields during the manufacturing process. A review of the post-accident photographs³ was unable to identify the presence of these shields in the wreckage; however, it was possible that they had melted in the ensuing fire. The associated stainless steel brackets and clamps were also not observed.

The photographs also indicated that the muffler shroud⁴, a stainless steel shroud that fitted over the muffler to heat the air flow for the cabin heater system⁴ and assisted with cooling the muffler and engine compartment, was not visible. The absence of a muffler shroud would reduce engine compartment cooling and expose a larger surface area of heated metal, thereby increasing the risk of a grass fire during off-airport landings. The reason for the muffler shroud not being evident in the photographs could not be determined.

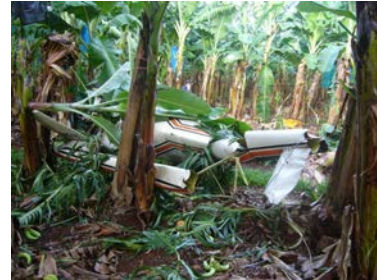
Damage to VH-BNG

At about 0615, on descent to the staging area, when at about 150-200 ft AGL, the helicopter rotor blades collided with a tree, dislodged a branch, and the helicopter subsequently collided with terrain. The helicopter was substantially damaged and the pilot sustained serious injuries (Figure 1).

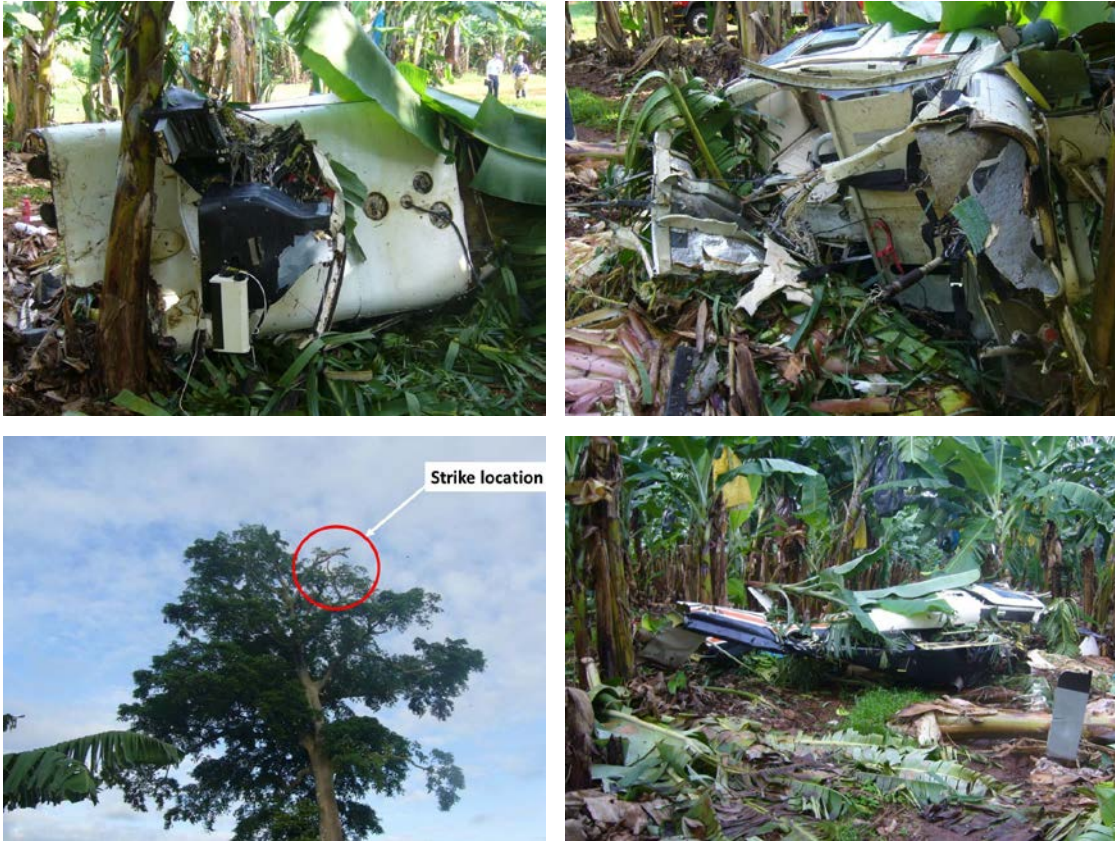
Figure 1: Damage to VH-BNG and large tree strike

- He did not see the tree at any time.
- The helicopter was in a nose-high attitude on descent to the staging area, which caused a significant blind spot.
- There was some overspray on the windscreen, reducing the visibility through it.
- The helicopter was heading towards the south-east and glare from the rising sun further reduced visibility.
- He had taken off to the west, then turned to the north towards the block to be sprayed, so had not sighted the tree on departure. The return route however put the helicopter directly in line with the tree.

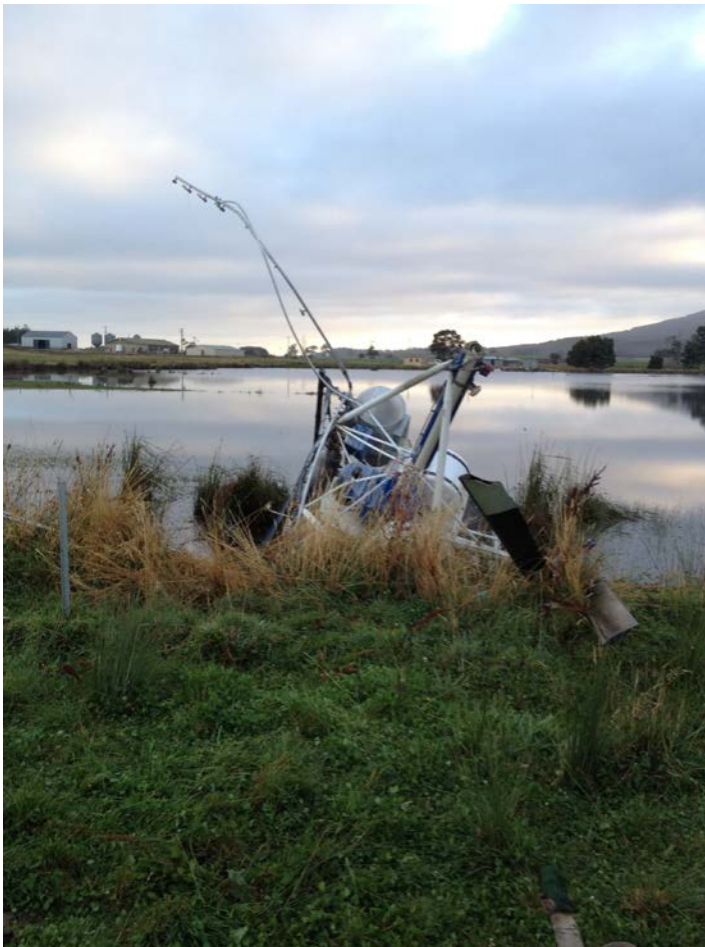
Figure 1: Damage to VH-HAK

The helicopter took off and climbed to about 20 ft above ground level. When about three quarters of the way across the dam, the engine stopped due to fuel exhaustion. The pilot conducted a forced landing onto the edge of the dam, with part of the helicopter sinking into the water and mud. The main rotor blades collided with the embankment resulting in substantial damage (Figure 1).

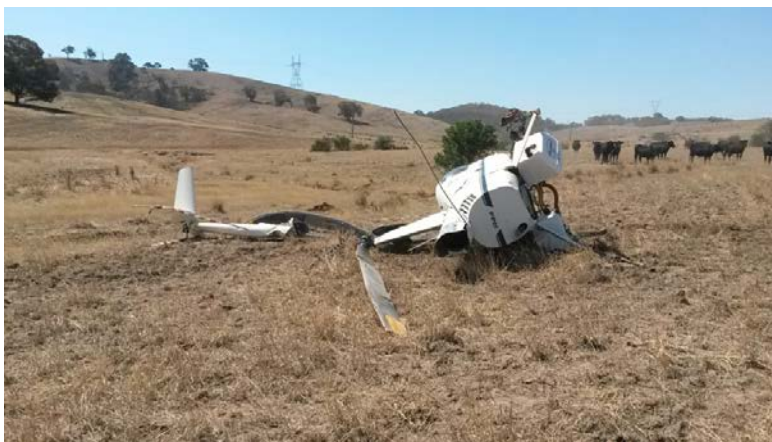
Figure 1: Damage to VH-UGR

The helicopter was about 40-50 m beyond where the load had been jettisoned, and the pilot was focused on gaining lift, when the left skid contacted the ground, and the helicopter rolled over (Figure 1).

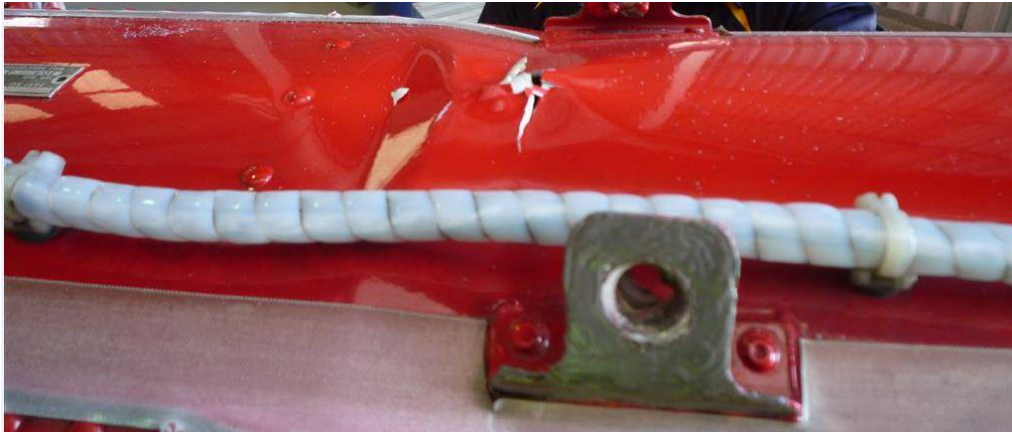
Figure 1: Damage to VH-XJA

When at about 20 ft AGL, the instructor directed the student to commence levelling the helicopter. At the same time the low rotor revolutions per minute (RRPM) warning horn sounded. The instructor realised that the throttle was still at idle and took control of the helicopter from the student. He controlled the yaw, levelled the helicopter, allowed the helicopter to sink, and completed the autorotation to the ground, however the helicopter landed heavily, resulting in substantial damage (Figure 1).
