Fall from the pilot ladder on the bulk carrier *Atlantic Princess*

Whyalla, South Australia | 3 July 2013

ATSB Transport Safety Report
Marine Occurrence Investigation
300-MO-2013-007
Final – 9 May 2014

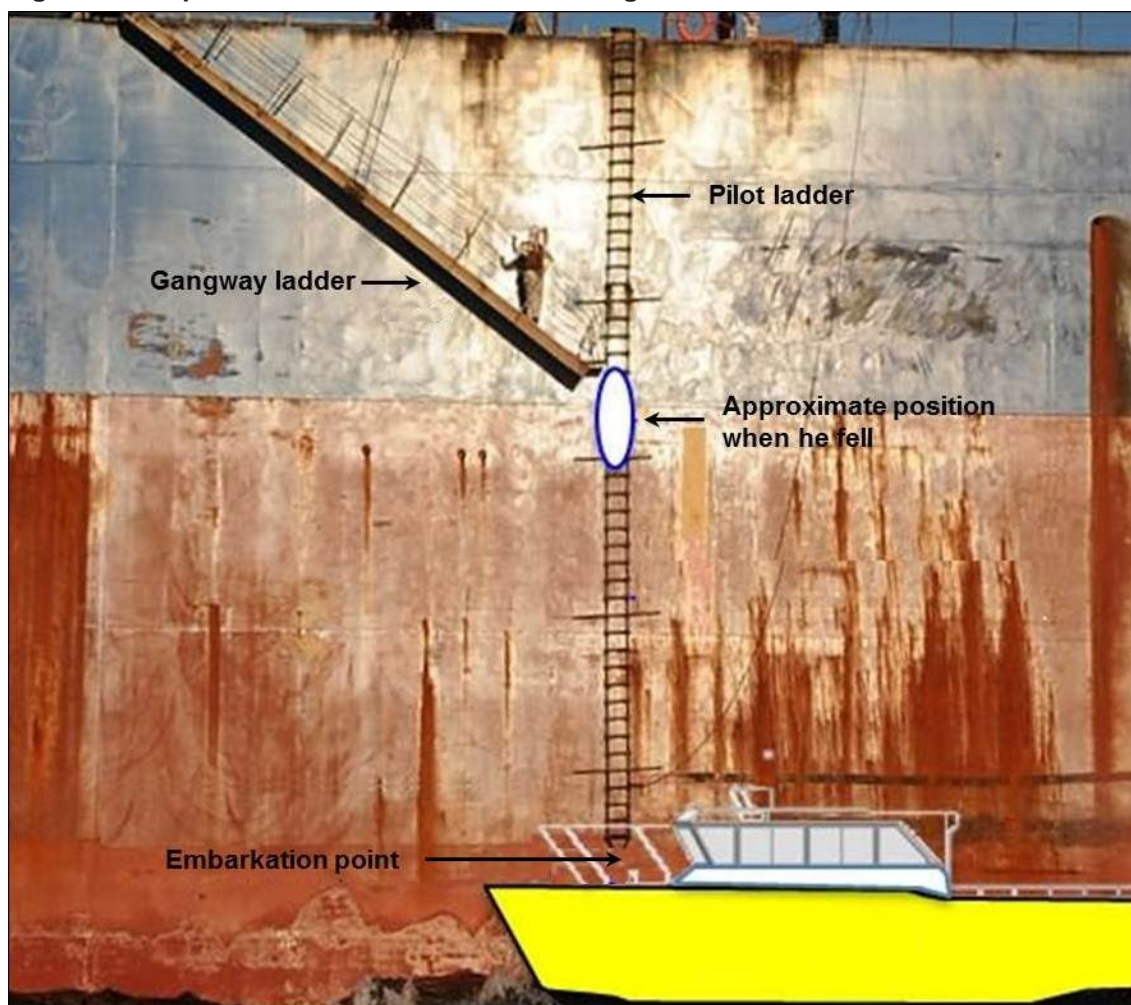
Figure 3: The port side combination ladder arrangement

The deckhand saw that the bottom of the pilot ladder was about two rungs above the deck of the launch, which he felt was too high to climb. He gestured to the crew at the top of the pilot ladder, about 17 m above him, to lower the ladder. At about this time, the two purchaser's representatives moved from inside the cabin to the foredeck.

When the purchaser's master had climbed about 7 m up the ladder, with his head almost in line with the accommodation ladder platform (Figure 3), he stopped. He began gesturing with his right arm and then grasped the ladder with both hands. He remained in that position for about 4 to 5

The ordinary seaman, who was standing-by at the top of the pilot ladder, heard the call for help and ran to the top of the gangway ladder. He was about to make his way down the gangway when, at 1050, he saw the purchaser's master fall from the pilot ladder and land in the centre of *Switcher's* foredeck.

Prior to the boarding of the ATSB investigators on 5 July, the combination ladder had been moved from the port side to the starboard side and a risk analysis was carried out in relation to the upcoming transfer. As a result, the investigators were transferred from the transshipment barge (a larger and more stable platform than the launch) and they were required to wear a safety harness that was attached to a safety line and descent unit.¹⁰

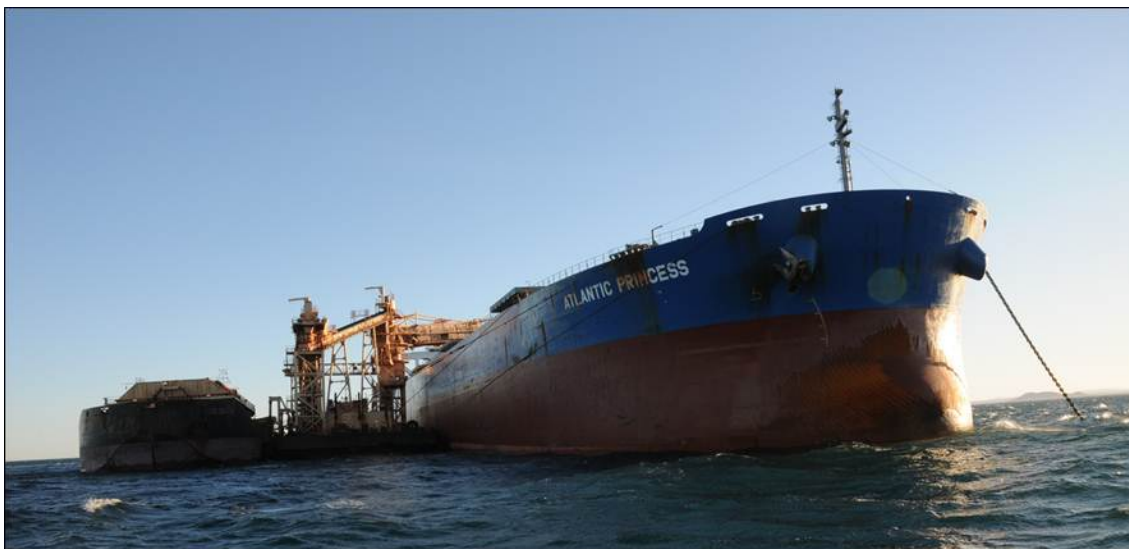
Figure 4: A SUB and *Spencer Gulf* secured alongside *Atlantic Princess*

Atlantic Princess was tied up alongside the Floating Offshore Transfer Barge (FOTB) *Spencer Gulf* (Figure 4) at a place loading cargo. Therefore, according to the *Navigation Act 2012* and Marine Order 21, the ship was in a port. Therefore, the master was required to provide a safe means of access.

At the time of the accident, there was no permanent structure on board the FOTB that was used to provide safe access for personnel boarding and disembarking a ship, like *Atlantic Princess*, that was in the process of loading cargo. Furthermore, the barge operator's written advice to *Atlantic Princess's* master stated that:

The ATSB recommends that CSL Australia should take action to ensure that masters can provide a safe means of access between their ships and the Floating Offshore Transfer Barge *Spencer Gulf* in accordance with the requirements of Marine Order 21.

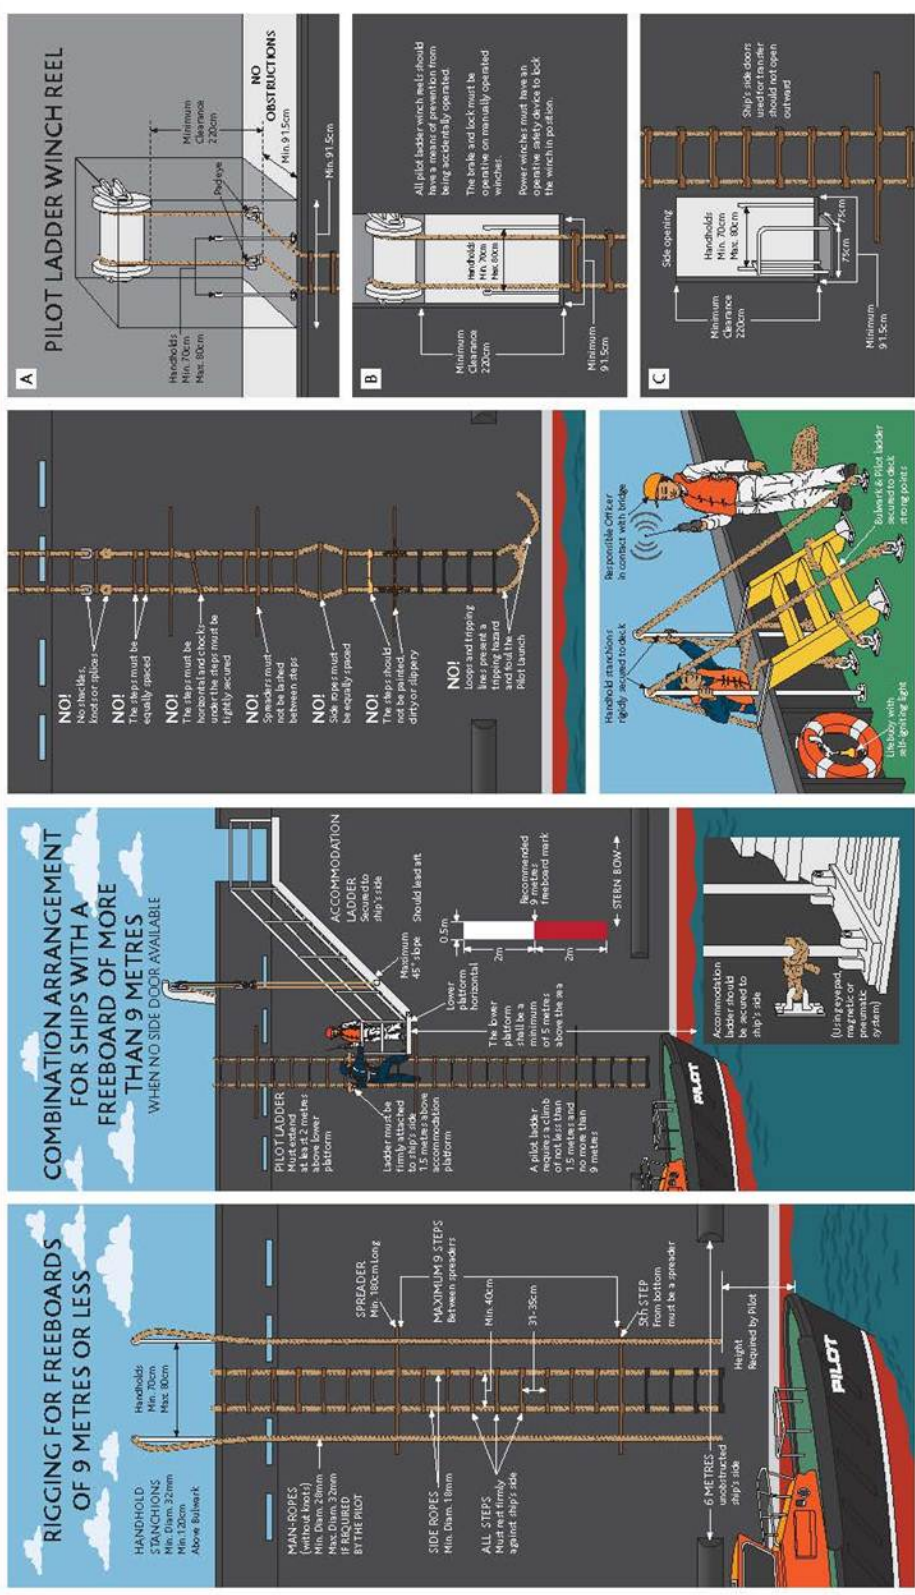
Figure 6: IMPA required boarding arrangements for pilots

This guidance material defined the standards required for the transfer of a pilot, a person who is trained and experienced in the use of pilot ladders. It provided no details of any further precautions that should be taken, or considered, when transferring persons less experienced at climbing and descending pilot ladders or those that are possibly not physically capable of doing so without assistance.
