Australian Government  
Australian Transport Safety Bureau

# Aviation Short Investigations Bulletin

Issue 33

**ATSB Transport Safety Report**  
Aviation Short Investigations  
AB-2014-115  
Final – 6 August 2014

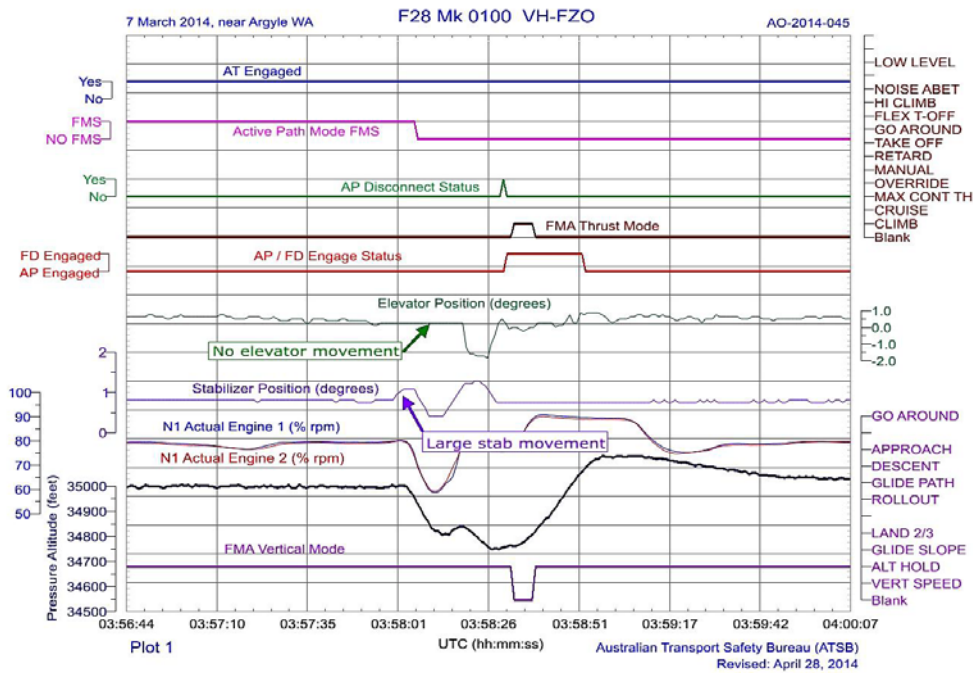
Figure 1: Flight data for VH-FZO

- The data indicated that the uncommanded descent was caused by a stuck elevator.
- The recorded altitude deviation in the descent was 253 ft and maximum vertical speed about 1,400 fpm, based on pressure altitude changes.

Fokker also analysed the flight data in relation to the uncommanded descent and found that the elevator had become stuck for about 20 seconds. Immediately prior to the loss of altitude, autopilot 1 was engaged but there was no elevator movement. At the same moment there was stabilizer deflection. The elevator servo was unable to deflect the elevator, thus current continued to run through the elevator servo motor because the autopilot continuously tried to correct the flight path. The automatic trim function steered the stabilizer to minimize the current running through the elevator servo motor.

Fokker released Service Bulletin 70/100, to upgrade to a new servomotor and servomount for the elevator position, to solve the pitch oscillations. The associated Service Experience Digest stated that the most probable cause of a temporary stuck elevator servo (elevator 'stiction') was ice accretion on the elevator servo-mount capstan or elevator servo-drive cables when the aircraft was flown into a humid environment such as cloud. A lubrication task was advised to prevent 'stiction'.

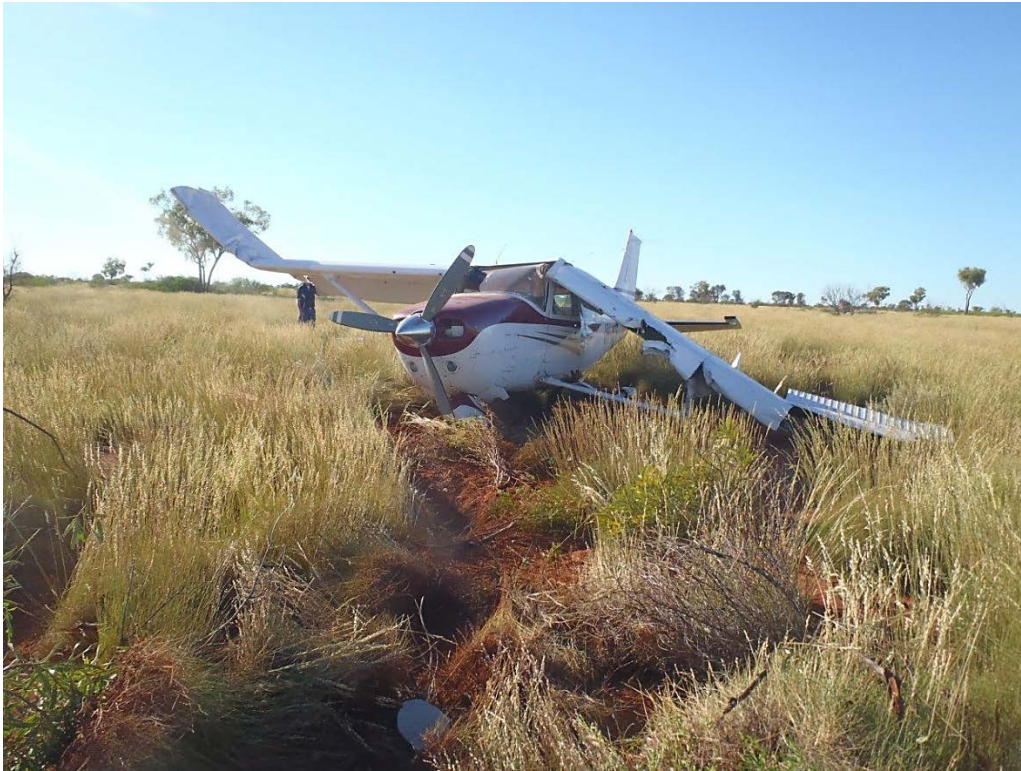
**Figure 1: Accident site**

On landing, the left wing impacted a tree and the aircraft spun around 180 degrees. The left wing was bent obstructing the only cockpit exit door. The fuel system had been disrupted and fuel was quickly entering the cockpit area. The pilot shut down all remaining systems and climbed into the rear section of the aircraft. The forward section of the cargo door was obstructed by the flaps in the full down position. The pilot exited the aircraft through the rear section of the cargo door and was not injured. The aircraft was substantially damaged (Figure 1).

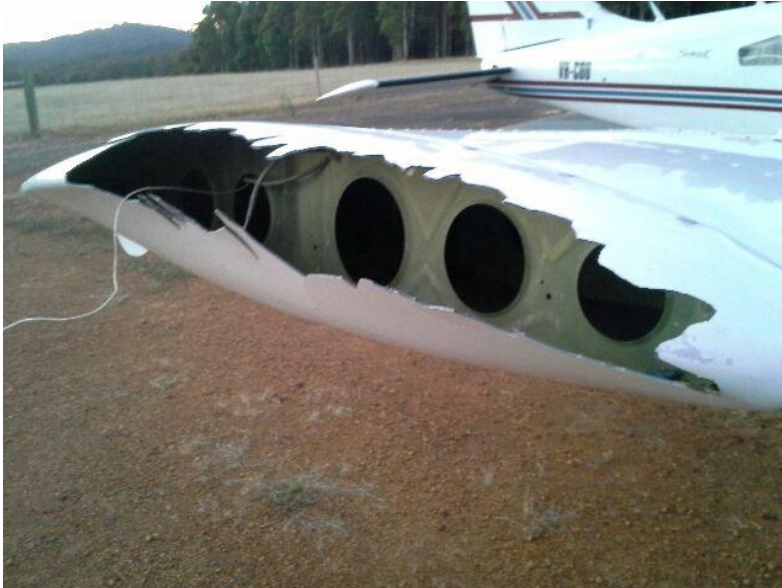
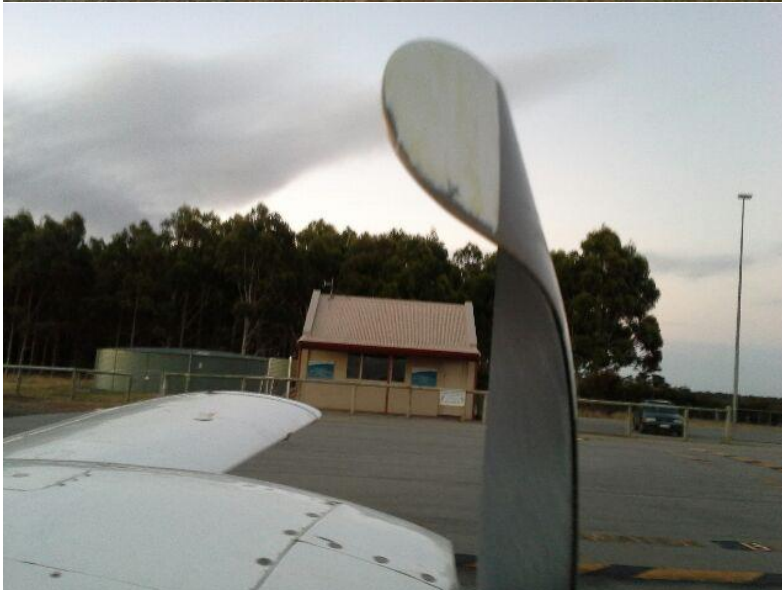
**Figure 1 and 2: VH-COU damage**

Still unable to see outside, the pilot was unaware of what the aircraft had struck, or the resultant damage to the aircraft, so conducted some checks. He assessed the handling characteristics of the aircraft as being normal. He noted there was no engine vibration, so elected not to shut down either engine. He also decided to leave both the landing gear and flaps in the current configuration and, as he regained normal visibility, joined for a left downwind, low level circuit onto runway 09.

After completing a normal landing, the pilot shut down the aircraft then egressed safely. The pilot was not injured; however, the aircraft was substantially damaged.

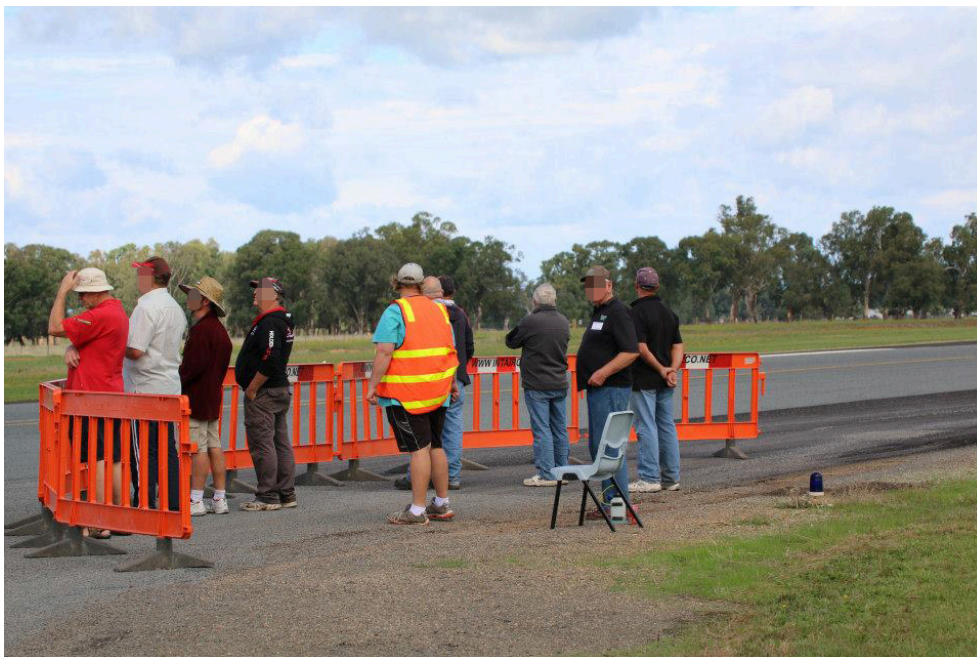
**Figure 3: Barricades alongside runway 18 at taxiway intersection**

FEZ touched down near the threshold on runway 18 (Figure 2). As FEZ became airborne following the touch and go, the instructor then noticed some barricades off the right side of the

runway (Figure 3). The instructor took over control of the aircraft and vacated the area, departing to Mangalore.

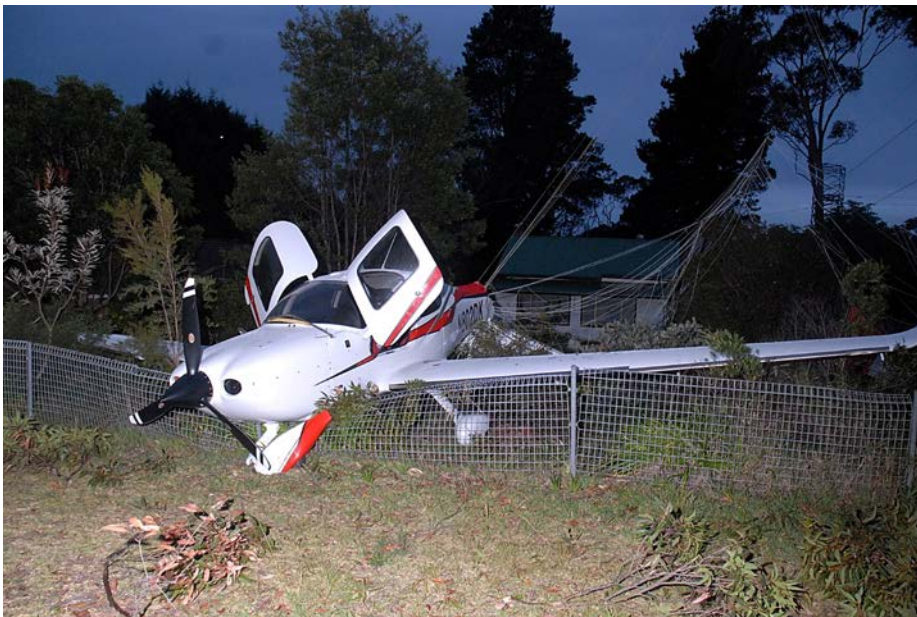
**Figure 1: Accident site of Cirrus SR22, N802DK**

The aircraft was overhead high voltage powerlines and the passenger in the front seat asked the PIC whether there was any way to manoeuvre the aircraft to avoid them and was advised that there was not. The aircraft narrowly avoided the powerlines, collided with branches of a tree, and came to rest on a fence in the garden of a residential dwelling (Figure 1). The passenger in the front seat reported that he observed that the ignition and master switches and fuel selector were still ‘ON’ and selected them to ‘OFF’. He reported that he had to shake the PIC as he appeared dazed, and told the PIC and the passenger to hurry up and open the door and exit the aircraft. The PIC reported that after exiting the aircraft he confirmed that no injuries had been sustained and spoke to National Search and Rescue personnel to confirm that the emergency beacon had been activated.

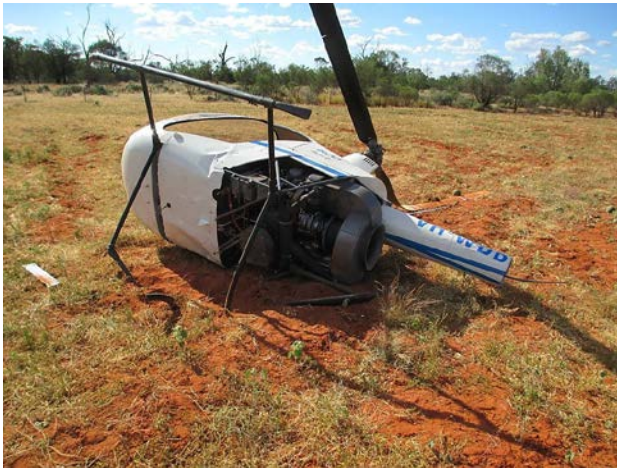
Figure 1: Damage to WDB

As the helicopter turned left, the pilot felt a violent shudder through the cyclic<sup>2</sup> control. The pilot reported that the helicopter continued to yaw<sup>3</sup> and he applied opposite pedal in an attempt to counteract the yaw, however the pedal was ineffective and the yaw accelerated. The pilot rolled the throttle off, moved the cyclic forward and lowered the collective<sup>4</sup>. As the helicopter descended rapidly, the pilot then raised the collective to cushion the landing. The right skid touched down first and the helicopter rolled to the right, coming to rest on the right side (Figure 1).

The helicopter was substantially damaged and the pilot was uninjured.

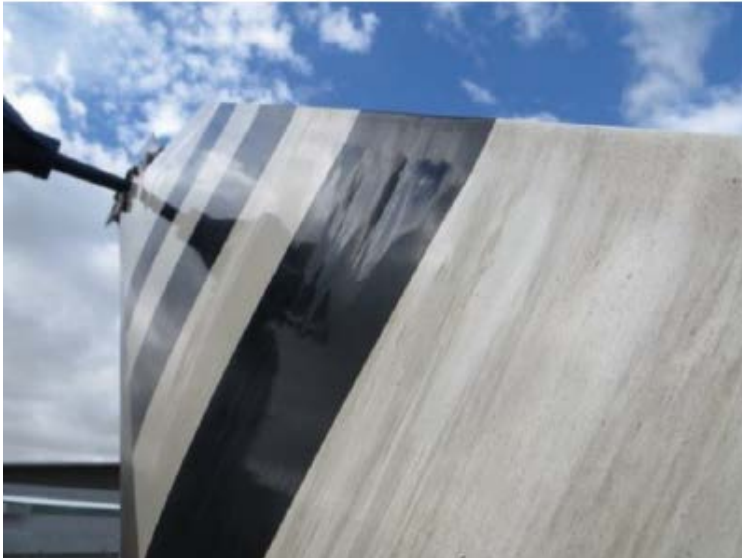
**Figure 1: Damage to ESD tail rotor**

After landing at the hospital, the pilot exited the helicopter and inspected the main rotor blades. The ACO then advised that it was the tail rotor not the main rotor that had struck the foliage and the pilot observed some ripples on the tail rotor blades and called the base engineer to inspect the helicopter (Figure 1).

The engineering inspection revealed that the tail rotor blades required replacement and the tail rotor gear boxes and hub assembly required inspection.
