Aviation Short Investigations Bulletin

Issue 34

ATSB Transport Safety Report
Aviation Short Investigations
AB-2014-138
Final – 3 September 2014

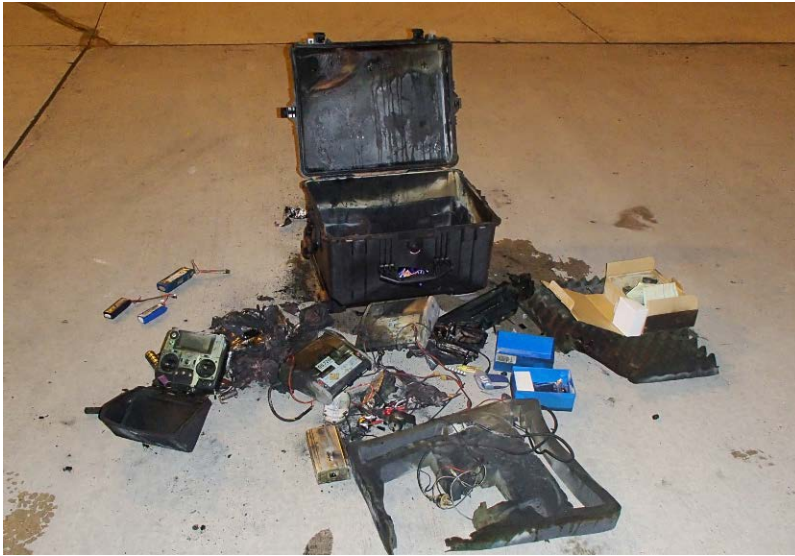
The ARFF arrived and a smouldering hard-plastic case was removed to a safe location and cooled with a fine water spray. The passenger who had checked in the case was located and was asked whether any batteries were in it, to which the passenger responded there were none. The ARFF and Australian Federal Police inspected all four of the bags checked in by the passenger and found 19 batteries intact and additional 6-8 batteries that had been destroyed by fire.

An initial investigation revealed that several lithium-ion polymer batteries and an RPA controller were contained in the case. An electrical short circuit involving the batteries resulted in the initiation of a fire, destroying the contents and damaging the case (Figures 1, 2 and 3). An RPA controller containing other, similar, lithium-ion polymer batteries was found in one of the passenger's other checked-in bags. The fire-damaged case had been screened through the oversized luggage point at Melbourne Airport.

Figure 1: Fire-damaged bag and contents

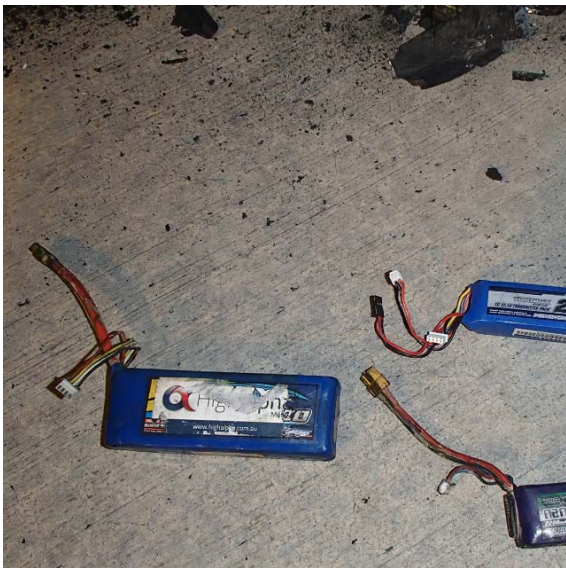
Figure 2: Batteries found in the case

An analysis conducted by Fiji Airways found that the post-incident images indicated a Lithium-ion Polymer battery fire involving high capacity – high discharge batteries. The battery balancers (shown in Figure 3), are used for charging heavy duty batteries.

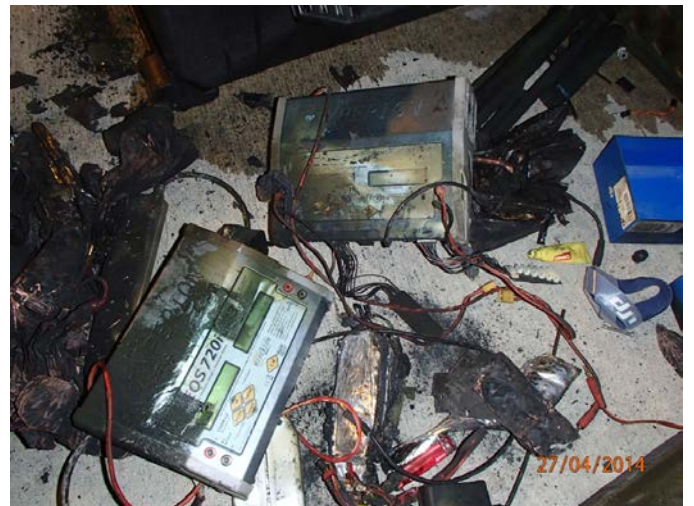
Figure 3: Battery balancers

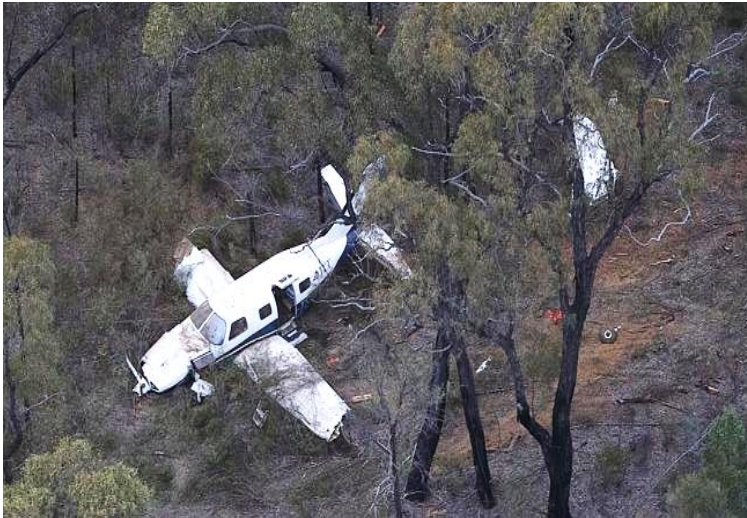
The aircraft sustained substantial damage (Figure 1).

Figure 1: Damage to VH-TSV

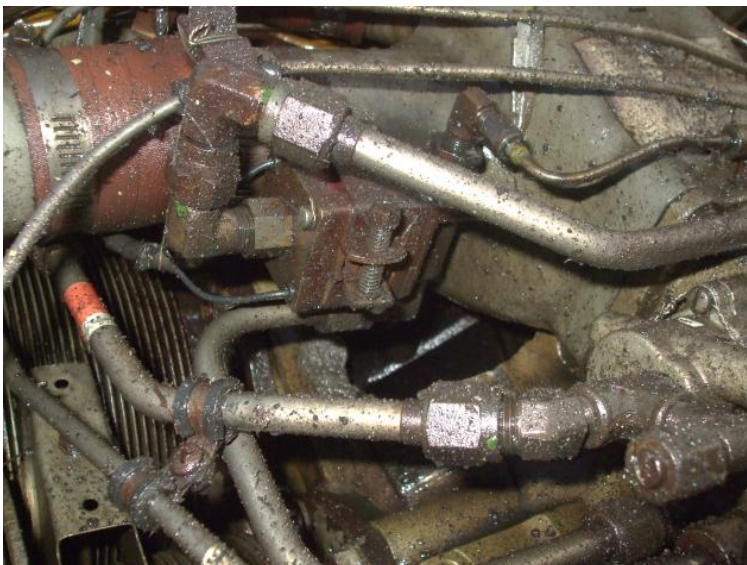
A preliminary post-accident inspection of the engine found a hole in the right side of the crankcase, indicating an internal mechanical failure (Figure 2).

Figure 2: Hole in upper crankcase

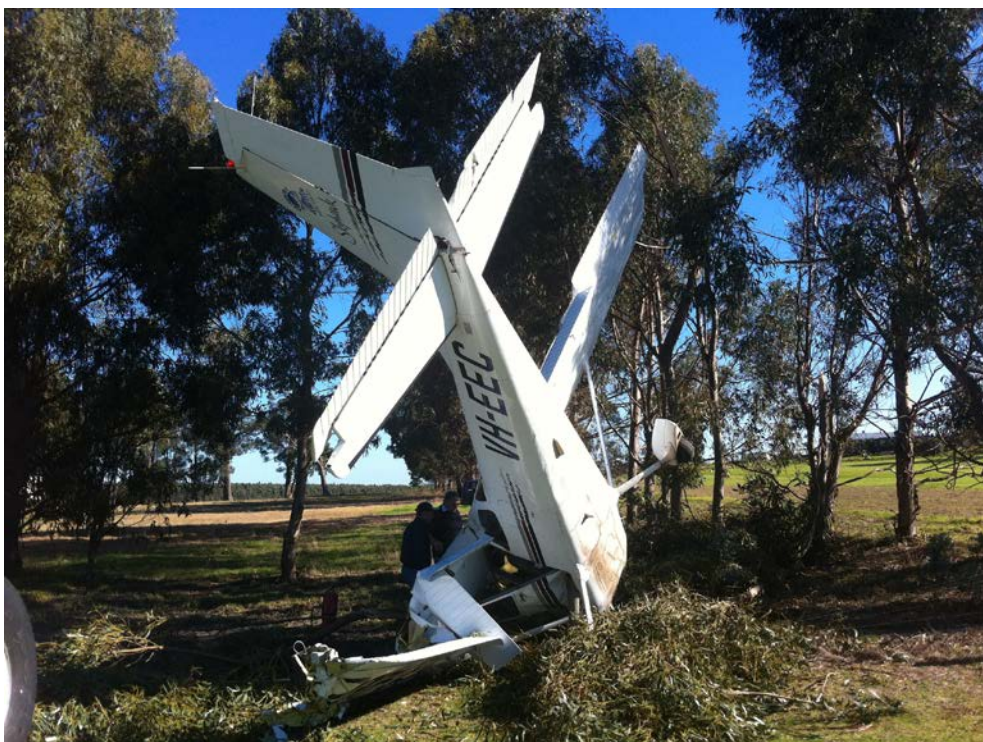
When established on final for runway 06, the pilot reported that he had selected two stages of flap and had the aircraft stabilised at about 65 kt. When about 50 ft above ground level, the pilot reported that the aircraft encountered a wind gust which carried the aircraft about 30 m to the right. The pilot moved the aileron controls into wind and applied full power to commence a go-around; however the aircraft's right wing collided with trees on the right side of the landing area. The pilot reported that the right wing may have stalled as he applied full right aileron. The aircraft fell to the ground resulting in substantial damage (Figure 2).

Figure 2: Accident site

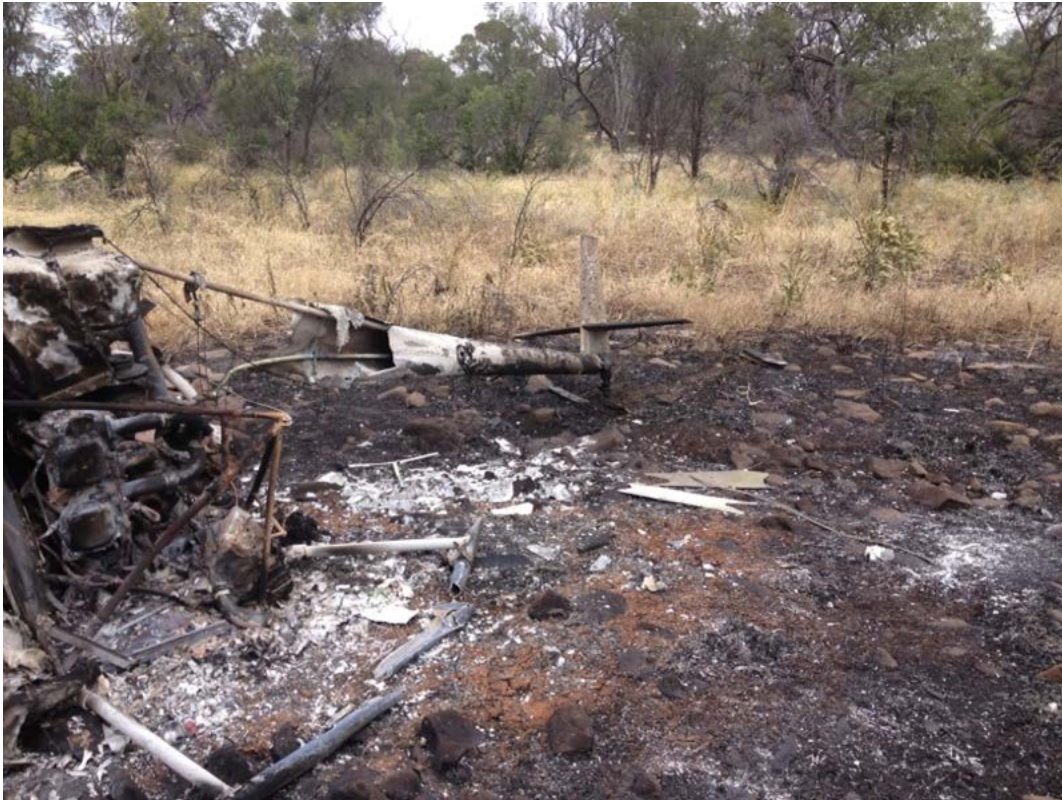
After the helicopter settled on the ground, the pilot applied control friction, unstrapped, and stepped onto the skid to assess the damage. At about that moment, he became aware of a fire in the grass beneath the engine behind the cockpit area. The pilot commented that the fire appeared to be growing rapidly. He vacated the helicopter and retreated to a safe area, as the flames spread quickly up the side of the helicopter and into the cockpit area. The helicopter was subsequently destroyed by the fire (Figure 1).

Figure 1: Accident site showing long, dry grass and ‘gidgee’ trees in the background

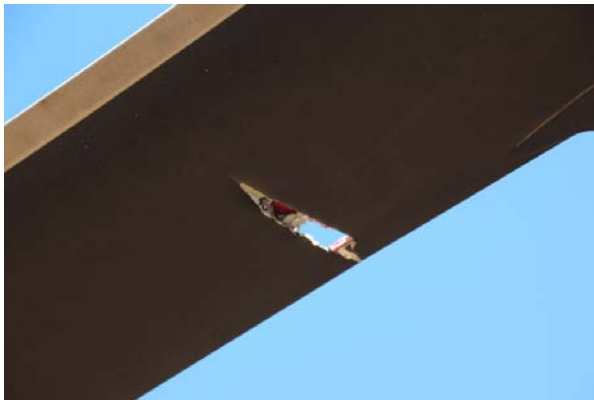
The pilot opened the door, observed that the helicopter was on backwards sloping ground and did not see any damage to the helicopter. He then confirmed that there were no abnormal indications, vibrations or oscillations and he slowly raised the helicopter back up into the hover, moved it forwards a few metres and landed on a more level surface. After shutting down the engine, the pilot inspected the helicopter and found substantial damage to the landing skid, a hole in the main rotor blade (Figure 2) where it had struck the wirestrike cutter (Figure 3), and damage to the tail boom.

Figure 2: Hole in the main rotor blade

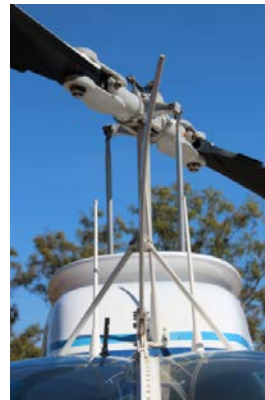
Figure 3: Main rotor and wire cutter

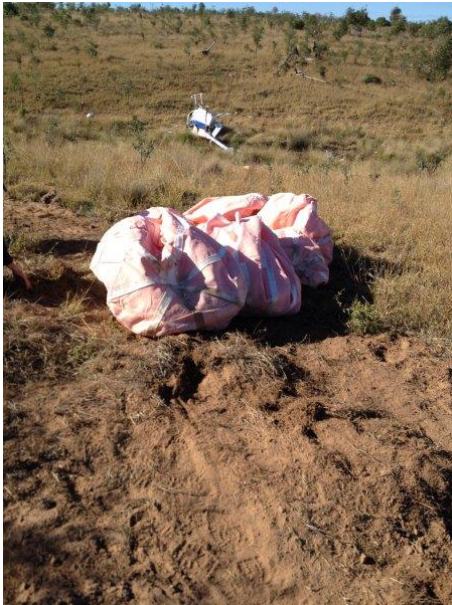
Due to vegetation behind the helicopter, the pilot manoeuvred slightly further to the right, however when crabbing right to the selected landing area, the long-line became fully extended and went taut. As the line pulled taut it had moved to come directly out the left side of the helicopter from under the centre of the left skid. This created a hinge moment which caused the helicopter to roll to the right (Figure 1).

Figure 1: Bags and accident site

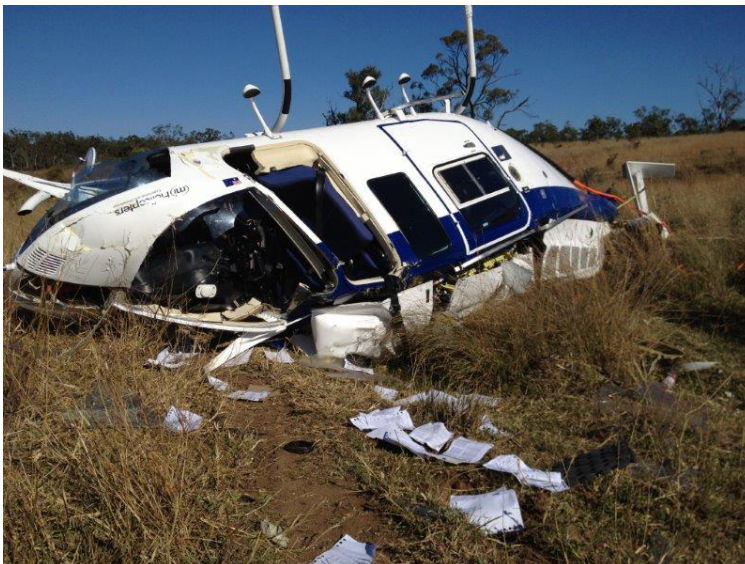
The pilot immediately attempted to press the hook release switch for the long-line and applied right cyclic to fly the helicopter in the direction of the roll. However the main rotor blades contacted the ground before the pilot reached the switch. The helicopter rolled over and came to rest inverted. The pilot switched off the fuel and battery and activated the emergency beacon. He exited the helicopter and then detected a small grass fire burning under the engine exhaust and retrieved the fire extinguisher to put out the fire. The helicopter sustained substantial damage (Figure 2).

Figure 2: Damage to VH-NKW

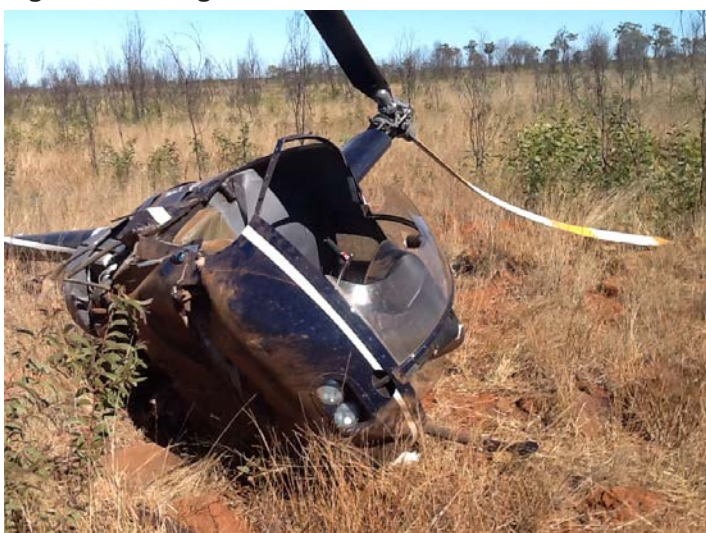
The helicopter landed hard, bounced once and rotated through about 180° before coming to rest. The supervising pilot turned off the master switch, activated the emergency beacon, selected the fuel to OFF and contacted emergency services. The pilot sustained serious injuries and the supervising pilot minor injuries. The helicopter was substantially damaged (Figure 1).

Figure 1: Damage to VH-ZZM
