Derailment of freight train 9501V

South Dynon Junction, West Melbourne, Victoria | 2 March 2013

ATSB Transport Safety Report
Rail Occurrence Investigation
RO-2013-009
Final – 4 September 2014

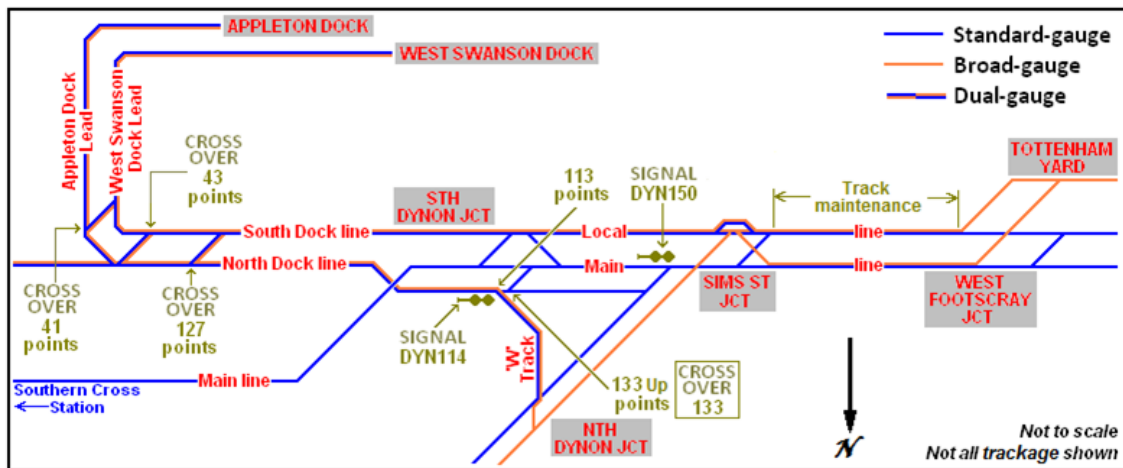
Figure 1: Simplified area track plan

The route selected, however, was for a standard-gauge train and did not contain broad-gauge track beyond signal DYN114 or provide access through to Tottenham yard.

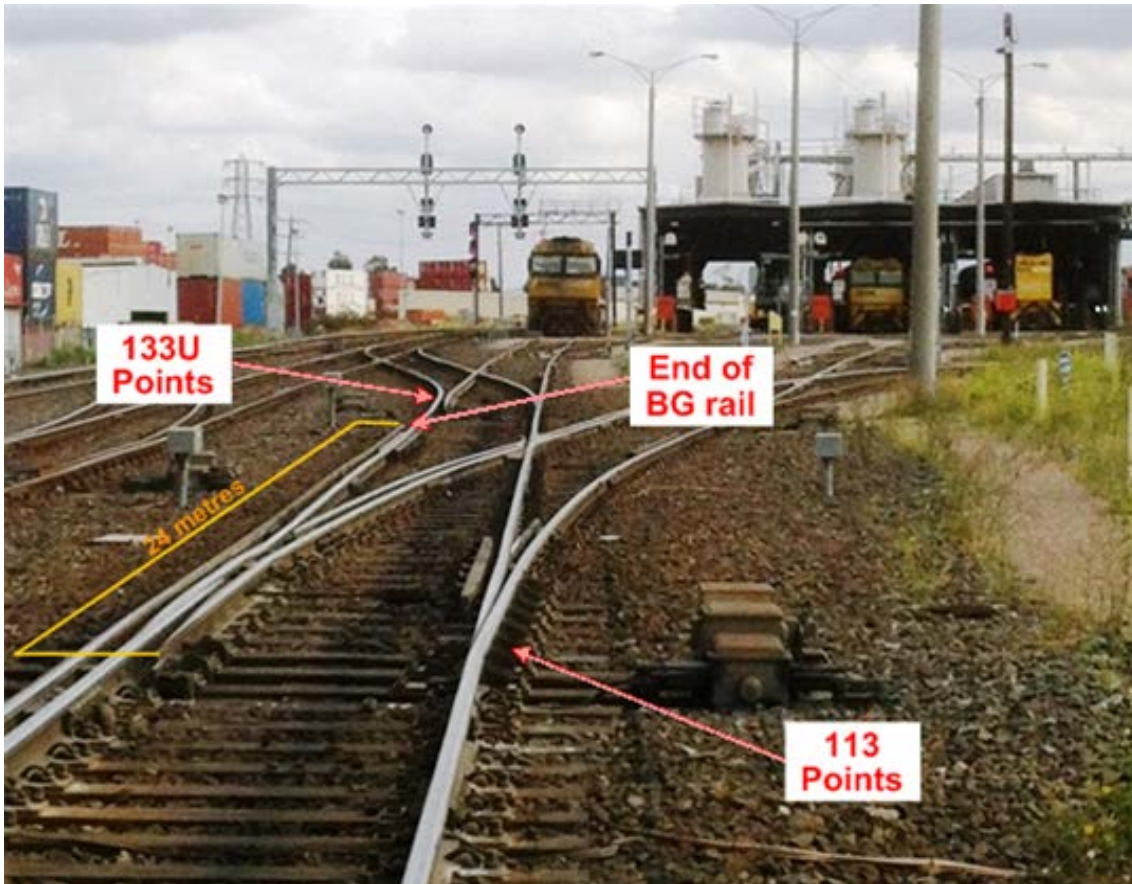
Figure 2: View of derailment site in the direction of travel

At about 0623, the NCO issued verbal authority to the driver to pass signal DYN114. The locomotive crew then proceeded past signal DYN114 for a distance of about 40 m, where the broad-gauge rail ended (Figure 2) and the lead bogie and leading wheel set of the trailing bogie on locomotive A77 derailed.

The derailment was at low speed and there was no injury to the train crew, but there was minor damage to the bogies of the lead locomotive (A77) and track infrastructure. The derailment resulted in the closure of the main line out of Melbourne (Southern Cross Station) for a number of hours, affecting interstate passenger and other movements both inbound and outbound.

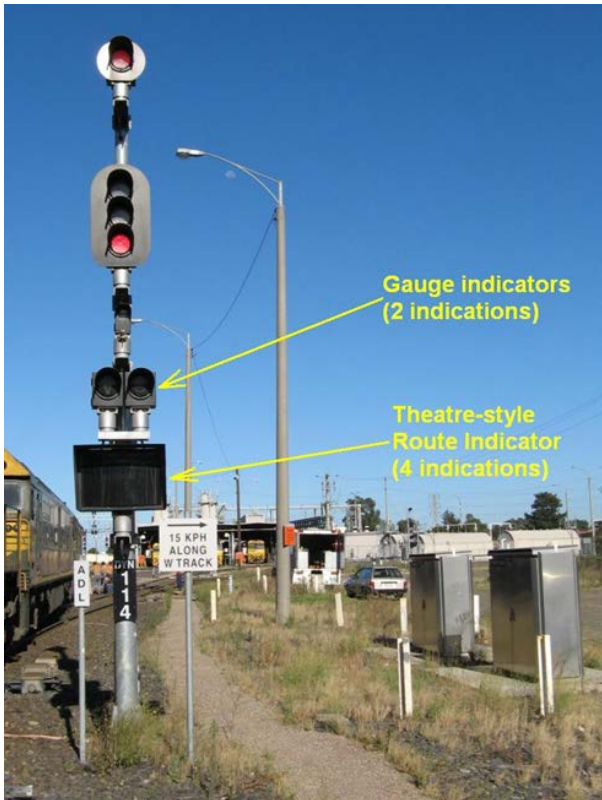
Figure 3: Signal DYN114

Signal DYN114 was commissioned in late 2010 as part of the works associated with the South Improvement Alliance (SIA)⁸ Missing Link project⁹. DYN114 was a Home¹⁰ signal that protected the dual-gauge points 113 and was equipped with gauge and Theatre Route indications (Figure 3). These indications only illuminated when the signal displayed a Proceed indication. As the signal was displaying a Stop indication to train 9501, neither indicator was illuminated.

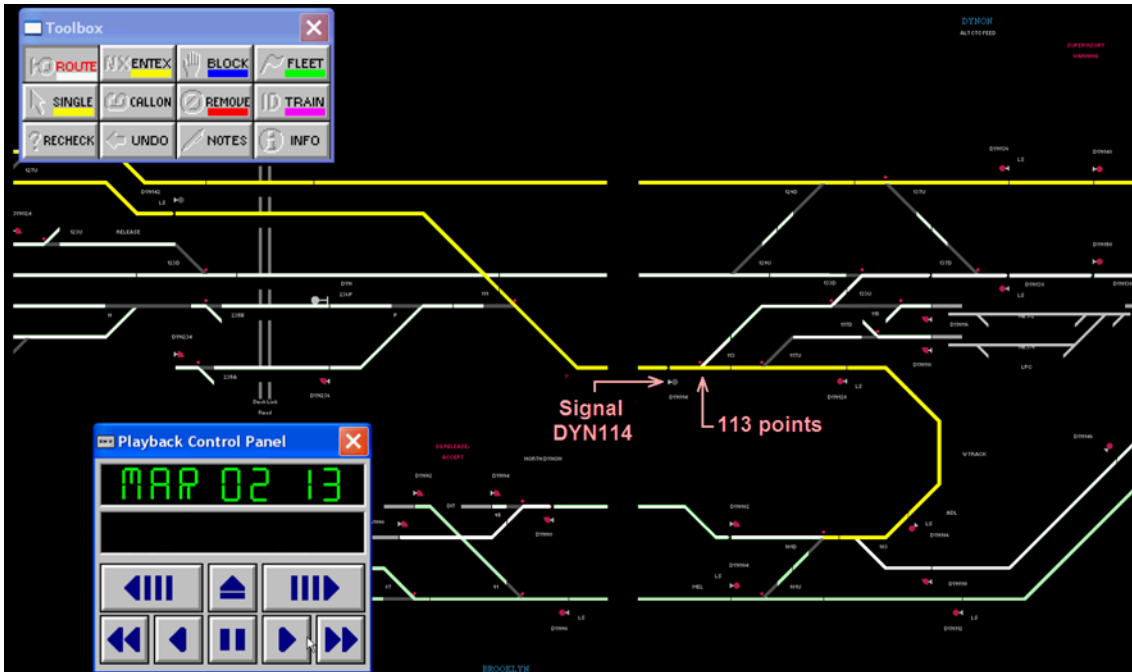
Figure 4: Phoenix train control system display. Trackage and track gauges - Dynon area

Figure 4 depicts a portion of the network controller’s display. It shows available dual-gauge (yellow), standard-gauge (white), and broad-gauge (pale green)¹¹ track.

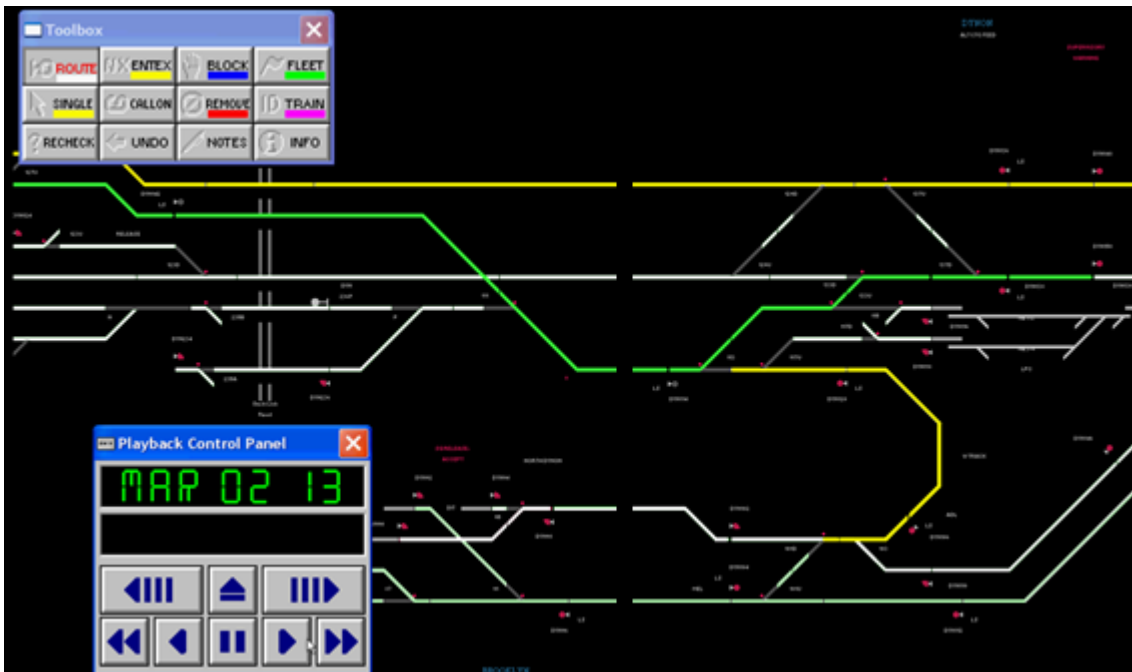
Figure 5: Phoenix train control system display with multi-gauge¹² route selected

On this occasion, a transition in the gauge configuration of the track (from dual-gauge to single-gauge trackage) occurred partway along the established route, with the dual-gauge component turning away at the 113 points. However, despite this variation in the gauge configuration, the system determined the route to be viable and continued to present it to the network controller as such.

The same portion of the network controller's display is depicted in Figure 5 showing the selected route for train 9501 (left-to-right in bold green), through South Dynon Junction.

ARTC has modified the train control system to alert network control officers when a route is set that is not compatible with the gauge of the train, and has amended processes regarding authorising train movements past signals that are displaying a Stop indication.

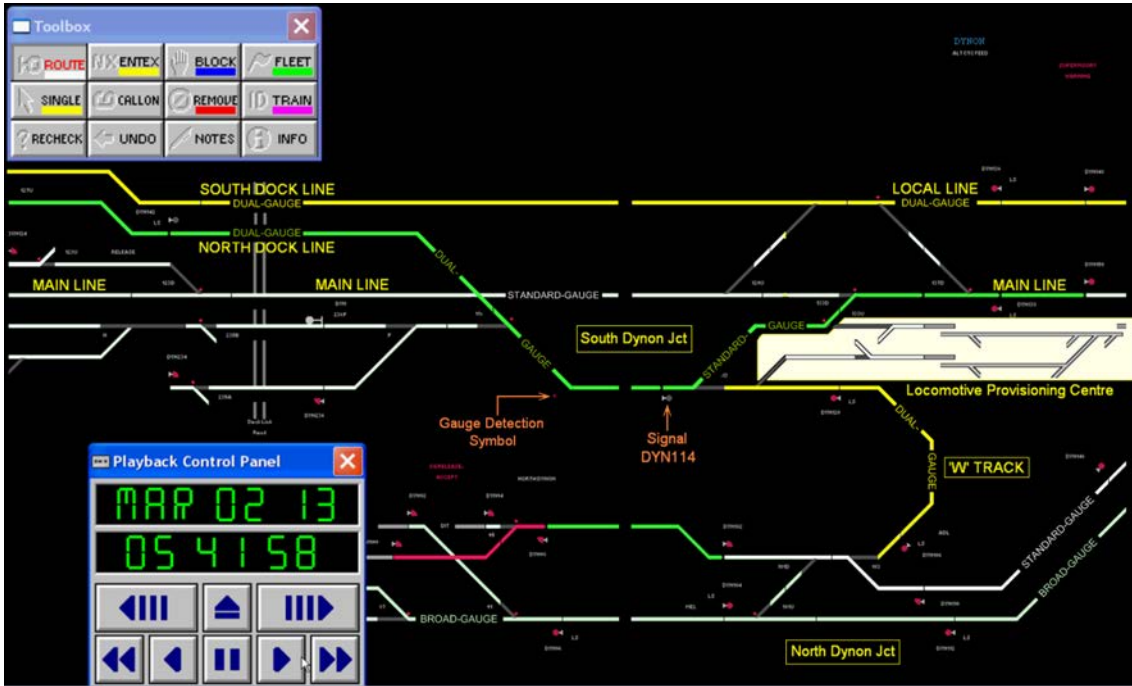
Figure 6: Phoenix train control system display – interpretation of multi-gauge routes

Figure 6 depicts the same display as Figure 5, with the addition of annotation to highlight the degree of interpretation required of the NCO. Although shown as a singular colour on the display, the selected route was dual-gauge as far as signal DYN114 and standard-gauge beyond.

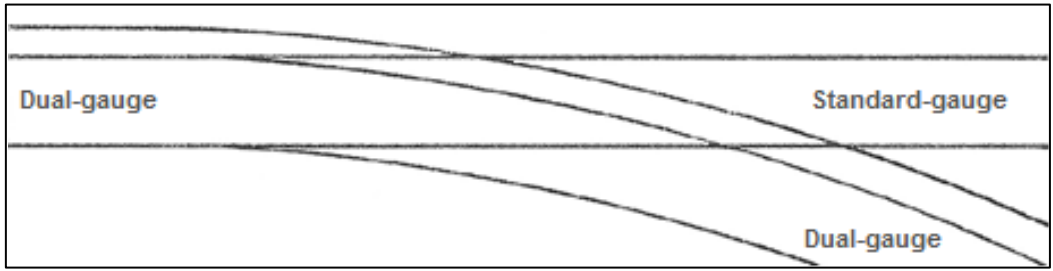
Figure 7: Dual-gauge turnout with only standard-gauge switchable

It was ARTC engineering practice to install dual gauge points assemblies when constructing layouts incorporating multiple track gauges. This allowed a single type of points installation rather than various site-specific configurations. The introduction of this type of points assembly, where one of the track gauges is truncated in one of the exit directions, has created the potential for this type of derailment, and defences provided to date have proven inadequate.

Australian Rail Track Corporation is aware of the hazard posed by the cessation of the broad-gauge rail and will include consideration of it in future risk assessments as well as the option for additional controls (such as [1] the installation of indicators at dual-gauge turnouts to indicate track gauge configuration on both the straight and turnout routes; and, [2] the application of white, reflectorised branding to the top of the rail head near the end of the broad-gauge rail, and/or the welding of short lengths of thin steel to the head of the broad-gauge rail at such regular intervals as to create a 'rumble-strip' effect.).
