ATSB TRANSPORT SAFETY REPORT

Aviation Occurrence Investigation – AO-2008-037

Final

**Air-ground communication event
19 km north-north-east of Perth Airport, WA
28 May 2008
PK-GGE
Boeing Company 737-5U3**

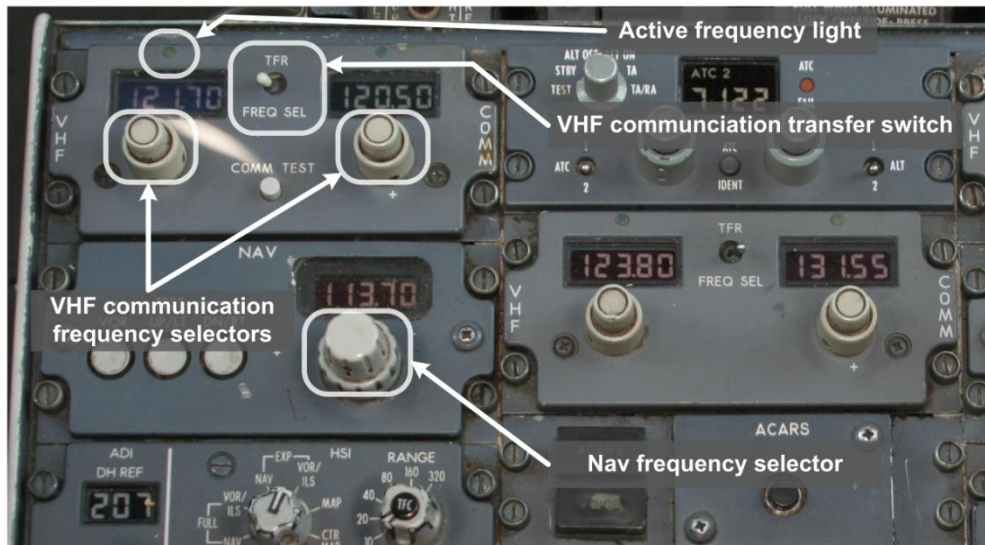
Figure 3: VHF - 1 and Nav - 1, 121.7 MHz is the active frequency and 120.5 MHz on standby. Nav - 1 is set to frequency 113.70 MHz

It was unlikely that the transmit and receive functions would have simultaneously failed in the independent VHF - 1 and VHF - 2 radio communication systems that were used by the crew in their attempts to resolve the communications failure. The investigation concluded that the apparent failure to the crew of the aircraft's second, autonomous VHF communications system may have been because they had copied the incorrect frequency that was displayed on the VHF - 1 communication radio.

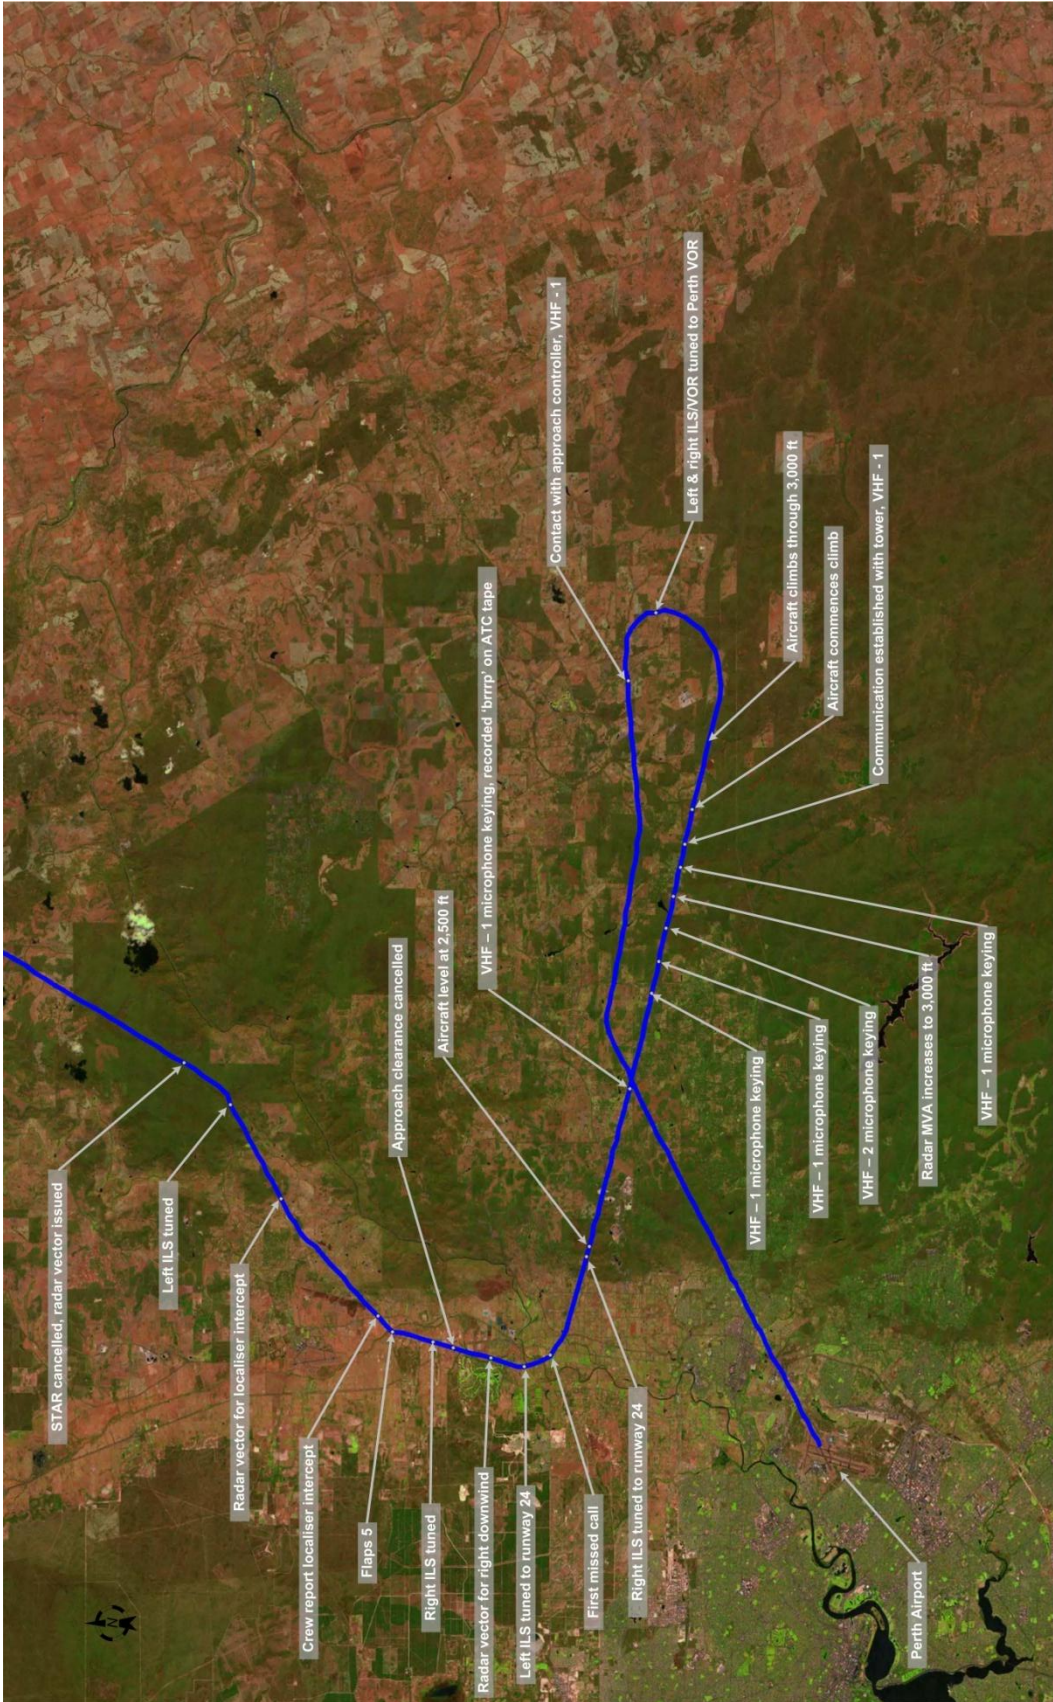
APPENDIX A: AIRCRAFT GROUND TRACK AND RELEVANT EVENTS DURING THE APPROACH

The recorded air traffic control (ATC) audio information indicated a loss of two-way communication between ATC and the crew for just over 4 minutes, during which, the crew would have been aware of their inability to contact the approach controller for 1 minute and 52 seconds. That loss of communication occurred while the aircraft was operating in instrument meteorological conditions (IMC), and at a minimum vectoring altitude (MVA) that, although initially appropriate for the aircraft's anticipated track, was below the published 25 NM (46 km) minimum sector altitude (MSA). In the event, and despite the lack of any alerts or warnings from the aircraft's Enhanced Ground Proximity Warning System (EGPWS), the action by the crew in response to the loss of communication resulted in the aircraft being below the relevant MVA and MSA for 1 minute and 11 seconds.
