# Operational non-compliance

## Sydney (Kingsford Smith) Airport, NSW

### 17 July 2008

INFRA-08530

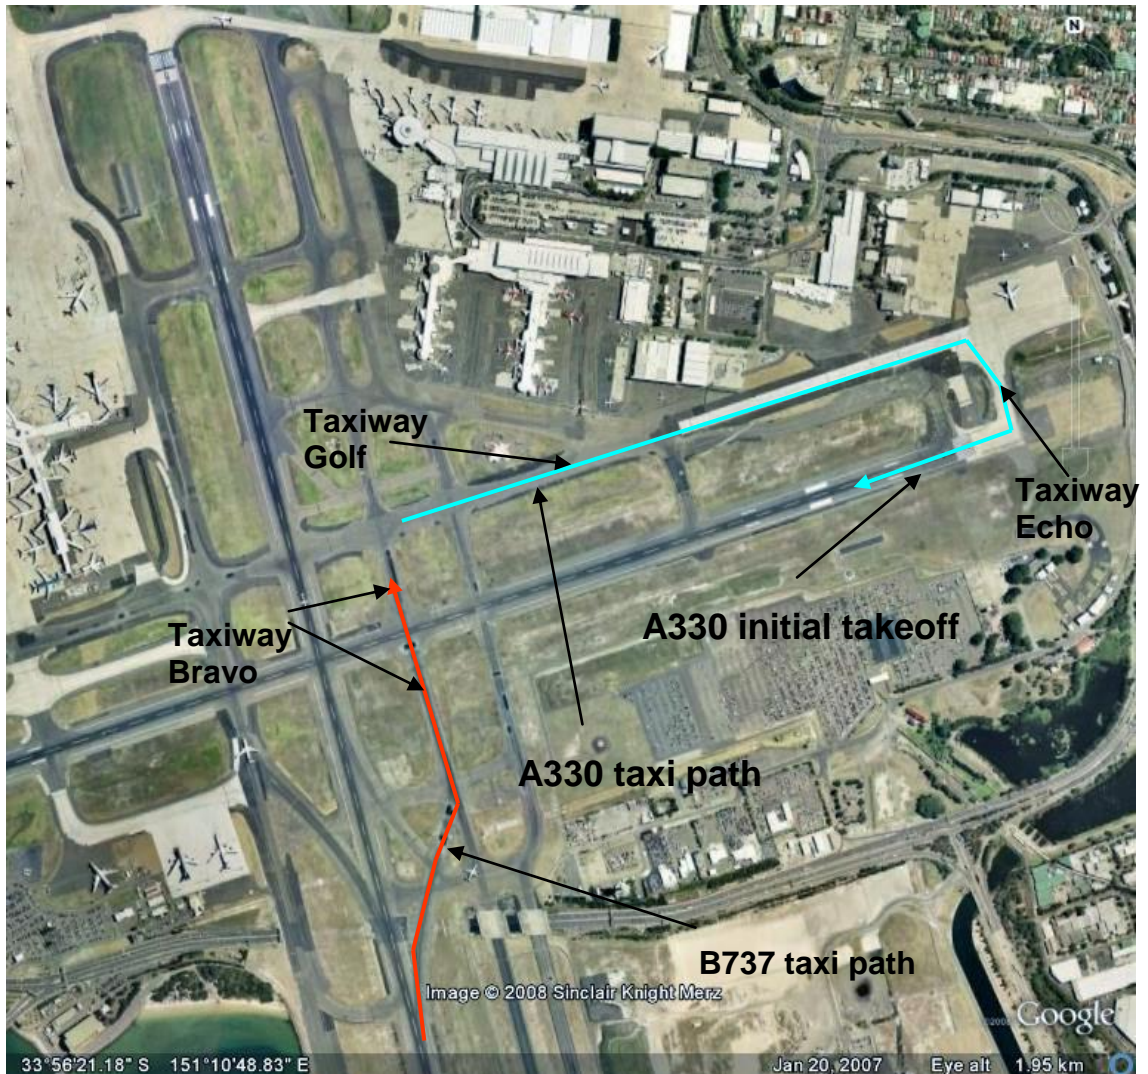
Figure 1: Sydney (Kingsford Smith) Airport layout – photo courtesy of Google Earth

The crew reported ready for departure while taxiing on taxiway 'Golf' (Figure 1) to the holding point for runway 25. ATC cleared the crew to line-up and wait, and assigned a heading of 240°M to be flown after takeoff. While lining up, the pilot in command (PIC) asked the copilot for a review of the take-off and departure procedure.
