ATSB TRANSPORT SAFETY REPORT
Marine Occurrence Investigation No. 252
Final

Independent investigation into the grounding of the
Marshall Islands registered passenger ship

Van Gogh

at Devonport, Tasmania
23 February 2008

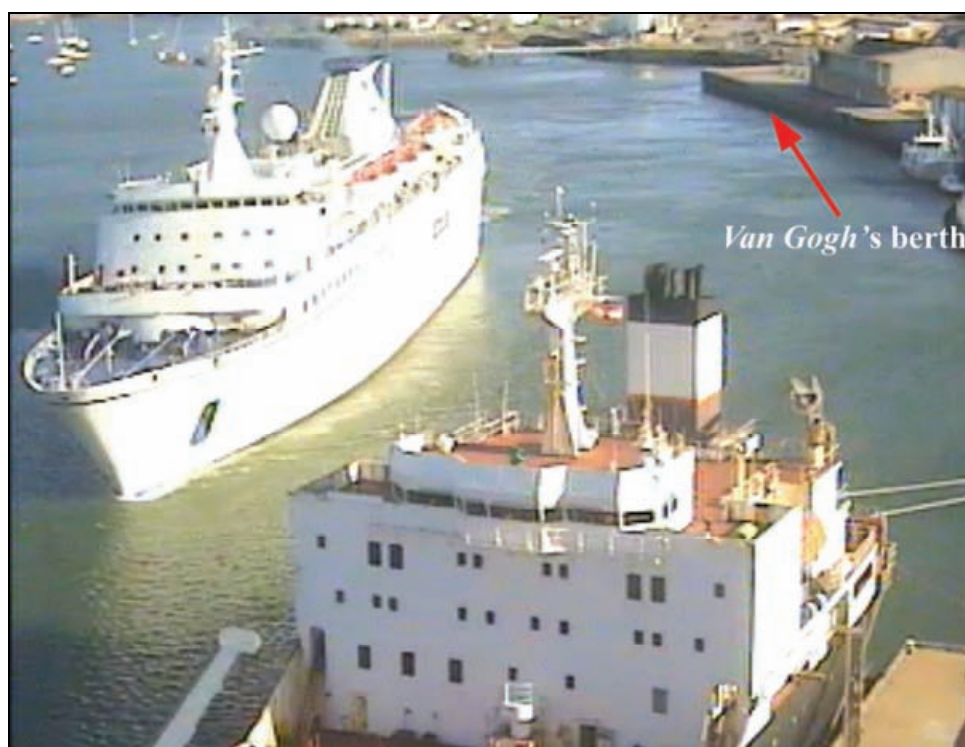
Figure 3: CCTV image of *Van Gogh* approaching *Goliath*

As soon as the pilot took over the conduct of the ship, it became apparent to him that the ship was being set down onto *Goliath* and that it was not handling as he had expected.

Between 1813 and 1814, *Van Gogh* closed to within ten metres of *Goliath* before the rudder started to become effective as the ship began to make way through the water to generate sufficient water flow over the rudder. By that stage, *Van Gogh* was close enough, and moving fast enough (about six knots relative to the stationary ship), to subject *Goliath* to interaction, which pulled it off the berth and caused it to surge ahead.

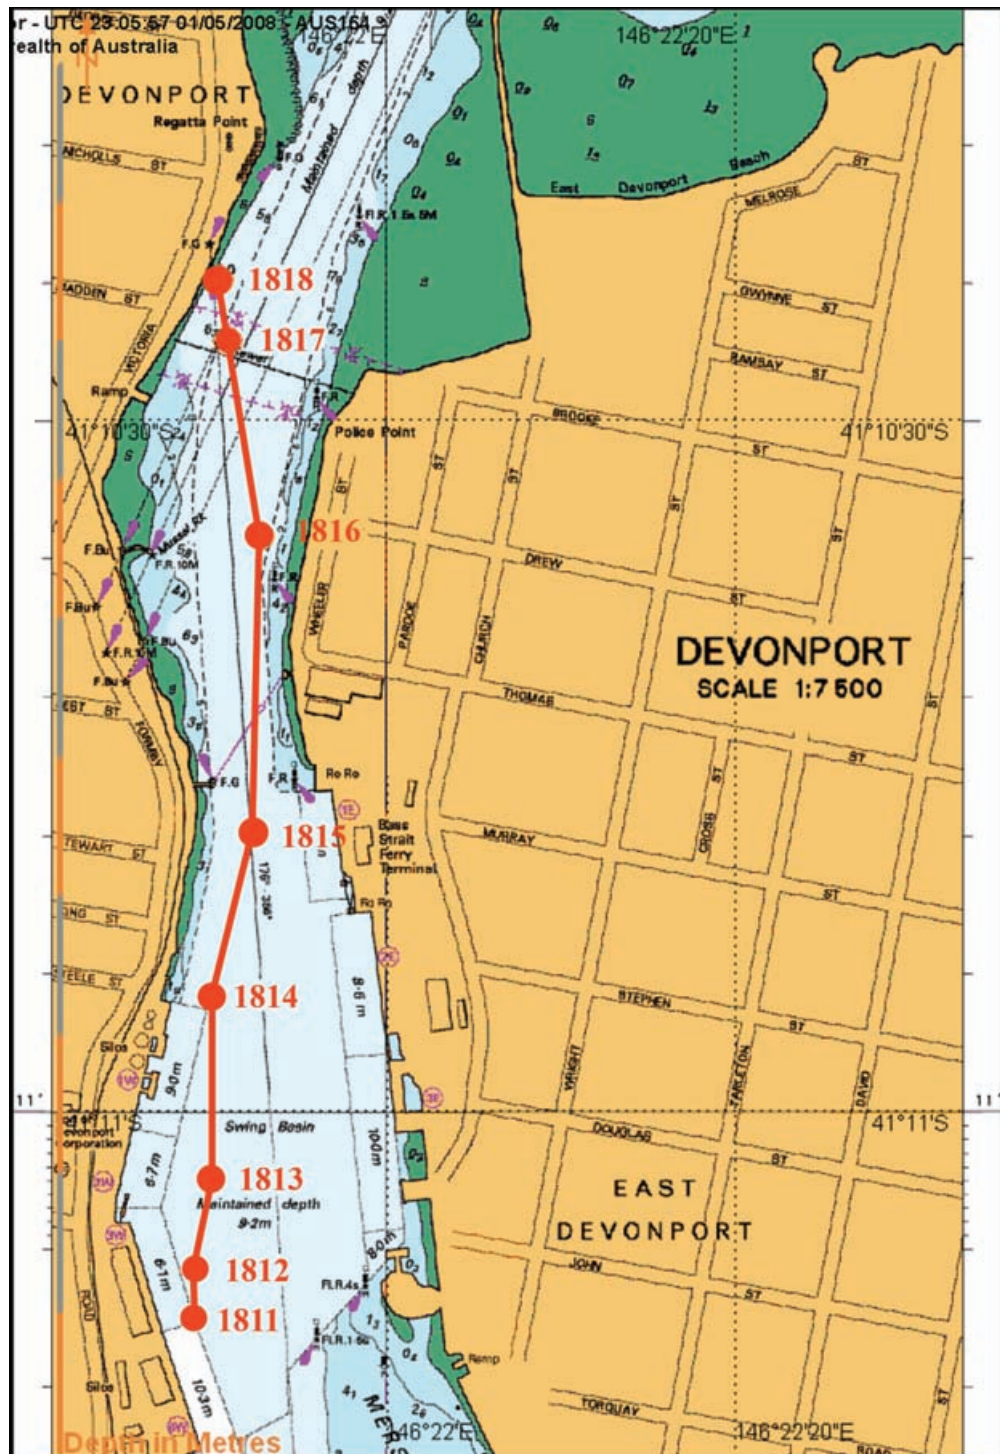
Figure 4: Section of navigational chart Aus 164 showing *Van Gogh's* passage

By 1817, the ship's speed had fallen to six knots. At about 1817½ at a speed of about one knot, *Van Gogh* briefly grounded in the vicinity of the leads near Regatta Point on the western shore of the Mersey River (Figures 4 and 5). Immediately following the grounding, under the influence of the ebb tide and wind, the ship's stern started to swing to starboard. In an attempt to stop the swing into the river, and

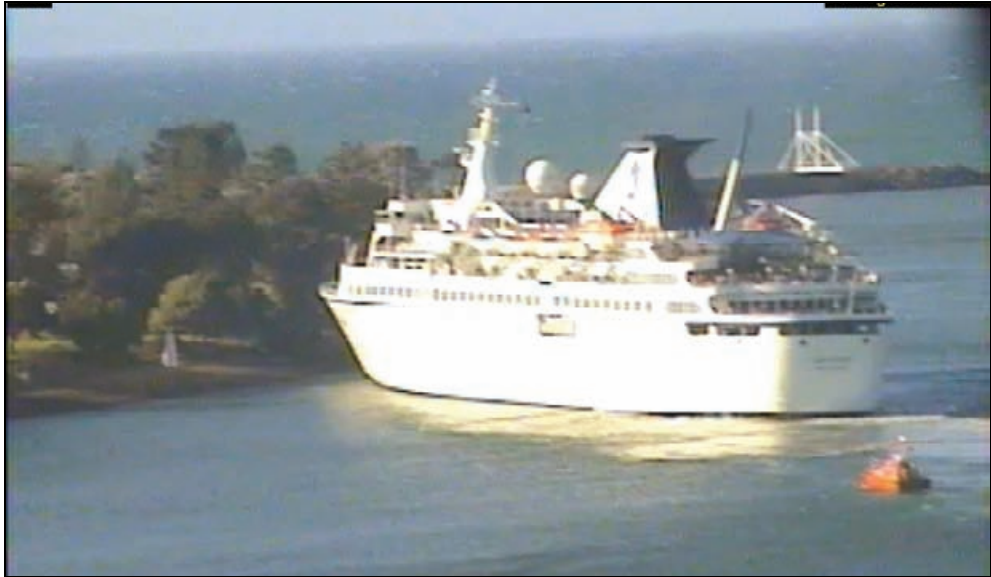
Figure 5: CCTV image of *Van Gogh* at time of grounding

possibly blocking the channel, the pilot immediately ordered full astern on the starboard engine, full ahead on the port engine and full starboard thrust on the bow thruster.

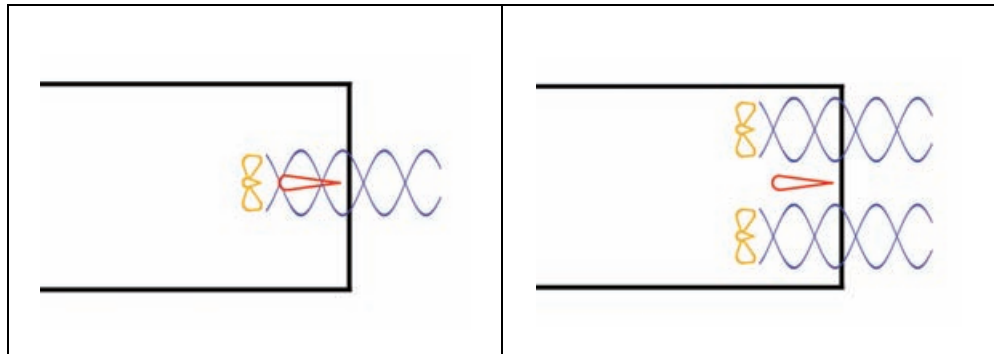
Figure 6 (a) & (b): Single propeller/single rudder versus twin propeller/single rudder

A ship's rudder is effective in providing a turning moment to the ship only when there is a flow of water over its surface. In the case of a single propeller/single rudder configuration ship (Figure 6 (a)) and a twin propeller/twin rudder configuration ship, accelerated water flow from the propeller/s directly over the rudder blade/s enhances the manoeuvrability of the ship, even at slow speeds.

However, in the case of twin propeller/single rudder configuration ships (Figure 6 (b)), like *Van Gogh*, the water flow from the propellers does not pass directly over the rudder, which is set on the ship's centre line. Even with the helm 'hard over', the rudder may be either wholly or partially outside the water flow from the propellers. This means that the ship's response to the rudder is poor at low speeds because the rudder is reliant upon the ship's motion through the water, and not the propeller wash, to generate water flow across it in order to generate the turning moment in the ship.
