**ATSB TRANSPORT SAFETY REPORT**  
Marine Occurrence Investigation No. 253  
Final

Independent investigation into the engine room fire  
on board the Marshall Islands registered container ship

# **MSC Lugano**

off Esperance, Western Australia  
31 March 2008

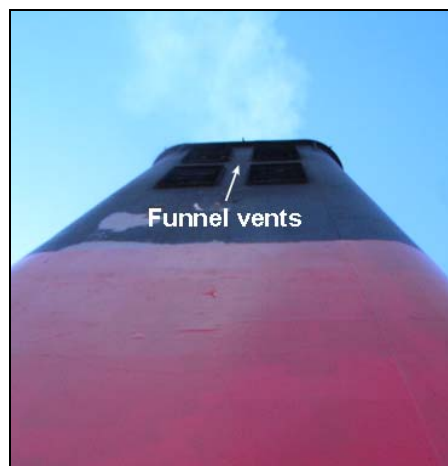
**Figure 5: Funnel (re-painted after fire)**

Eye witness accounts of the fire, the amount of smoke it produced, the peeling of the funnel paint and the heat being radiated from the engine room casing were all indicators of the size and intensity of the fire. The master should have been aware that a large scale fire had been burning for almost an hour when the CO<sub>2</sub> system was operated. As a result of this long burning, large scale fire, there had certainly been a large build up of heat in the engine room.

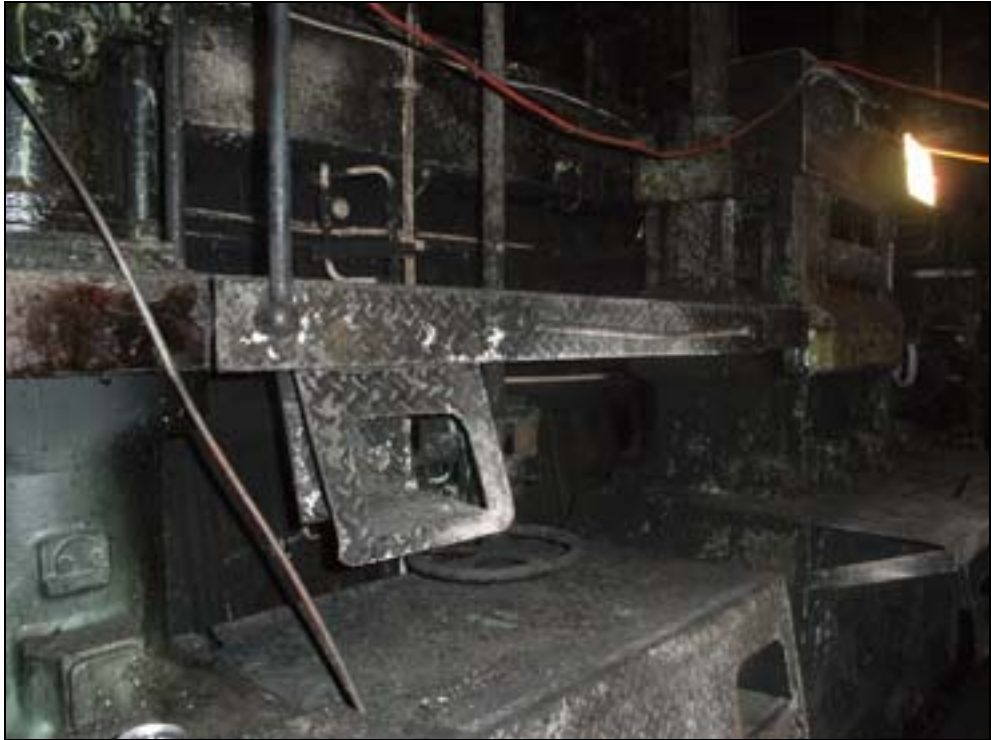
**Figure 8: Aft port side of main engine middles**

The fire and heat damage to the main engine was concentrated at the port aft end of the engine at, and above, the engine middles. The fire had not developed downwards on the engine towards the floor plates below. The aft end of the engine at the floor plate level was still coated in a film of lubricating oil that had not been affected by the fire.

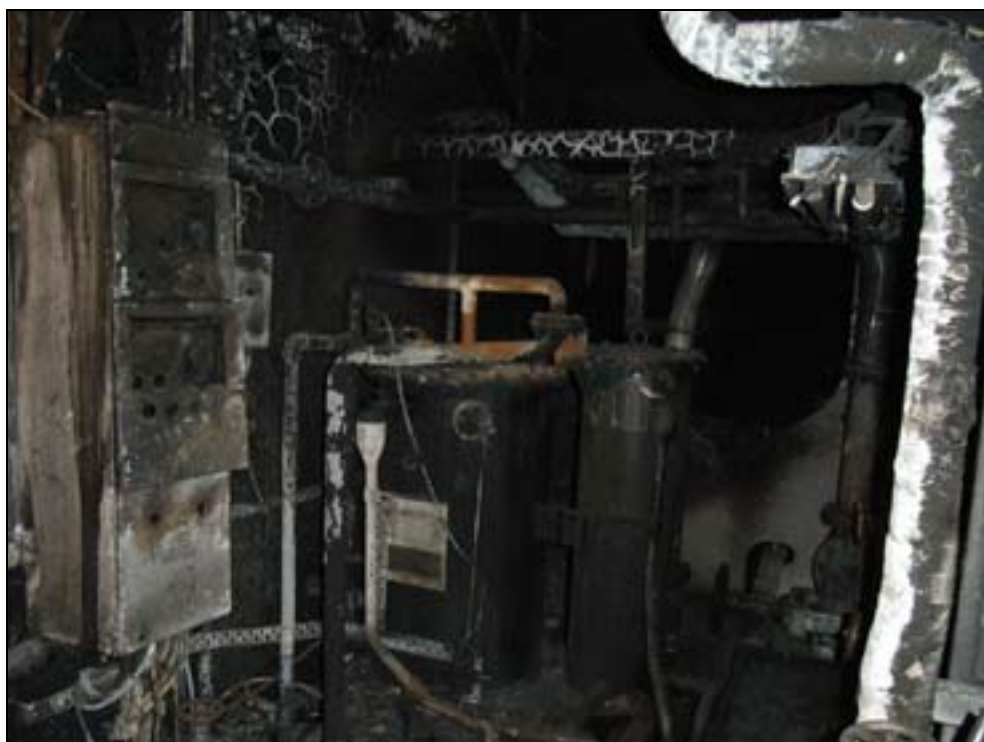
**Figure 10: Oily water separator**

The master instructed the crew to open the engine room fire dampers in order to ventilate the space. A short time later, the engineers and the electrician entered the engine room to assess the damage and to attempt to re-start the machinery. All of the bulkheads from the third platform deck up were covered in soot. The aft port side of the main engine had been damaged by fire and heat (Figure 8). There was a large amount of damage and deformation to the deck, and deck head, outside the third platform deck store (Figure 9). The oily water separator had also been damaged by fire (Figure 10) but the auxiliary diesel generators appeared to be undamaged.

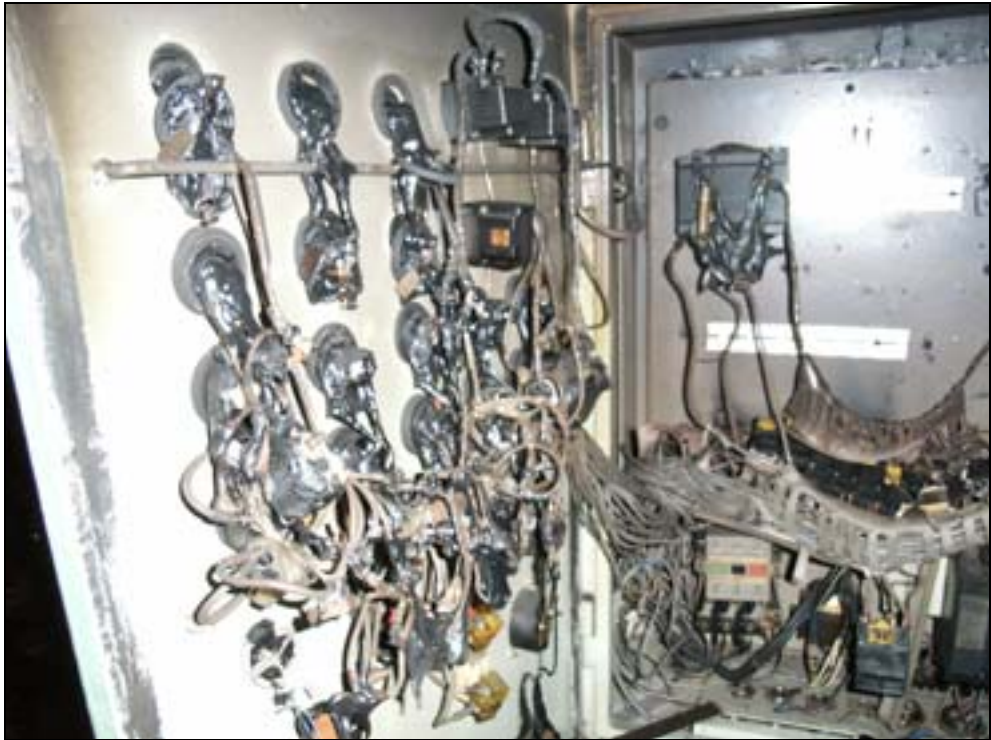
Figure 14: Inside the purifier room electrical cabinet

store/purifier room bulkhead had caused extensive damage to the electrical cabinets fixed to the bulkhead inside the purifier room (Figure 14).

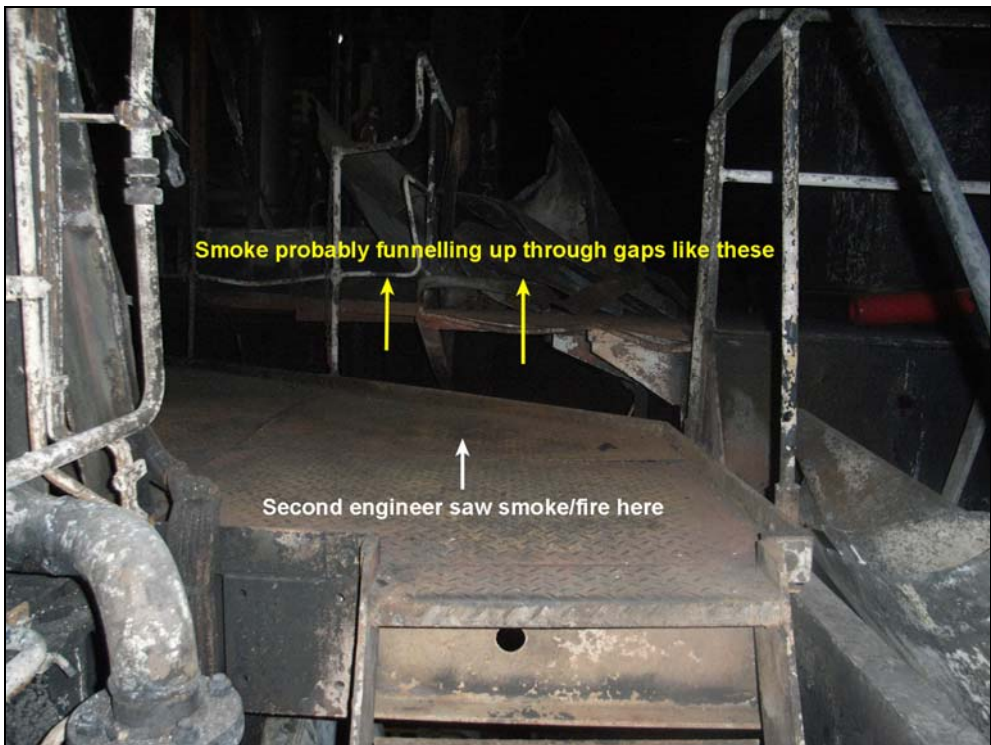
Figure 15: The area aft of the main engine turbocharger where the second engineer saw the smoke and flame

While the second engineer stated that when he looked out of the workshop he saw 'smoke and flame' in the area aft of the number one (aft) main engine turbocharger, it is likely that he actually saw the thick black smoke that was being produced by a fire that had started one deck below. The smoke was probably funnelling up

through the gaps in and around the second platform deck plating (Figure 15). While it is possible that he saw flames from the fire below, it is more likely that he saw the thick black smoke and drew the natural conclusion that there must have been some flame.

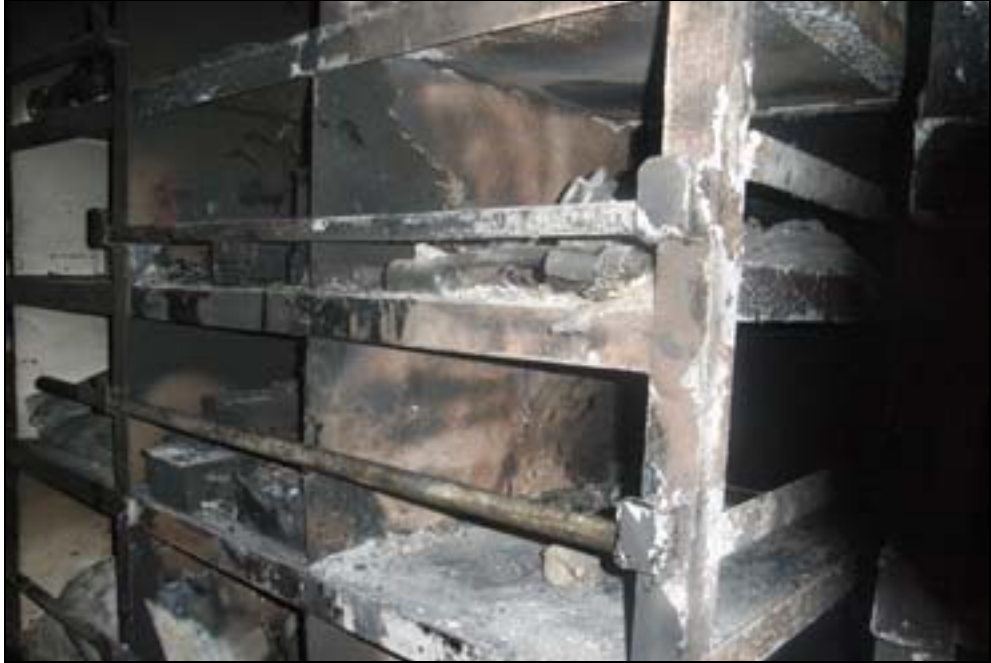
**Figure 16: Shelving at the front of the store**

From the store's entrance, the fire moved in two directions, both into the store and away from it. Nearly everything stowed near the entrance of the store had been destroyed (Figure 16). However, the fire had caused little damage to the equipment stowed at the rear of the store, particularly to those items stowed on the higher shelves (Figure 17).

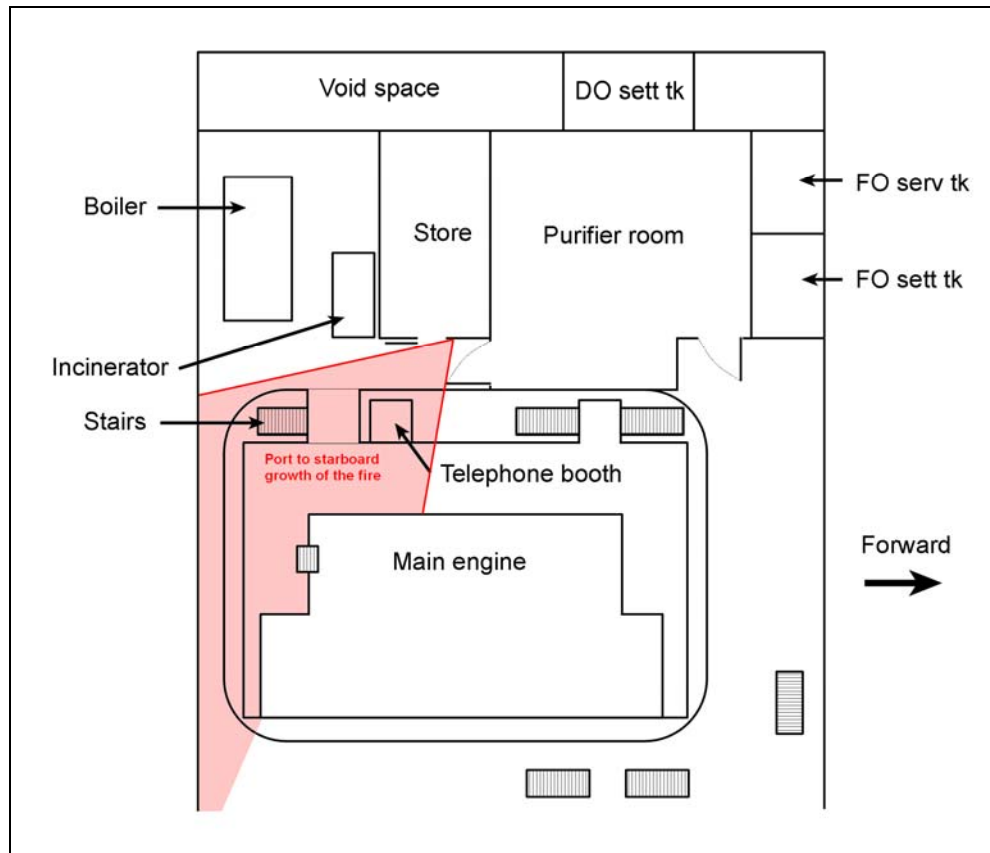
**Figure 18: Diagram indicating the fire's port to starboard development**

It is likely that the fire's spread was initially being directed by the engine room ventilation. Thus, as the fire developed, it was directed inboard, towards the main engine and upwards towards the exhaust casing and funnel abaft the main engine (Figure 18). Even with the engine room ventilation fans stopped, and the fire dampers shut, there would have been a natural funnelling effect of air flow from the seat of the fire, to starboard and aft, up towards the open engine room skylight.

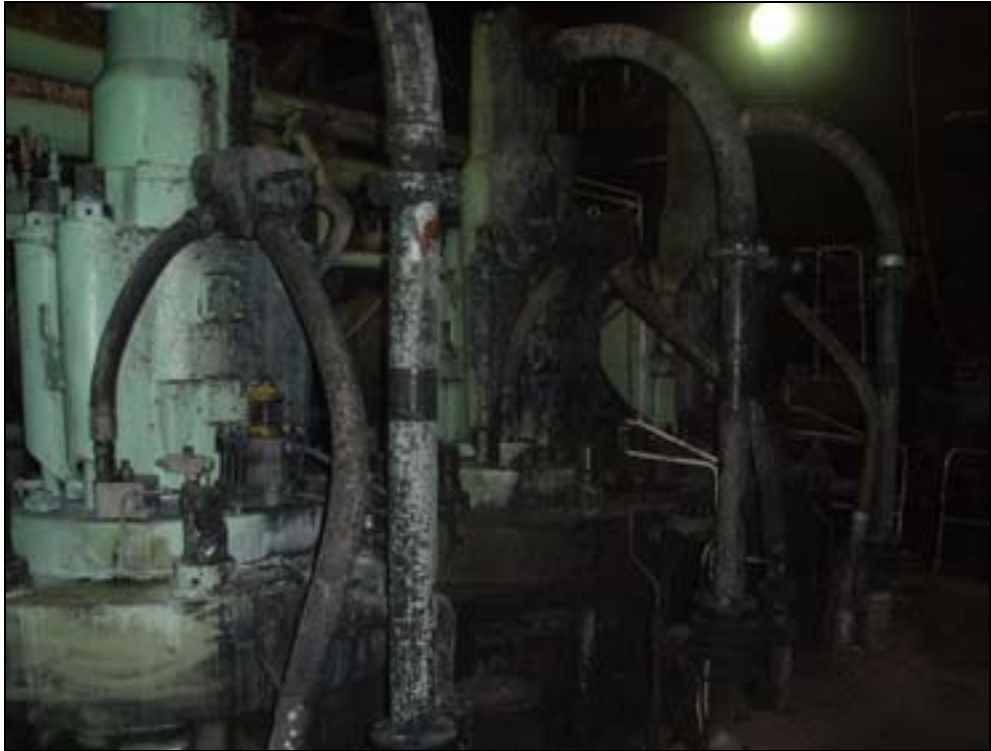
**Figure 19: Main engine number three cylinder head and exhaust valve**

There were several areas on the engine that indicated the port to starboard, forward to aft, spread of the fire, at both the main engine middle level and the cylinder head level. The most obvious examples of this were the three aft cylinder heads and exhaust valves (cylinders one, two and three). The port side of the exhaust valves had been subjected to fire and heat while the starboard sides of the valves had suffered little damage, indicating that they had been shielded from the fire. In fact, the paint on the starboard sides of the valves had not been affected by the fire at all (Figure 19). While the aft end of number one cylinder head and exhaust valve had also been damaged by heat, this damage was consistent with a flow of heat from under the decking immediately aft of the main engine.

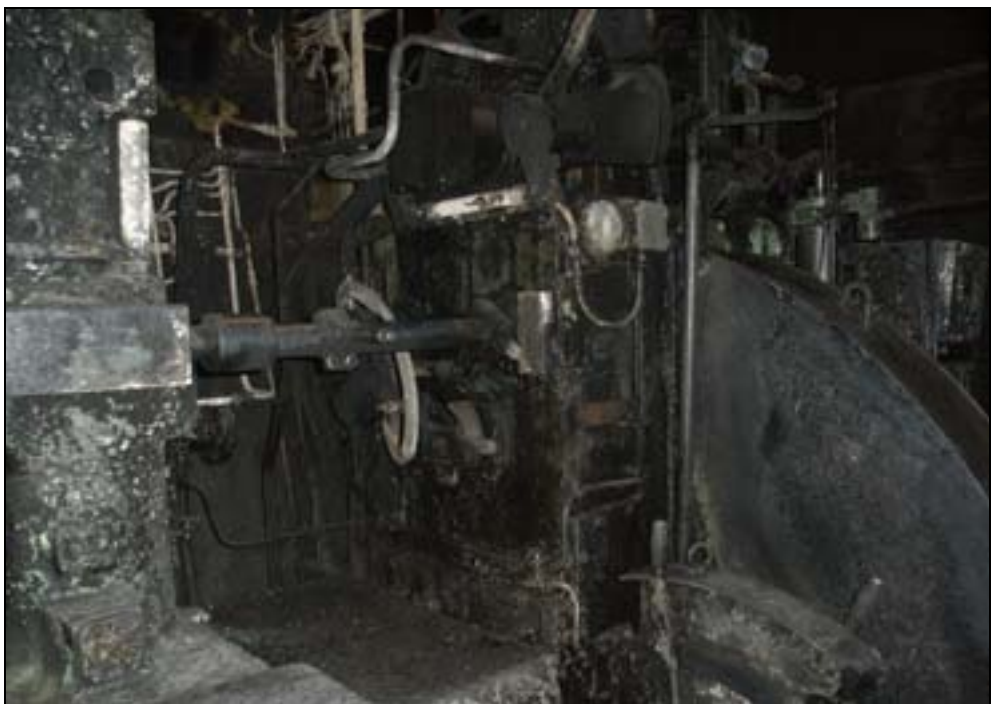
**Figure 20: Engine side control stand**

The engine side controls and much of the main engine remote control system were located at the port aft end of the engine at the middle level. As a result, they were severely damaged by the fire (Figure 20).

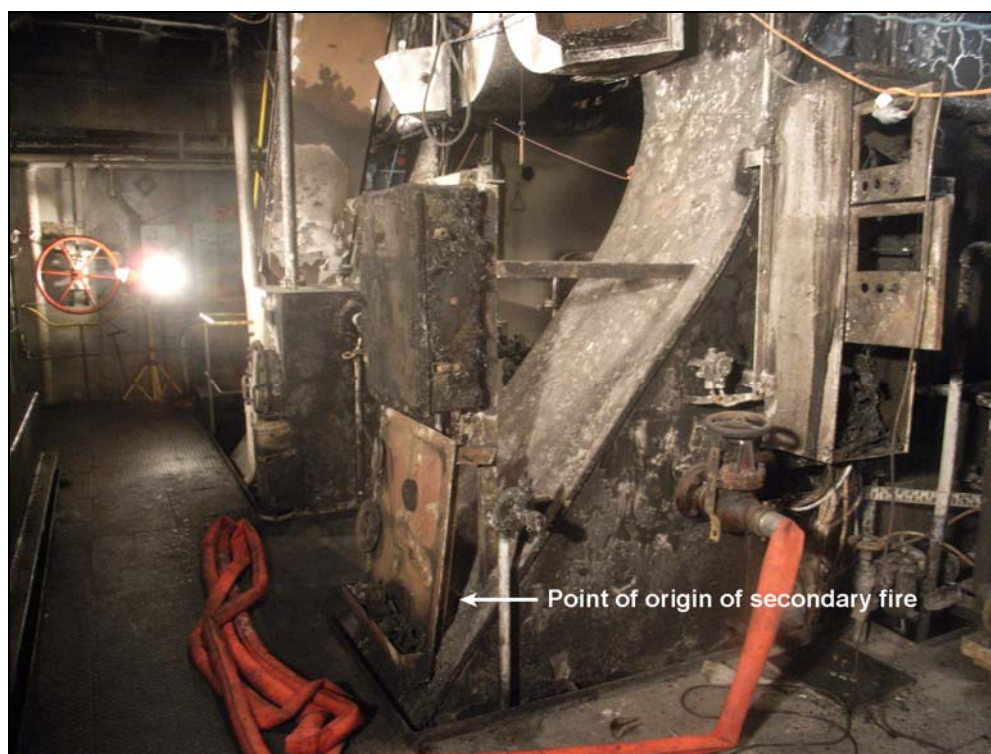
**Figure 21: Point of origin of the secondary fire**

The investigation found that another fire had started at the floor plate level in the vicinity of the oily water separator (Figure 21), on the port side of the main engine, immediately below the third platform deck store. The evidence links this fire to the primary fire on the deck above.

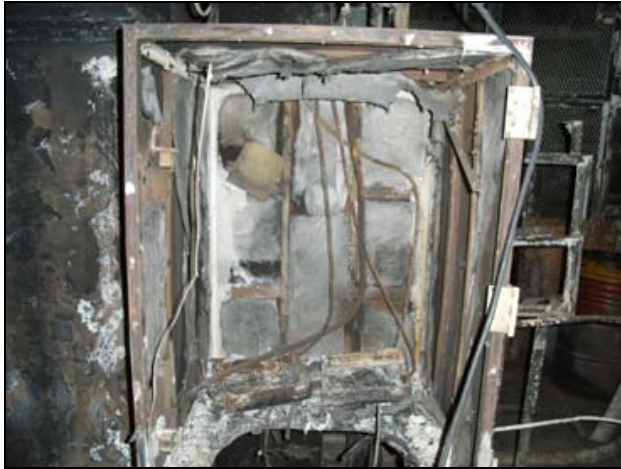
**Figure 22: Burnt out telephone booth**

As the primary fire developed, it engulfed a telephone booth located near the engine control stand, destroying it (Figure 22). When this occurred, the perspex door fitted to the telephone booth (Figure 23) caught fire. The burning liquid perspex dripped downwards and landed behind a shadow board located directly below (Figure 21). Pieces of timber stowed behind the shadow board were then ignited by the burning perspex and a fire started in this area, eventually engulfing the oily water separator.

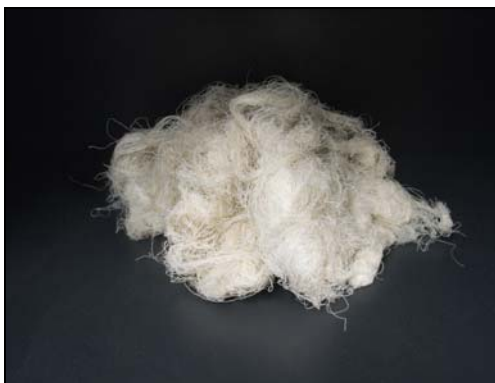
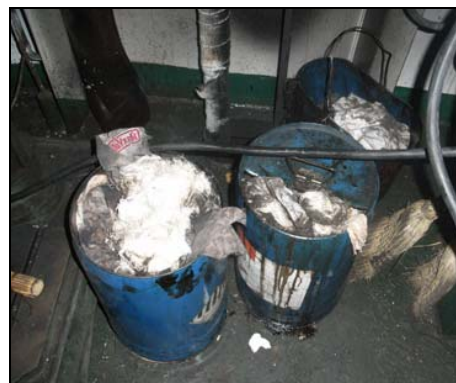
In their attempts to keep the engine room clean, the crew were consuming large quantities of rags and cotton waste. The cotton waste (Figure 24 and 25) was particularly effective when wiping up the oil because of its large surface area and the natural absorbency of cotton.

The evidence indicates that there were oily rags and cotton waste stored near the incinerator when the fire started on board MSC Lugano on 31 March and it is likely that these rags provided the initial fuel source for the fire.

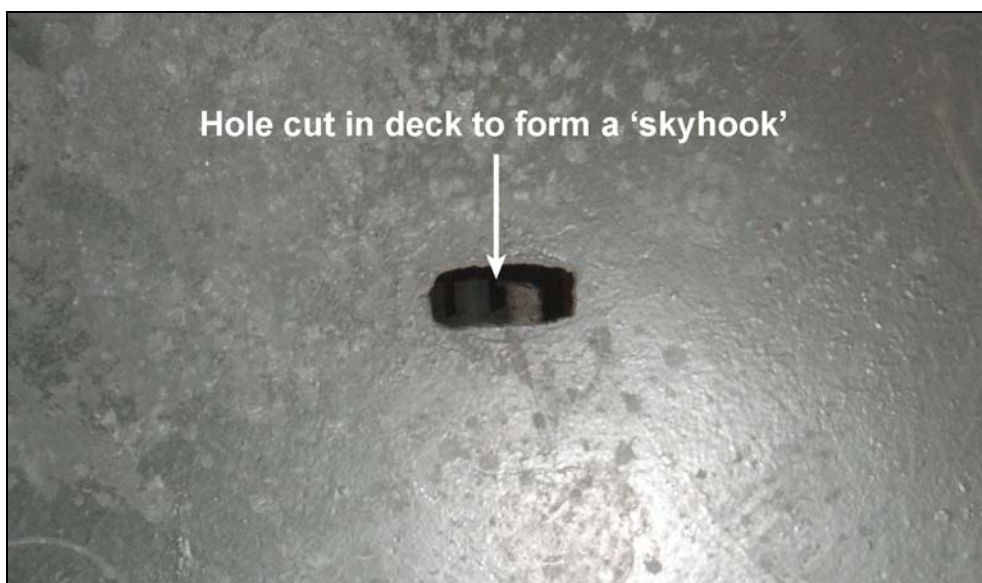
**Figure 26: Hole cut in deck**

However, when the ATSB investigators inspected the engine room after the fire they discovered that a large number of holes had been cut in the steel decks around the engine room (Figure 26). It was also noted that while the conduction of heat through the decks in these areas was insufficient to cause widespread damage, the transfer of heat via convection through the holes in the deck was sufficient to cause localised damage.

When the holes were cut in the engine room decks to create the 'sky hooks', the consideration was probably only for the immediate need to lift a piece of machinery. Time was not taken to weld an appropriate lifting eye in place and it is likely that the risks associated with cutting the holes in the deck were not appropriately considered.

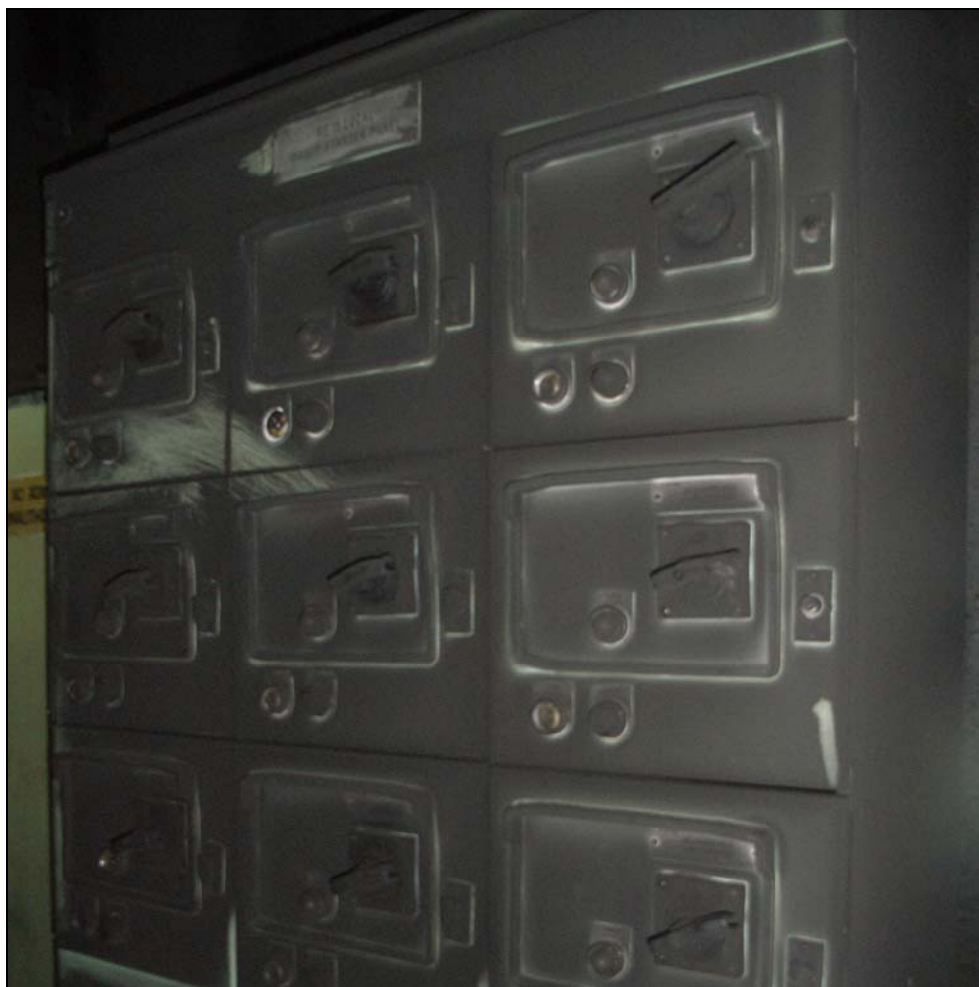
An example of this was the electrical distribution board mounted to starboard at the forward end of the engine room, on the second platform deck, diagonally across the engine room from the fire's point of origin. The area surrounding the distribution board was almost unaffected by the fire. However, the distribution board, with a hole cut in the deck directly in front of it, showed signs of heat and smoke damage (Figure 27).

**Figure 27:** Electrical distribution board with damaged switches directly in line with the hole that had been cut in the deck
