# Derailment of freight train 6DA2

near Marryat, South Australia | 26 July 2014

**ATSB Transport Safety Report**  
Rail Occurrence Investigation  
RO-2014-014  
Preliminary – 23 September 2014

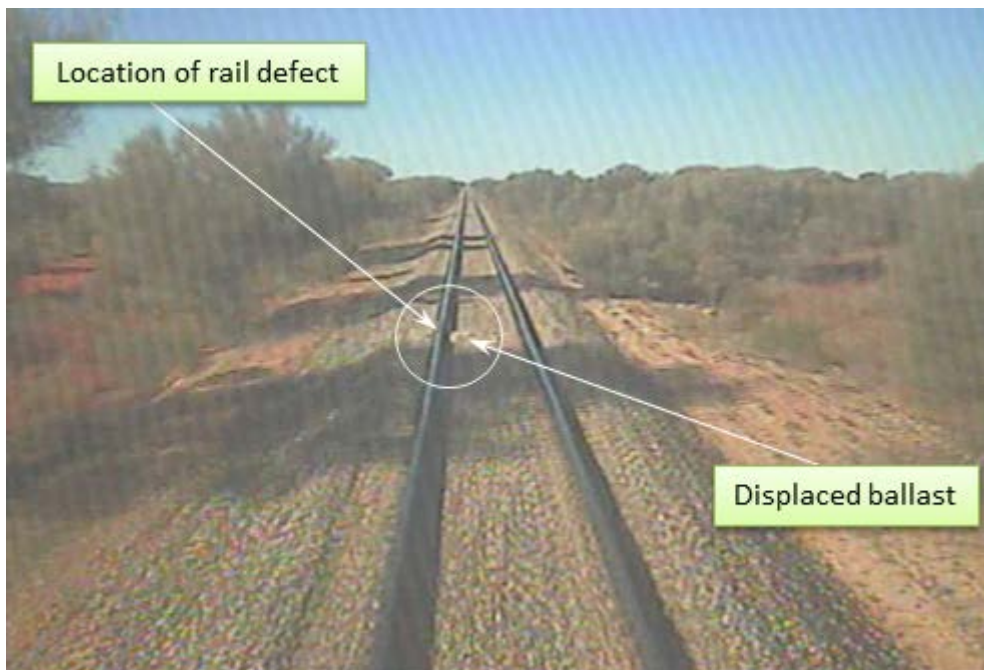
Preliminary examination of the train and locomotive data indicated that there were no anomalies with the train handling or mechanical condition before the derailment. A review of video and audio recordings extracted from leading locomotive GWU 006 supported the drivers report of a 'large bang' when they travelled over what they thought was a broken rail (Figure 2).

**Figure 2: Location of rail defect & minor ballast displacement near 1036.530 km mark.**

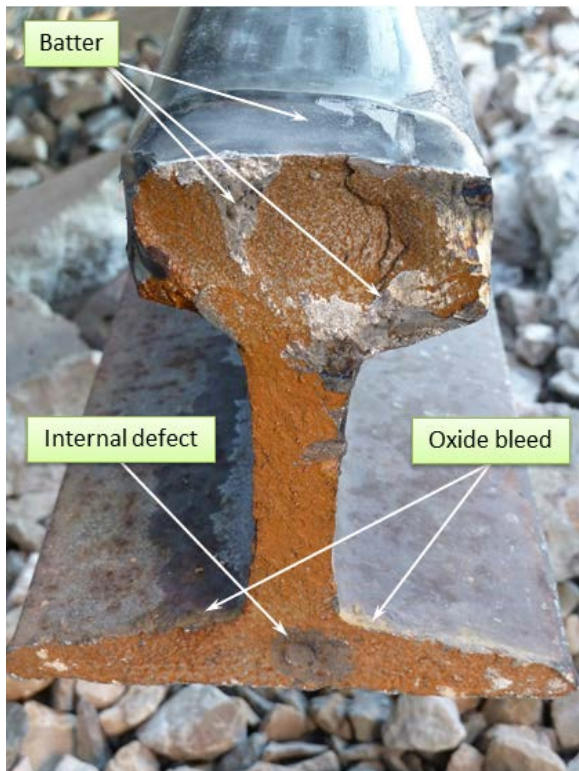
The ATSB's examination of the track leading into the derailment site determined the most likely contributor to the derailment was a break in the east rail near the 1036.530 km mark. An inspection of the mating ends from two broken rail sections strewn near the point of derailment identified variable oxidisation levels across the fracture surfaces and a localised feature that was characteristic of an internal material defect (Figure 3).

**Figure 3: Broken rail fracture surface**

The oxidisation that extended across the rail foot and through the web was noticeably greater than on the fracture surfaces through the rail head. This was consistent with the rail break originating in the rail foot and propagating vertically through the rail web.

Evidence of iron oxide bleed on the top surface of the foot suggested that the fracture had propagated slowly and been in existence for some period – potentially remaining undetected during track inspections and the passage of previous trains.

The rail head at the point of initial fracture showed light battering from train wheels that had traversed the break, before the rail breakup extended into multiple other sections - each about 700 mm long.
