Serious injury of a crew member on board *Julia N*

Port Hedland, Western Australia | 28 June 2014

ATSB Transport Safety Report
Marine Occurrence Investigation
310-MO-2014-005
Final – 24 September 2014

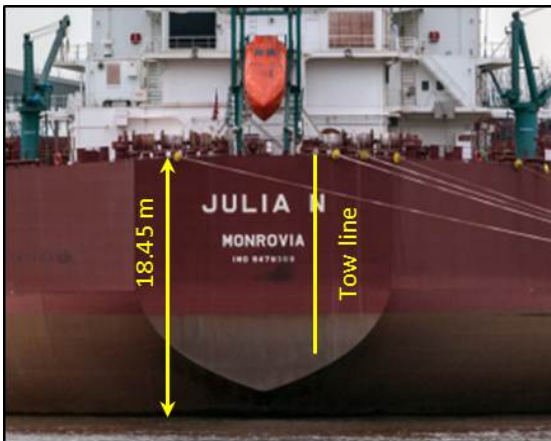
Figure 1: Approximate position of the tow line during retrieval²

At 1521¹, when it had been confirmed that the ship was in position, the pilot called the master of the tug at the stern of the ship to come in and retrieve its tow line (Figure 1 and Figure 2). When the tug was in position, the pilot asked *Julia N*'s master to instruct the aft mooring team (second mate and two seamen) to let go the tug's tow line.

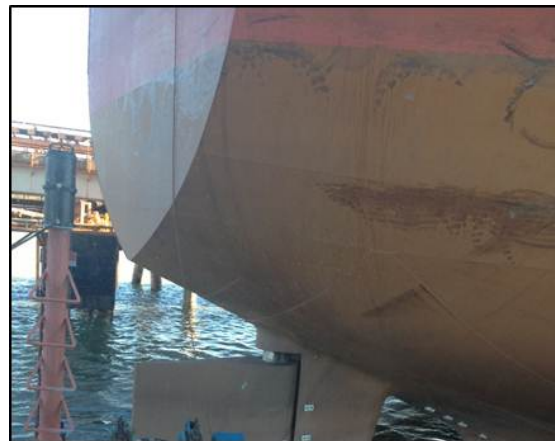
Figure 2: View of *Julia N* from the tug's bridge window

From his position at the port bridge console, the tug's engineer could see the tow line, the winch and the general purpose hand. However, due to the freeboard of the ship, no one on board the tug could see past the ship's main deck hand rails. As is usual, the tug's crew had no direct radio communications with the ship's aft mooring team, and were therefore reliant on visual contact with the mooring team for all communications.

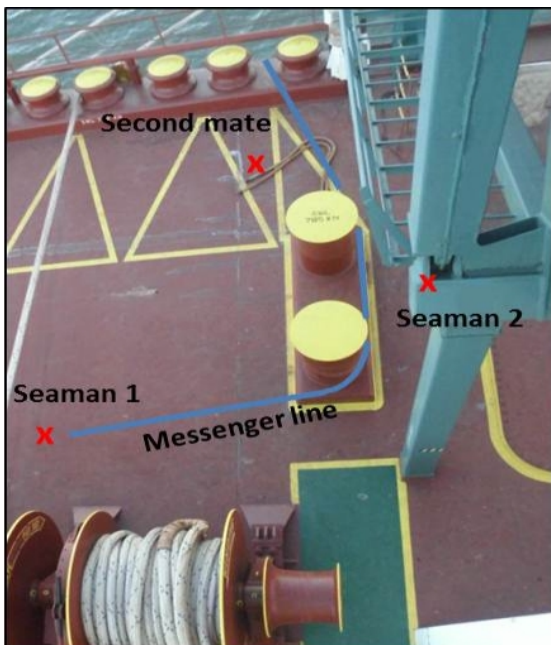
Figure 3: Crew and messenger line positions

Seaman 1 (Figure 3) ran the messenger line³ over the drum end of the mooring winch, while seaman 2 operated the winch to pull about 2 m of tow line inboard. The second mate wrapped the rope stopper around the main tow line while the messenger line was taken off the drum end and the eye of the tow line off the mooring bits. The messenger line was then put around the forward post of the mooring bits to assist with the controlled lowering of the tow line.

As the tow line was retrieved, seaman 2's right leg somehow became entangled in the messenger line. He was then dragged about 4 m across the deck and into the rollers of the fairlead. When his legs entered the fairlead the messenger line came under tension and it severed the seaman's right foot.

There were three crew members (second mate and two seamen) on the aft deck for mooring operations and it is likely that the second mate felt that he needed to assist the two seamen when releasing the tugs line from the bits. However, when doing so, he was not at the ship's side where he had a clear line of sight of the tug, and as such had relinquished his supervisory role. Then, when the seaman became entangled in the messenger line, there was no one on the aft deck of the ship in a position to signal to the tug's crew to stop retrieving the line.

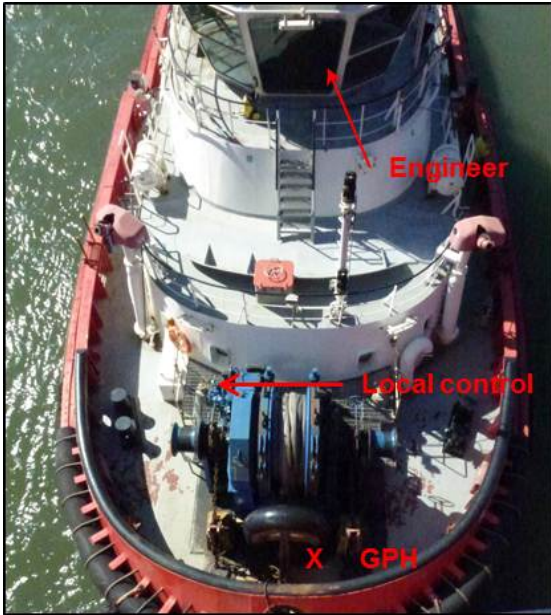
Figure 4: Position of the general purpose hand and the engineer.

On board the tug, the general purpose hand was standing forward of the winch (Figure 4) ready to guide the tow line onto the winch drum and the engineer was at the remote winch controls inside the bridge.
