# Flight envelope protection event involving an Airbus A320, VH-VFJ

Near Auckland, New Zealand, 7 September 2013

**ATSB Transport Safety Report**  
Aviation Occurrence Investigation  
AO-2013-159  
Final – 15 October 2014

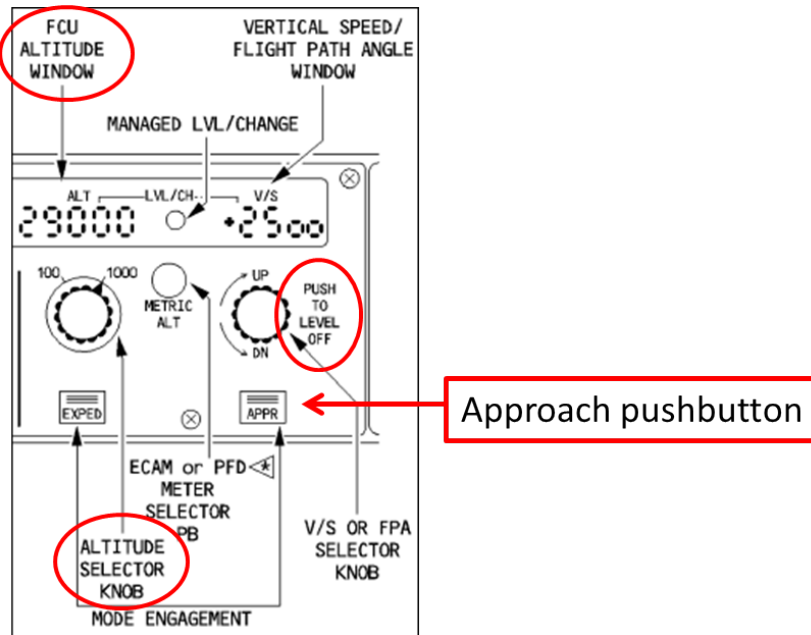
Figure 1: Relevant part of FCU panel (vertical control area)

Soon after altitude capture, the crew wound the FCU altitude window to 5,000 ft by rotating the altitude selector knob, then inadvertently pulled the altitude selector knob. This action caused the auto-flight system to engage in open climb mode<sup>4</sup> contrary to the intent of the crew which was to continue descent and resume the approach. In open climb mode, the auto-flight system (flight directors) commanded a climb to 5,000 ft – the altitude now set in the FCU altitude window. As engine thrust increased however, the FO initially maintained a shallow descent, having moments earlier disconnected the auto-pilot and assumed manual aircraft control. The combined effect of the increase in engine thrust and the shallow descent resulted in unwanted aircraft acceleration.

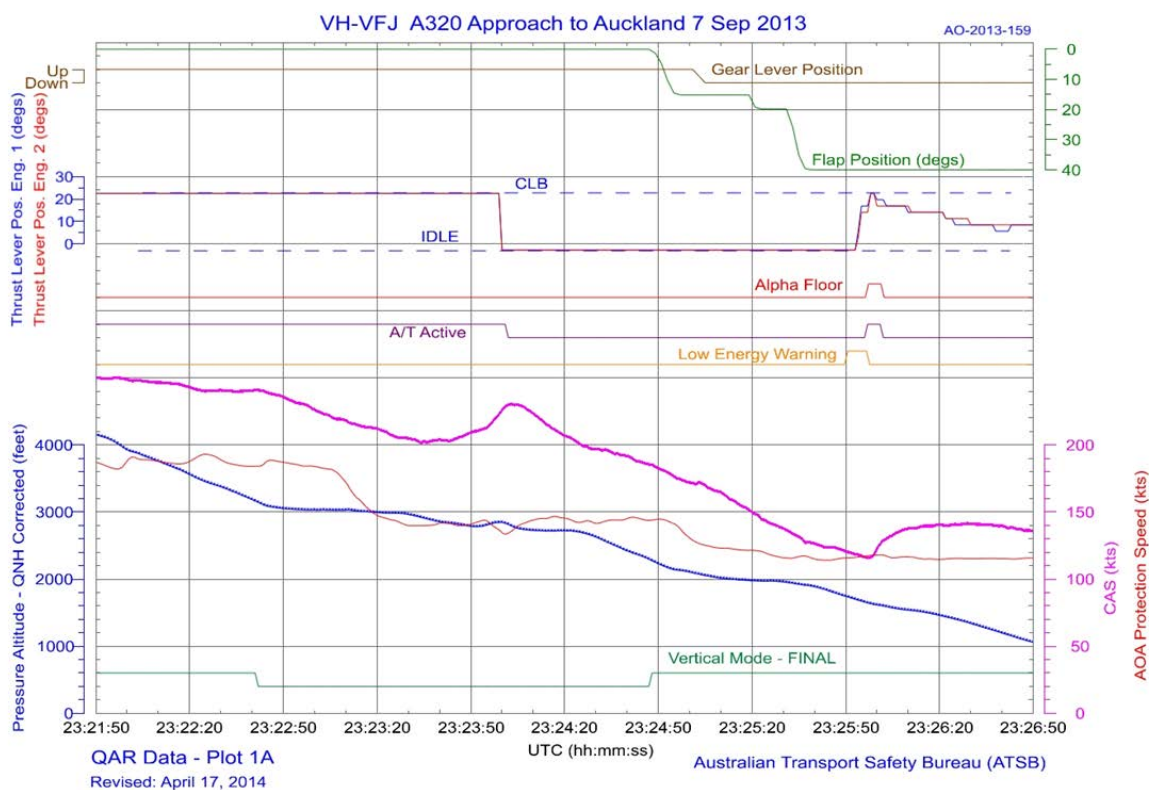
Figure 2: Quick access recorder data plot - selected parameters

As the aircraft descended through about 1,700 ft and reached a speed of 120 kt, the flight augmentation computers<sup>11</sup> generated an aural low-energy 'speed speed speed' warning. The captain responded to the low-energy warning by again taking control from the FO, disconnecting the auto-pilot and advancing the thrust levers toward the climb detent. Despite thrust lever advancement, aircraft speed briefly and marginally continued to reduce given the inertia of the aircraft and the finite time required (albeit very momentary) for the engines to deliver a thrust output that corresponded to the increased thrust lever setting. The aircraft slowed through the alpha<sup>12</sup> protection speed of about 117 kt, followed almost immediately by engagement of the alpha floor auto-thrust mode at 116 kt (which was the minimum speed reached). The nature of the low-energy warning, alpha protection speed and alpha floor auto-thrust mode, are described later in the report.

The alpha floor auto-thrust mode automatically re-activated the auto-thrust system and initiated the application take-off/go-around (TOGA) thrust, even though the captain was manually advancing the thrust levers at the same time. The captain disconnected the auto-thrust system using the instinctive disconnect pushbutton on the thrust levers about 5 seconds after alpha floor mode engagement, thereby allowing the crew to establish manual thrust control<sup>13</sup> and accelerate the aircraft to the approach speed. At the moment the captain disconnected the auto-thrust system, the aircraft was accelerating through about 129 kt and descending through about 1,600 ft. Manual thrust management was retained for the remainder of the flight, which continued from that point to an uneventful landing. A selection of recorded data that graphically represents the occurrence is shown in Figure 2.

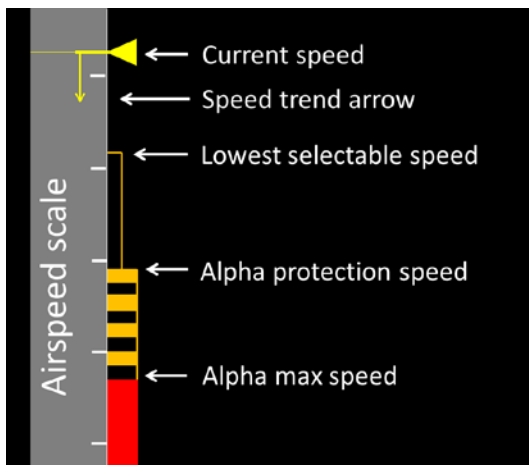
**Figure 3: Representation of primary flight display airspeed indicator low speed protection markings (normal law)**

The airspeed indicator is located on each pilot’s primary flight display. In addition to current airspeed, the indicator includes references to predicted speed and high angle-of-attack protection speeds (normal law). Some relevant information includes (Figure 3):

- A speed trend arrow that indicates what the speed will be in 10 seconds at the current rate of acceleration or deceleration.
- Lowest selectable speed, which is the lowest speed that can be selected by the crew while maintaining a suitable margin above the aircraft stall speed.
- Alpha protection speed, represented by the top of an amber and black strip.
- Alpha max speed, represented by the top of a red strip.

Note that the speed at which the low energy ‘speed speed speed’ alert will sound and the speed at which alpha floor auto-thrust mode will engage are not depicted on the airspeed indicator.
