Descent below the minimum permitted altitude involving Boeing 737-838, VH-VXB

35 km SW of Canberra Airport, Australian Capital Territory | 17 October 2012

ATSB Transport Safety Report
Aviation Occurrence Investigation
AO-2012-138
Final – 29 October 2014

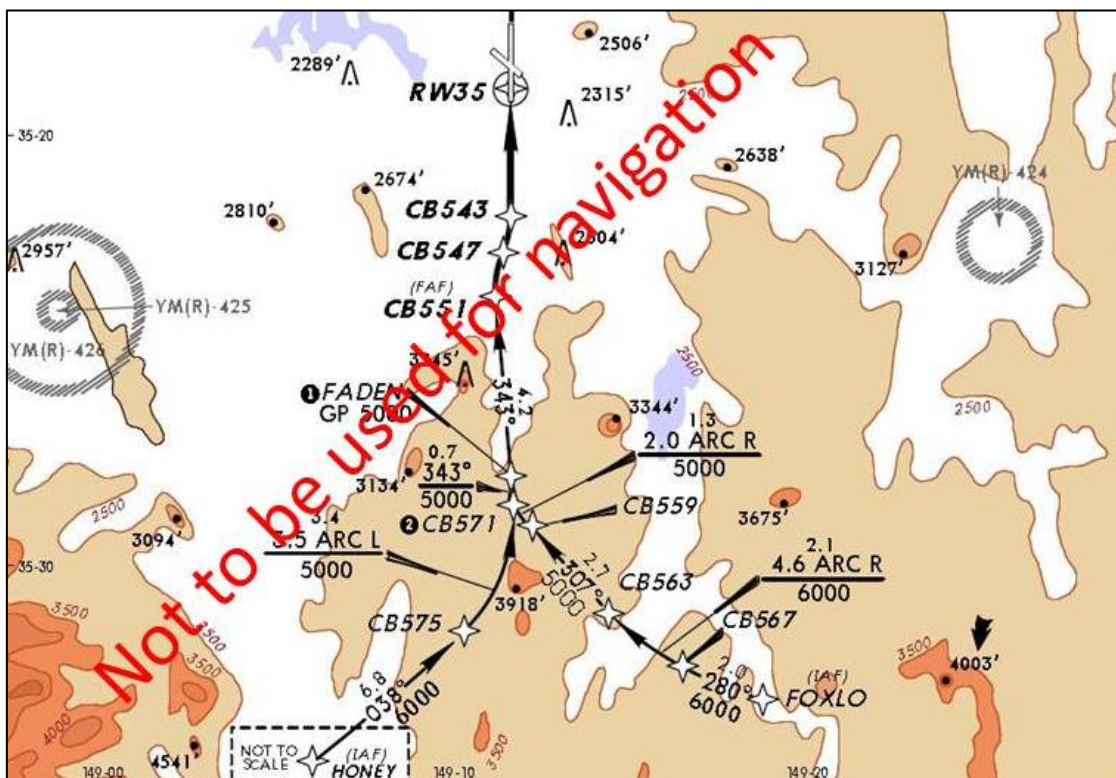
Figure 1: Extract of the Canberra RNAV-U (RNP) RWY 35 instrument approach chart (the complete chart, including vertical profile is at appendix B)

After landing, the captain reviewed the chart for the RNAV-U approach and the FMC data to check if there was an altitude restriction at HONEY. There was no altitude restriction at HONEY displayed on the RNAV-U approach chart or in the FMC database.

The RNAV-U approach chart issued by Qantas did not have a 'not below' altitude listed at waypoint HONEY. The equivalent Airservices Australia chart, which was for information to other operators only, did have a 'not below' altitude of 6,000 ft; however, this was 1,000 ft lower than the required crossing altitude of 7,000 ft. The captain noted that, had this crossing altitude been on the chart, the crew's awareness of the need to ensure they remained above 7,000 ft would have been higher. The absence of this prompt on the chart, coupled with the crew's high workload and focus on the airspeed, heightened the importance of the altitude alerting provided by setting the limiting altitude on the MCP, in this case 7,000 ft. The flight crew's selection of the approach decision altitude on the MCP removed the last cue for the crew to identify they had an airspace restriction to comply with, in addition to the company speed restriction.

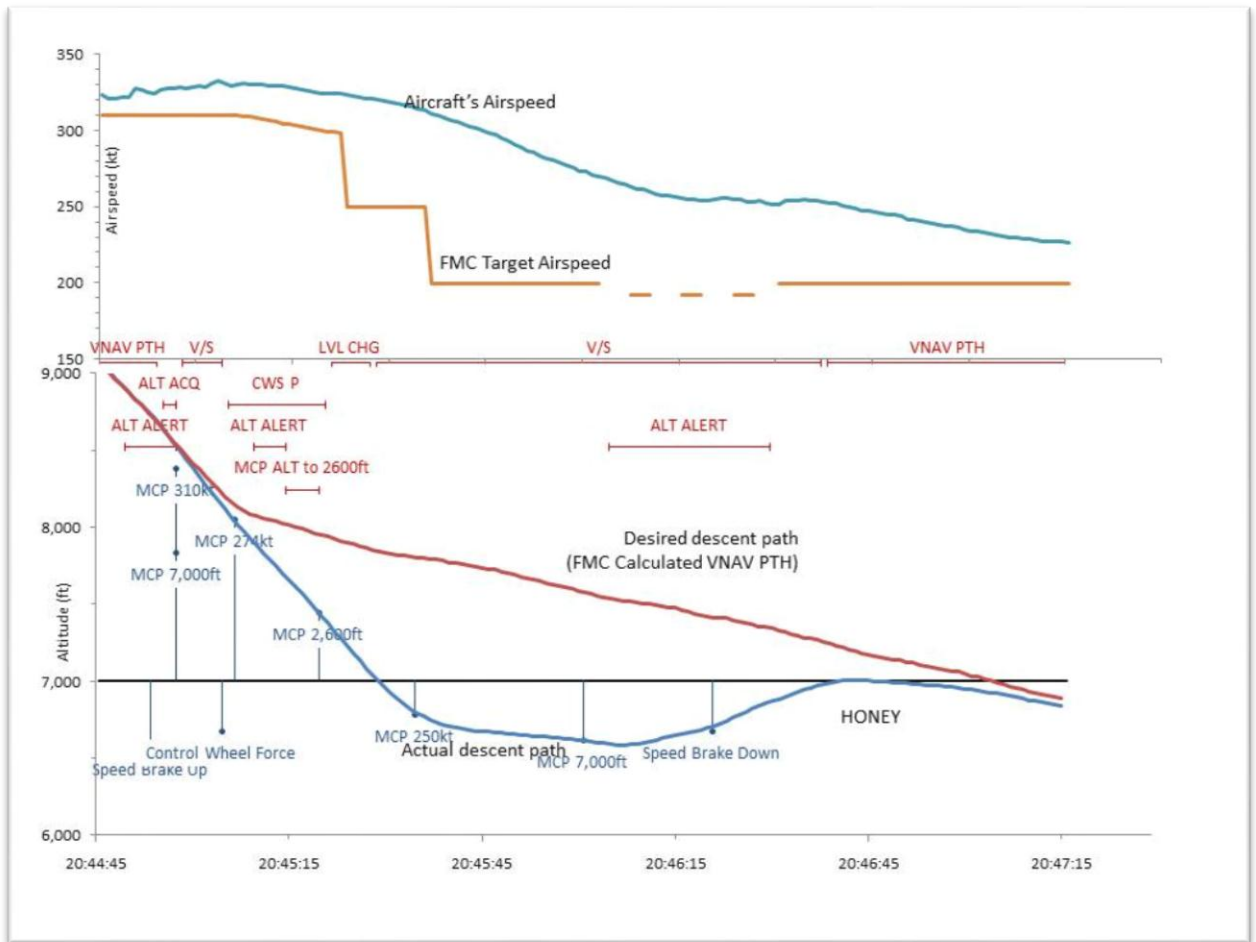
Figure 3: Descent profile with auto-flight modes and MCP inputs annotated

The aircraft's descent profile from about 9,000 ft until just after the aircraft passed HONEY is displayed graphically at Figure 3. At 2044:49, as the aircraft passed about 9,000 ft with a descent rate of about 2,700 feet per minute (fpm), the aircraft's altitude alert warning system (ALT ALERT) activated, indicating that the aircraft was approaching the 8,000 ft clearance limit set in the MCP. Four seconds later, the autopilot entered the altitude acquire mode (ALT ACQ) in order to level at 8,000 ft. At about the same time, ATC cleared the aircraft to continue descent to 7,000 ft and make the RNAV-U approach. The 7,000 ft altitude restriction ensured that the aircraft maintained at least 500 ft above the lower limit of controlled airspace until cleared further and provided in excess of 2,000 ft clearance above terrain.

As the FO responded to the ATC clearance at 2044:57, the captain changed the altitude in the MCP to 7,000 ft, which removed the 8,000 ft ALT ALERT warning. As a result of changing the MCP altitude while in the ALT ACQ mode, the autopilot changed its vertical control mode from the FMC-calculated vertical path (VNAV PTH) to vertical speed (V/S). On entering the V/S mode, the MCP airspeed and vertical speed windows (the IAS/MACH and VERT SPEED labelled windows at Figure 2) opened and displayed the current airspeed of 310 kt and rate of descent of 3,400 fpm.

At 2045:05, 7 seconds after the aircraft entered the V/S mode and about the time the aircraft's speed reached 330 kt, the captain inadvertently applied sufficient force to the control column to cause the autopilot to enter the control wheel steering pitch mode (CWS P). The change of vertical mode from V/S to CWS P resulted in the VERT SPEED window closing while the IAS/MACH window remained open. A few seconds later the captain reduced the selected airspeed in the MCP to 274 kt. Both flight crew recalled that, at this time, their major focus was on reducing the aircraft's airspeed.

At 2045:09, with the aircraft passing through 8,000 ft at a speed of about 330 kt and a rate of descent of about 3,000 fpm, the ALT ALERT warning again activated indicating that the aircraft was approaching 7,000 ft. The captain reported that, as the aircraft had been cleared for the RNAV-U approach, the decision altitude (DA) of 2,600 ft for the approach was set in the MCP in

The aircraft continued to descend at about 3,000 fpm in the CWS P mode until at 2045:21, as the aircraft descended through about 7,400 ft, the captain selected the level change (LVL CHG) mode on the MCP (Figure 2). The captain reported expecting that the automation would have reduced the airspeed to 250 kt by 7,000 ft, as set up in the FMC before commencing the descent. However, as the aircraft passed about 7,200 ft, it became evident that the automation was not slowing the aircraft sufficiently, so the captain selected the V/S mode with the aim of levelling the aircraft and reducing the airspeed. The selection of the V/S mode caused the VERT SPEED window to open at the current rate of descent, which the captain then reduced to zero. At 2045:33, the captain reduced the MCP airspeed from 274 kt to 250 kt and observed that the aircraft had inadvertently descended below the VNAV PTH. The captain's intention was to correct this condition by reducing the airspeed to 250 kt in level flight and then re-intercept the VNAV PTH from below.

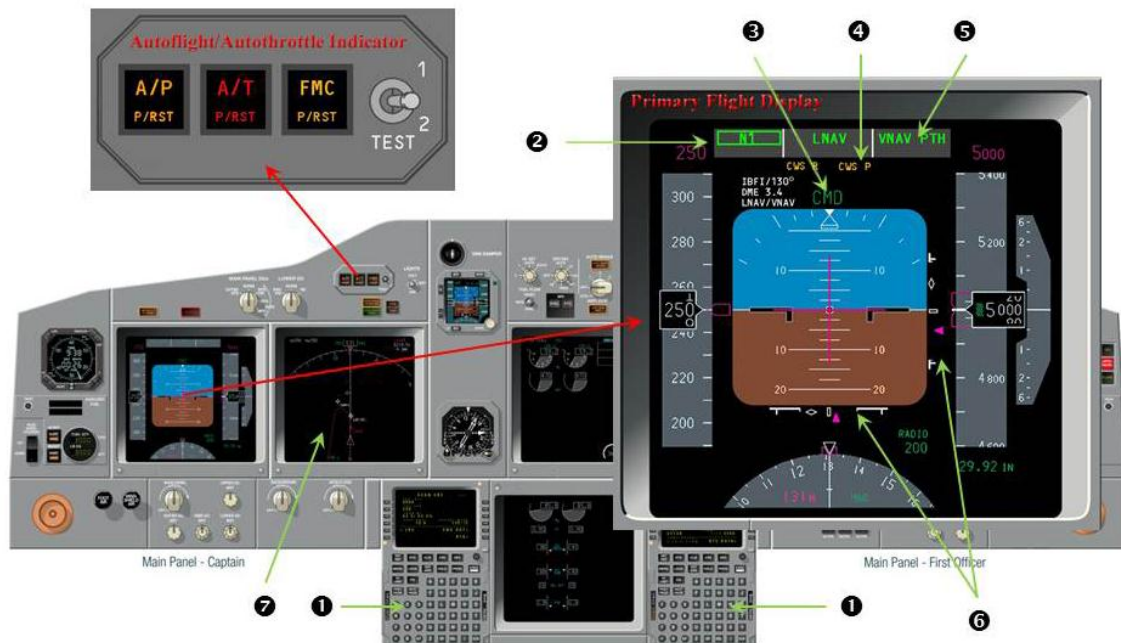
Figure 4: Flight deck main panel with expanded auto-flight/autothrottle indicator and primary flight display

The AFDS flight mode annunciator (FMA) displays the engaged AFDS modes above the attitude indicator on the pilot's primary flight display (PFD) (item ❷ on Figure 4). The FMA is divided into three sections from left to right, being autothrottle, roll and pitch. The autothrottle and roll modes displayed on the PFD in Figure 4 are N1 and LNAV, while the pitch mode displayed is VNAV PTH (item ❸ on Figure 4). An AFDS mode change results in a highlighted symbol (rectangle) being

- CMD, indicating that one or both autopilots are engaged (item ⑤)
- CWS P, indicating that the control wheel steering (CWS) pitch mode is engaged (item ④)
- CWS R, indicating that the CWS roll mode is engaged.

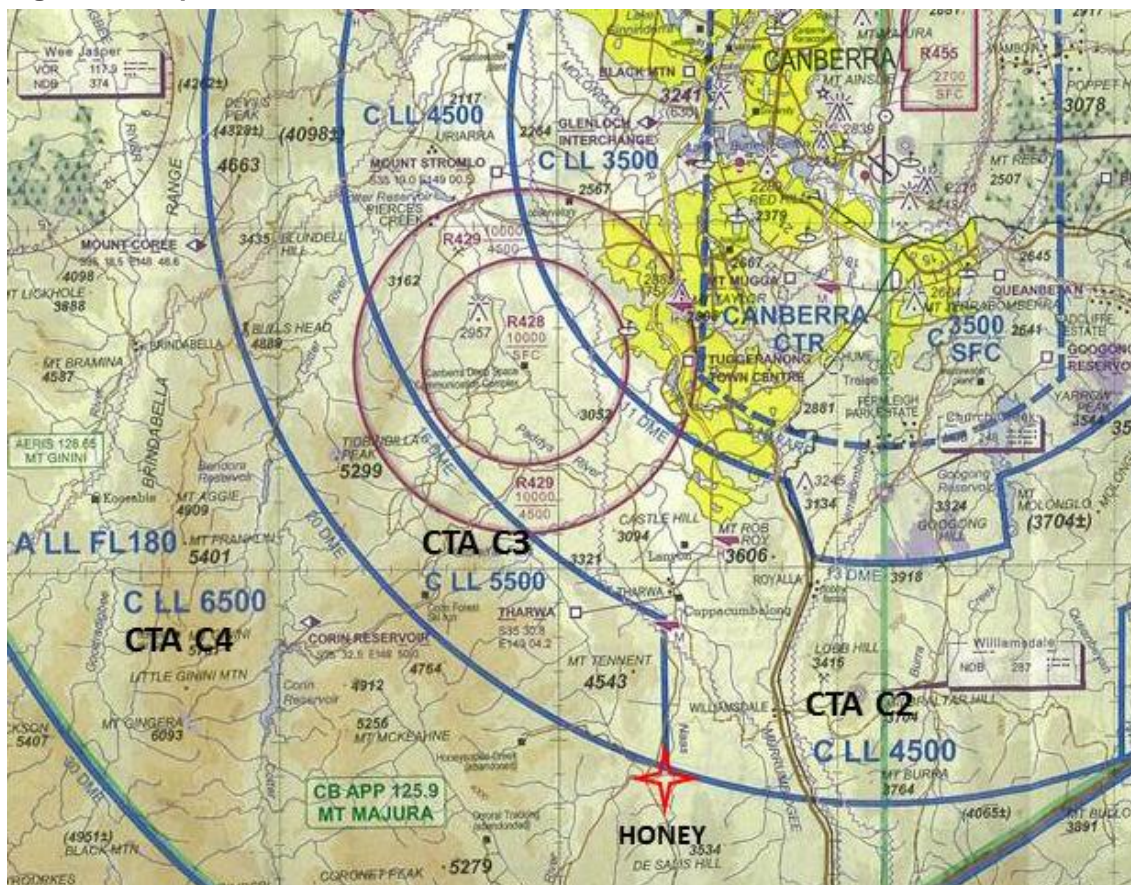
Figure 5: Airspace to the south-west of Canberra

The Designated Airspace Handbook (DAH) listed the particular airspace relevant to the descent towards RNAV-U initial approach fix (IAF) HONEY as a number of Class C controlled airspace segments. These segments were labelled CTA (controlled airspace) C2, C3 and C4, with lower

limits of 4,500 ft, 5,500 ft and 6,500 ft respectively. HONEY was about 200 m south-south-west of the common boundary between C2, C3 and C4, placing it just inside CTA C4. The lower limit of the Class C controlled airspace at HONEY was 6,500 ft.
