# Flap overspeed and altitude exceedance during go-around Airbus A321, VH-VWY

Cairns Airport, Queensland | 3 September 2012

**ATSB Transport Safety Report**  
Aviation Occurrence Investigation  
AO-2012-116  
Final – 3 November 2014

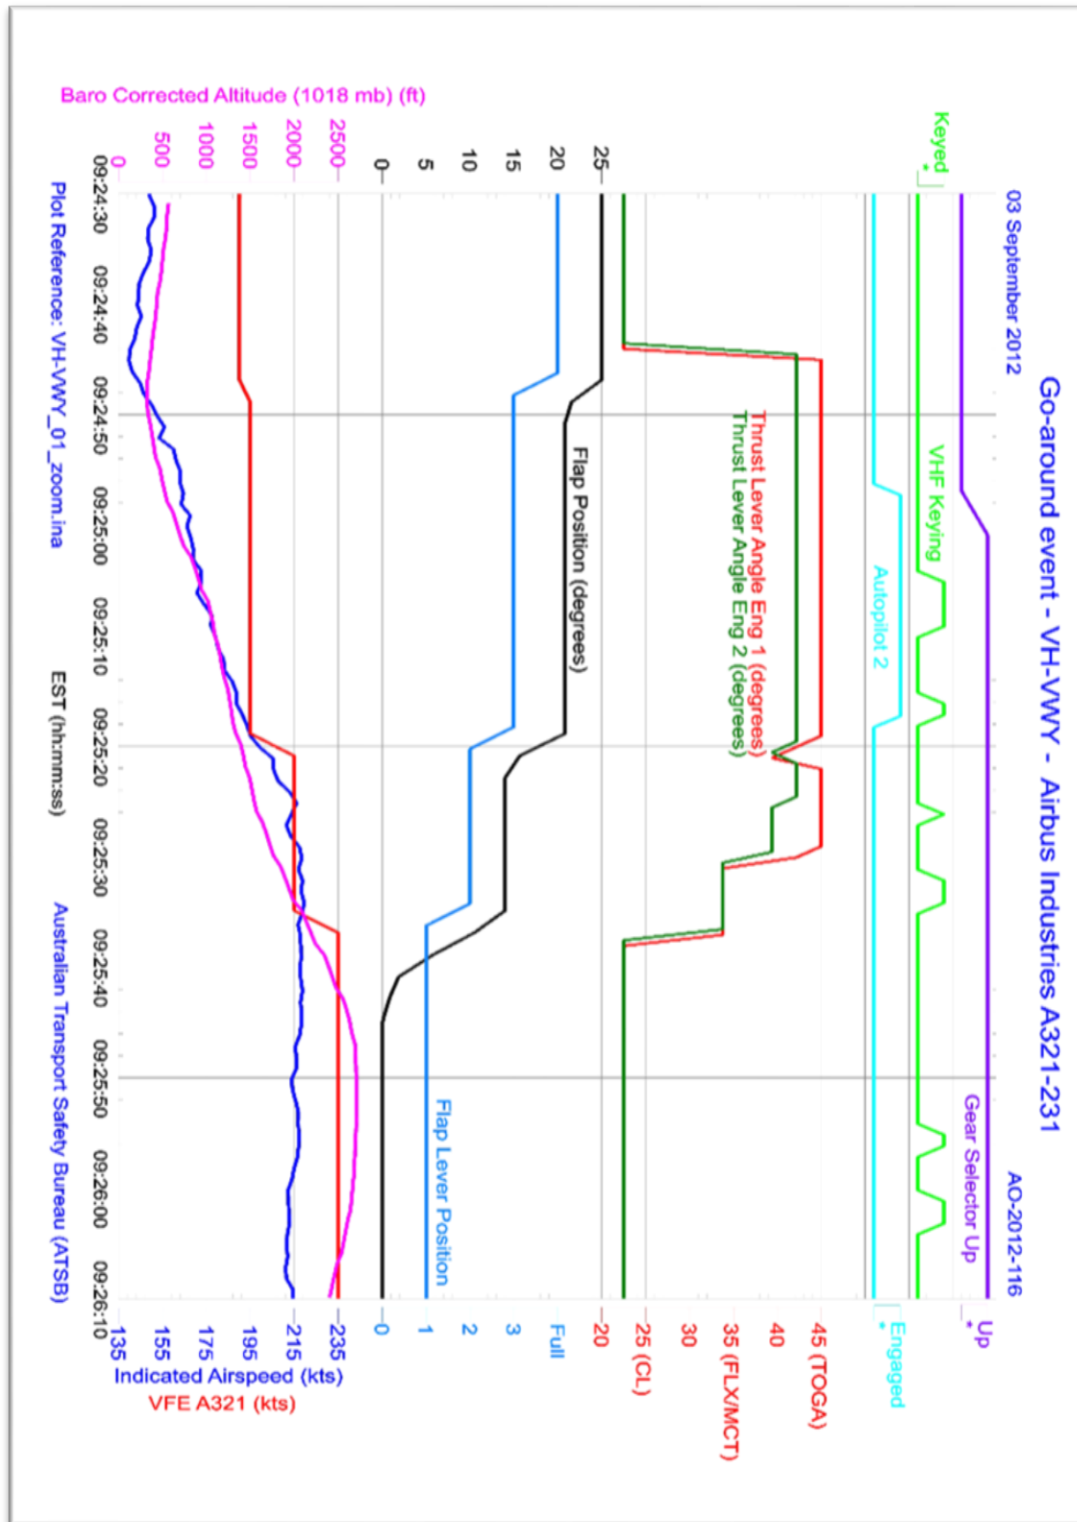
Figure 1: Selected flight parameters recorded during the go-around<sup>7</sup>

At 0925:30, as the airspeed reached 215 kt and the aircraft was approaching 1,800 ft, the first officer retarded the thrust levers to the flexible take-off/maximum continuous thrust (FLX/MCT) detent. Although this action reduced engine thrust, in this detent the thrust remained unresponsive to auto-flight system requirements.

At 0925:33, the captain read back the ATC instruction.<sup>5</sup> One second later, with the airspeed stabilised at just over 215 kt and the aircraft passing 2,000 ft, the overspeed warning system

During the go-around the flap limiting speed was exceeded by a maximum of 5 kt. A subsequent engineering inspection of the flap system revealed no damage. There were no other aircraft in the vicinity at the time of the go-around.

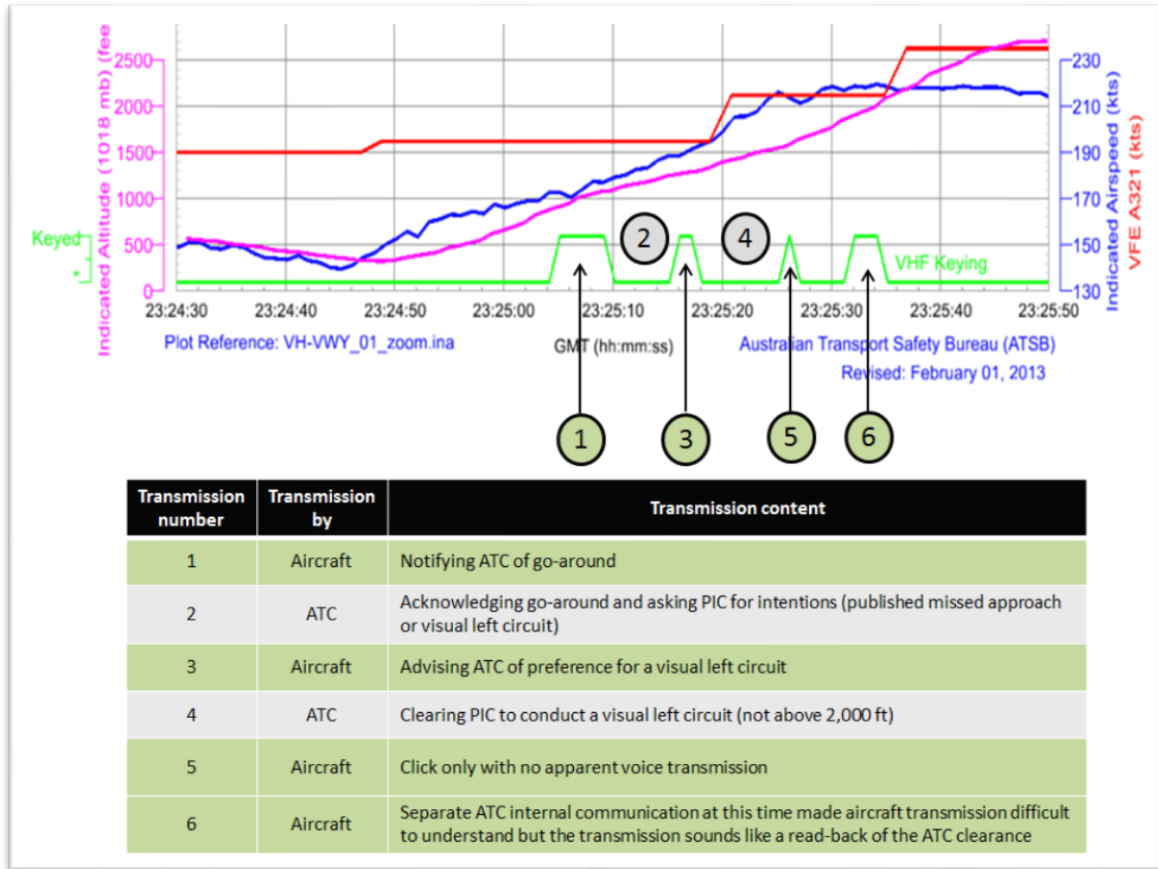
Figure 2: Flight crew-ATC communication during the go-around

the Instrument Landing System (ILS)<sup>3</sup> approach to runway 15 or a visual left circuit.<sup>4</sup> The captain immediately indicated a preference for a visual left circuit, to which the tower controller responded with the clearance ‘make a left circuit, not above 2,000, visual’.
