# Trim system malfunction involving a Fairchild SA227, VH-UZI

Rockhampton Airport, Queensland, 6 August 2014

**ATSB Transport Safety Report**  
Aviation Occurrence Investigation  
AO-2014-140  
Final – 3 December 2014

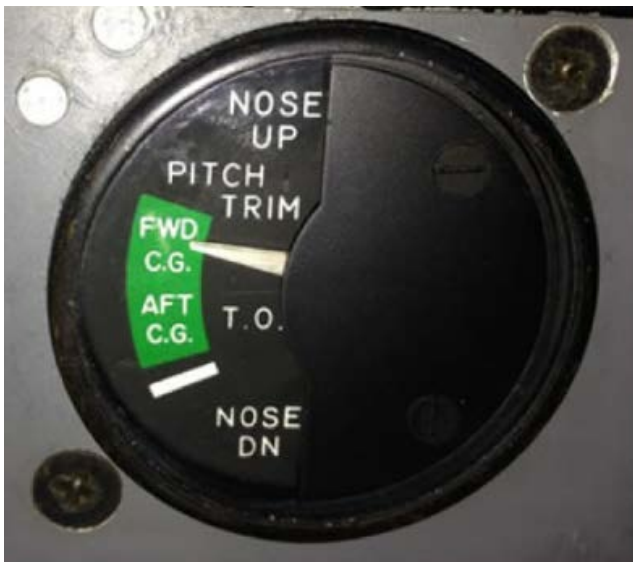
The pilot set the stabiliser trim gauge in the cockpit to read a nose up attitude, and then externally inspected the position of the stabiliser. He observed the stabiliser in a neutral position and therefore determined that the gauge did not accurately indicate the stabiliser position (Figure 1). The pilot assessed that the combination of the incorrectly loaded freight causing a forward centre of gravity and the inaccurate stabiliser trim gauge led to the out of trim warning and overly heavy control pressure required for the attempted take-off.

**Figure 1: Cockpit indication with horizontal stabiliser in the neutral (take-off) position**

An engineering inspection found that the actual position of the horizontal stabiliser was not being correctly displayed on the pitch trim indicator in the cockpit. The engineer then calibrated the system and returned the aircraft to service. During a fleet-wide check the following day, it was found that the pitch trim system on UZI was not being consistently displayed with accuracy on the cockpit indicator. The potentiometer in UZI was replaced which resolved the fault.

- Review the system calibration used in the initial engineering inspection.
