Derailment of train 735

Colebrook, Tasmania, 9 November 2014

ATSB Transport Safety Report

RO-2014-020

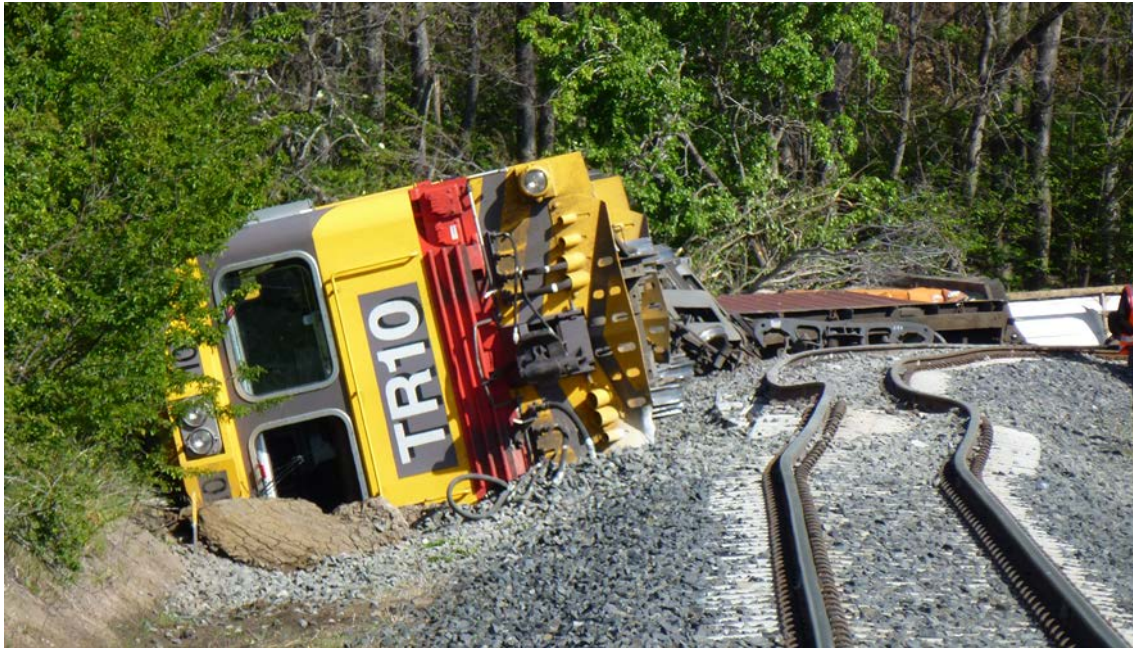
At 0516 the train crossed the level crossing at Mud Walls Rd at 30 km/h. The train's data logger showed that shortly thereafter, the speed had dropped to 20 km/h and the driver disengaged the dynamic brake. As the train gathered speed, the driver then reapplied the dynamic brake, followed by the train [air] brake. The train continued to gather speed, reaching 64 km/h as it approached the curve located at the 65 km post. As the train negotiated the curve, the driver placed the train brake into *emergency*. At the exit of the curve both locomotives left the track and rolled onto their sides into the cess drain (Figure 2). All but the last seven of the train's wagons derailed and most lost their cargo/freight containers.

Figure 2: Locomotive TR10 at the derailment site

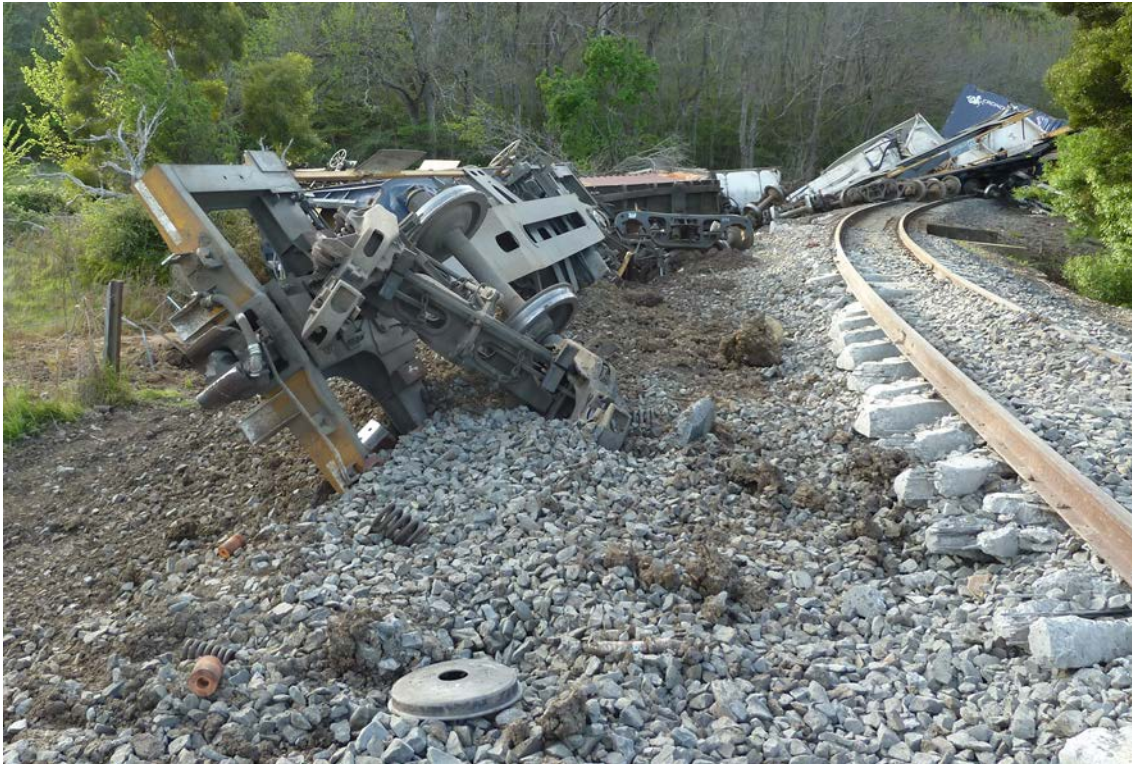
Figure 3: Derailed Wagons on the right hand side of the track and wagons behind stacked on the track.

Examination of the derailed wagons and locomotives indicated that none of the derailed rolling stock had travelled far in a derailed state. The locomotive and the first six wagons had been cast to the right of the track and the next three wagons were stacked up on and about the track. Some containers from the train had separated from their wagons and were cast to the right of the track. The last seven wagons of the consist had not derailed and had retained their loads.

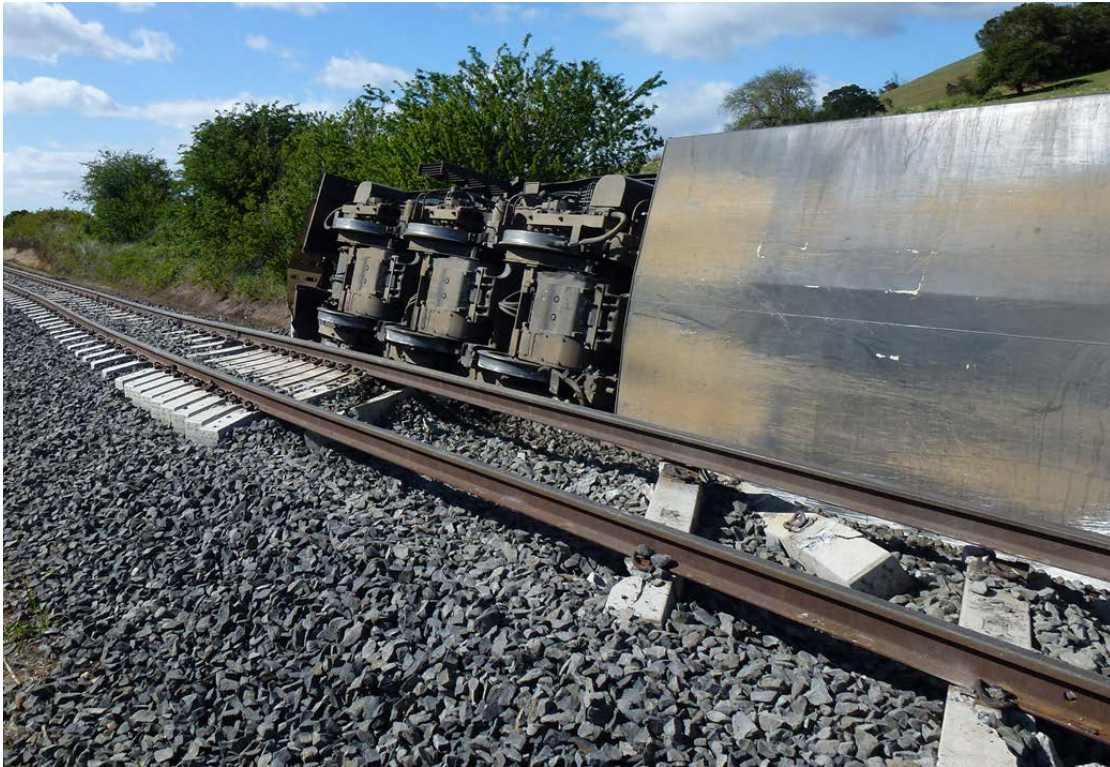
Examination of the track identified a number of marks on the head of the right hand rail, consistent with wheels moving abruptly across, and running along the rail head. Clusters of sleepers had been damaged and pushed into bunches (Figure 4) adjacent to where the locomotives came to rest.

Figure 4: Sleepers pushed into bunches adjacent to locomotive TR10.
