Train 7MD3 collision with motor vehicle

Katherine, Northern Territory | 12 October 2014

ATSB Transport Safety Report
Rail Occurrence Investigation
RO-2014-017
Final – 20 January 2015

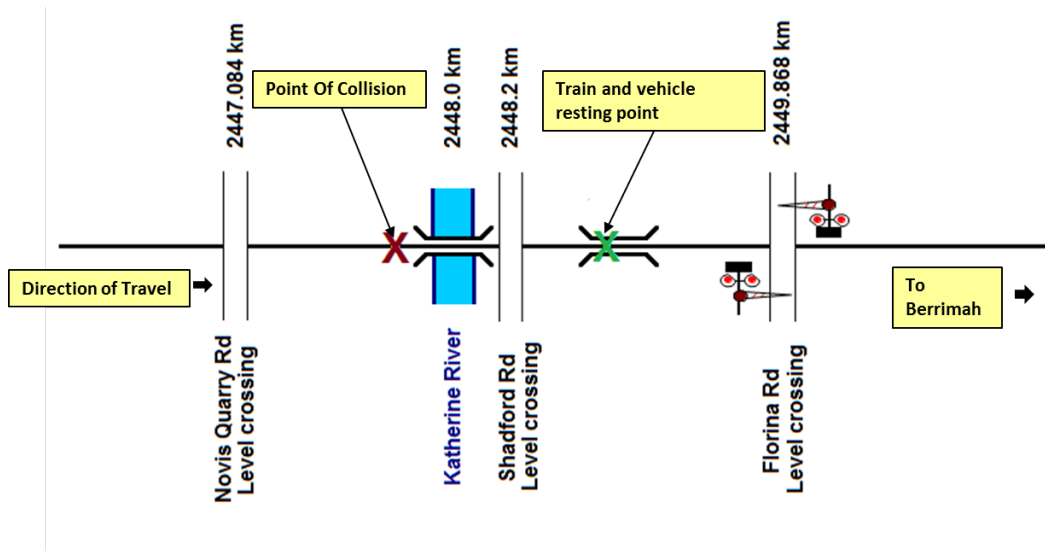
Figure 2: Collision and resting point

At about 0102, the lead locomotive of train 7MD3 struck the utility vehicle at a speed of about 70 km/h. The train crew believed that the impact had derailed the locomotive and they were about to fall off the bridge and into the Katherine River. While the road vehicle became lodged under the lead bogie, the locomotive and the trailing wagons remained on track. The train travelled approximately 500 m further (Figure 2) before finally coming to rest atop a culvert bridge, with the damaged vehicle hanging precariously over the right side of the bridge (Figure 3).

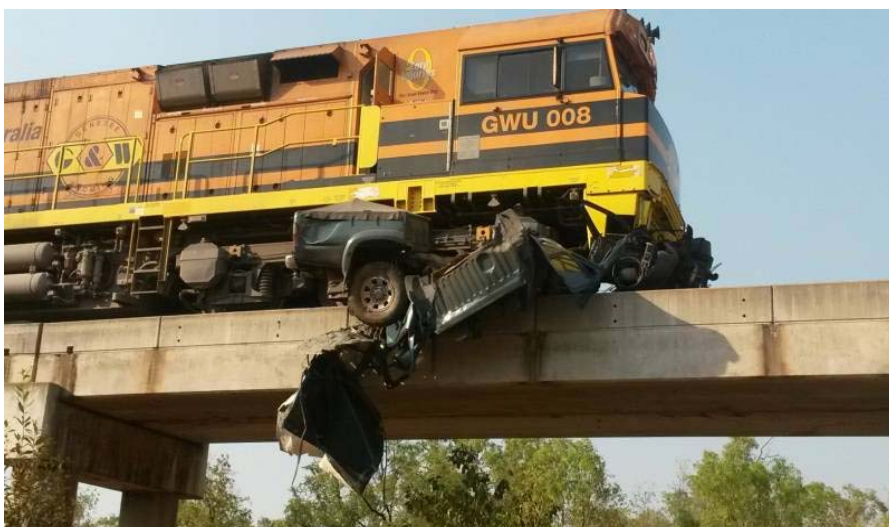
Figure 3: Vehicle position post collision

The point where the road vehicle attempted to traverse the railway did not contain any structure that resembled a level crossing, or any other provisions for road vehicles to safely cross the track. Evidence showed that in the attempt to traverse the rail line, the driver entered the rail corridor and mounted the east side of a steep embankment topped by the ballast formation supporting the rail track. The vehicle's front wheels subsequently 'hung' on the east rail, such that its chassis rested on the track ballast and embankment with the rear wheels only lightly contacting the ground and unable to provide sufficient tractive effort.
