# Aviation Short Investigations Bulletin

Issue 38

**ATSB Transport Safety Report**  
Aviation Short Investigations  
AB-2014-187  
Final – 27 January 2015

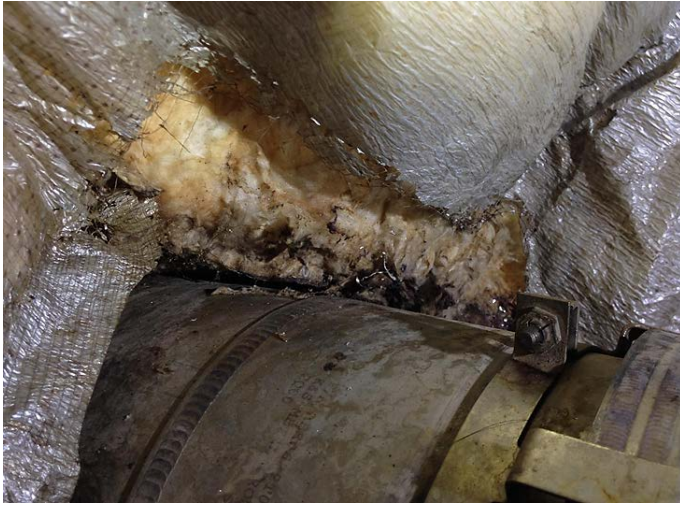
**Figure 1: Insulation blanket damage adjacent to upper surface of APU bleed air duct**

Following the flight, a subsequent engineering inspection found that a portion of insulation blanket fitted to the rear pressure bulkhead of the aircraft had collapsed and came into contact with the Auxiliary Power Unit (APU)<sup>1</sup> bleed air duct, where the duct passes through the rear pressure bulkhead. The engineering investigation determined that the insulation blanket had not been correctly refitted following maintenance by a previous operator of the aircraft.

The insulation blanket is constructed of glass wool encased in a wrapping material. The wrapping was damaged and heat affected where the insulation blanket was in contact with the APU bleed air duct. Damage to the wrapping exposed the inner glass wool material, which also showed evidence of having been affected by heat where the material was in contact with the bleed air duct

(Figures 1 and 2). Engineering staff determined that the insulation blanket in contact with the bleed air duct was the likely source of the fumes.

The operator found similar damage on another A330 aircraft, registered VH-XFA. As an interim measure, the operator prohibited use of the APU on both VH-XFB and VH-XFA. Both aircraft were then subject to an Engineering Order which required that a section of the insulation blanket adjacent to the APU bleed air ducting to be trimmed and sealed, and that the remainder of the blanket be appropriately restrained. The Engineering Order also required a detailed visual inspection of the rear pressure bulkhead structure immediately around the bleed air duct (looking for signs of heat damage, paint discolouration or distortion). The second part of the Engineering Order directed that the insulation blanket be replaced entirely, as a permanent repair.

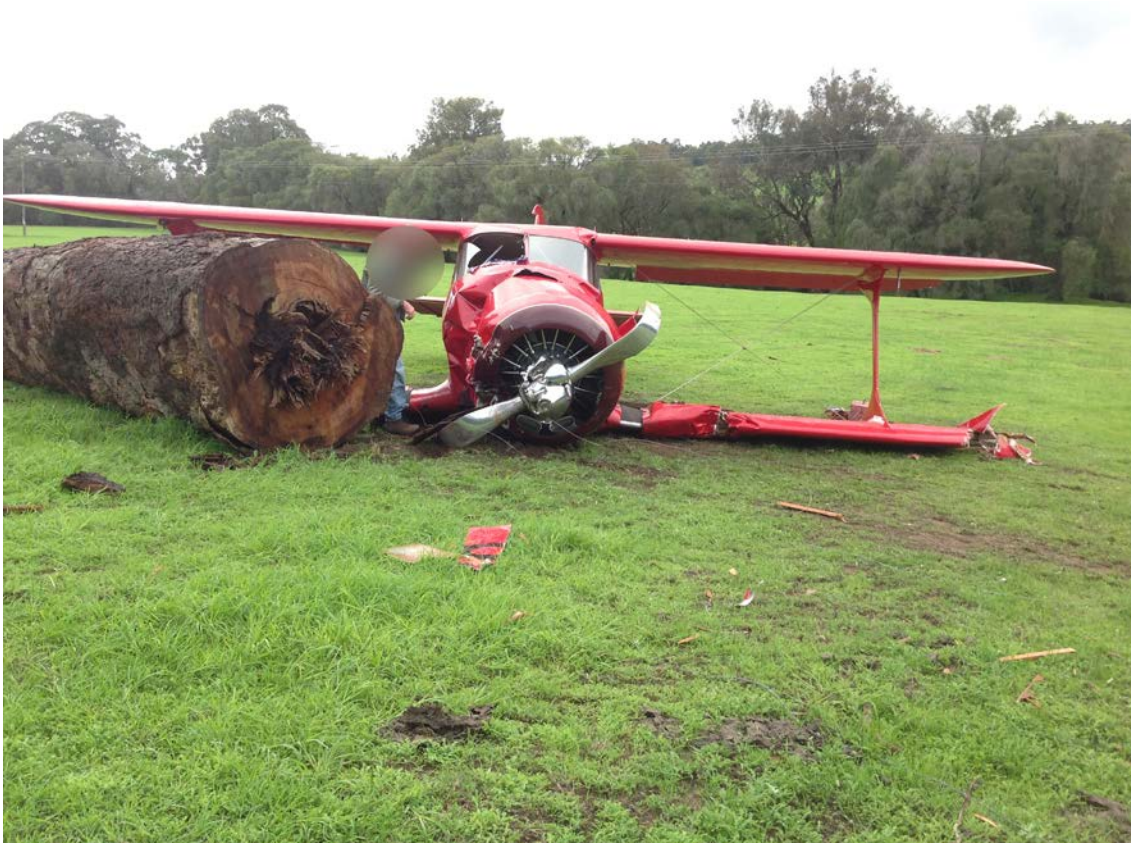
**Figure 1: Accident site**

After departure, the pilot tracked FNS in a northerly direction and climbed to an altitude of about 2,500 feet above mean sea level (AMSL). About a minute after setting the engine to cruise power, the pilot felt a violent vibration with an associated decrease in engine power. The pilot described the engine as 'surging' and 'back-firing'. The pilot conducted initial troubleshooting and was unable to identify a reason for the engine malfunction. The vibration ceased and the engine was no longer producing power but the propeller was windmilling. The pilot elected to leave the landing gear retracted and set up a glide approach tracking to the north-east to locate a more suitable landing area to conduct a forced landing. A suitable paddock was identified that was near a house. The aircraft flew over a line of tall trees and then clipped a fence that was next to a private road leading to the house, went through a second fence on the other side of the road, which partially arrested the aircraft. It then impacted a large log and came to rest (Figure 1). A passer-by assisted the pilot to evacuate the aircraft. The pilot was seriously injured and transported to hospital and the aircraft was substantially damaged.

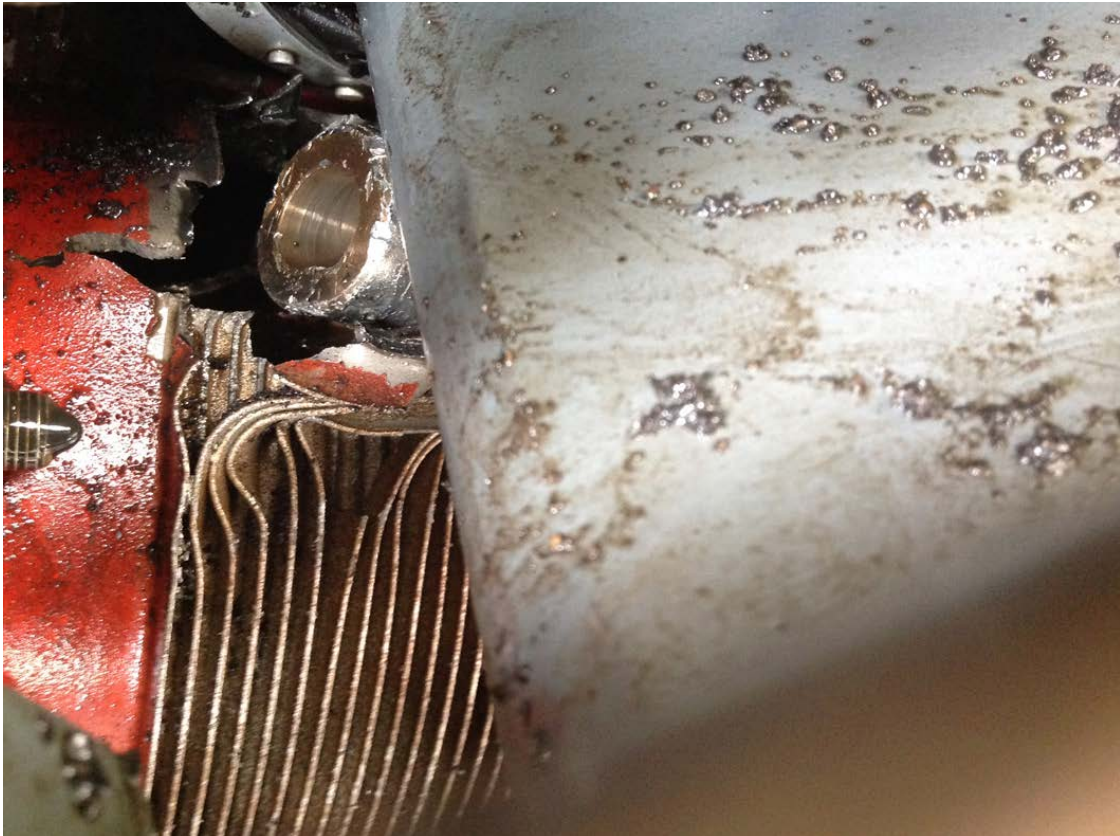
**Figure 2: External view of damage to number five cylinder**

The pilot reported that the engine was subsequently examined and that a hole was located in the number five cylinder wall (Figure 2). Extensive internal damage was found and the reason for the internal engine failure could not be determined. The pilot indicated that the engine had failed at about 223 hours since it was last overhauled and that the specified time between engine overhauls was 1,000 hours.

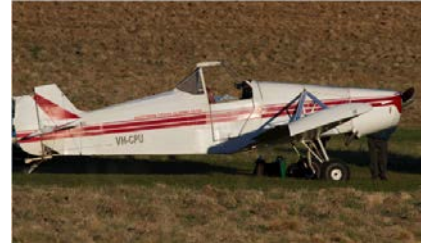
Damage to VH-CPU

The aircraft was heading south and as the airstrip was oriented approximately north-south, the pilot elected to overfly the runway. The pilot observed the windsock indicating a southerly wind of about 8-10 kt. When about 300 m beyond the runway threshold, the aircraft struck powerlines that crossed the runway about 15 m above ground level, dislodging the windscreen and canopy (Figure 1). The top of the fin was severed by the powerlines.

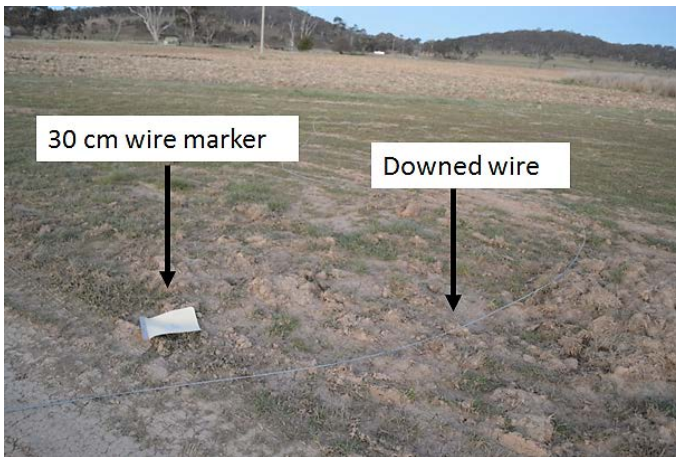
**Figure 4: Wire marker**

The wires were marked with square off-white markers, about 30 cm wide, located adjacent to but not overhead the runway (Figure 4).

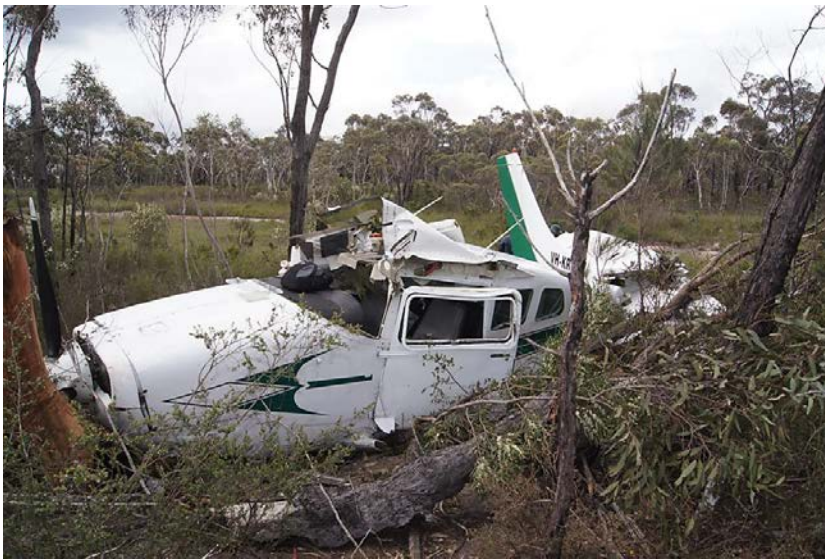
**Figure 2: Damage to VH-KRR**

At about 1114, and when at about 5,500 feet above mean sea level, the aircraft's engine surged and then stopped. The pilot conducted some emergency checks including an attempt to restart the engine, but did not select the fuel pump ON or change the selected fuel tank. The pilot broadcast a Mayday<sup>1</sup> call, assumed a glide speed of about 75 knots and looked for a suitable landing area. Initially the pilot observed only heavily treed areas, but when passing about 3,500 feet on descent, he sighted a clearing ahead. The pilot did not extend the flaps, so as to increase the glide range of the aircraft, and reduced the airspeed to about 65 knots just prior to impact. The aircraft collided with trees about 50 metres short of the intended landing site and was substantially damaged (Figure 2). The pilot sustained a minor injury.

The aircraft owners attended the accident site on Friday 17 October. They reported that about 7 litres of (unusable) fuel remained in the right tank and none in the left. The fuel bladders appeared to be intact and they did not observe any evidence of spilled fuel. The left fuel tank was selected and the master and magneto switches were ON. The engine casing was intact and there was no evidence of catastrophic engine damage.

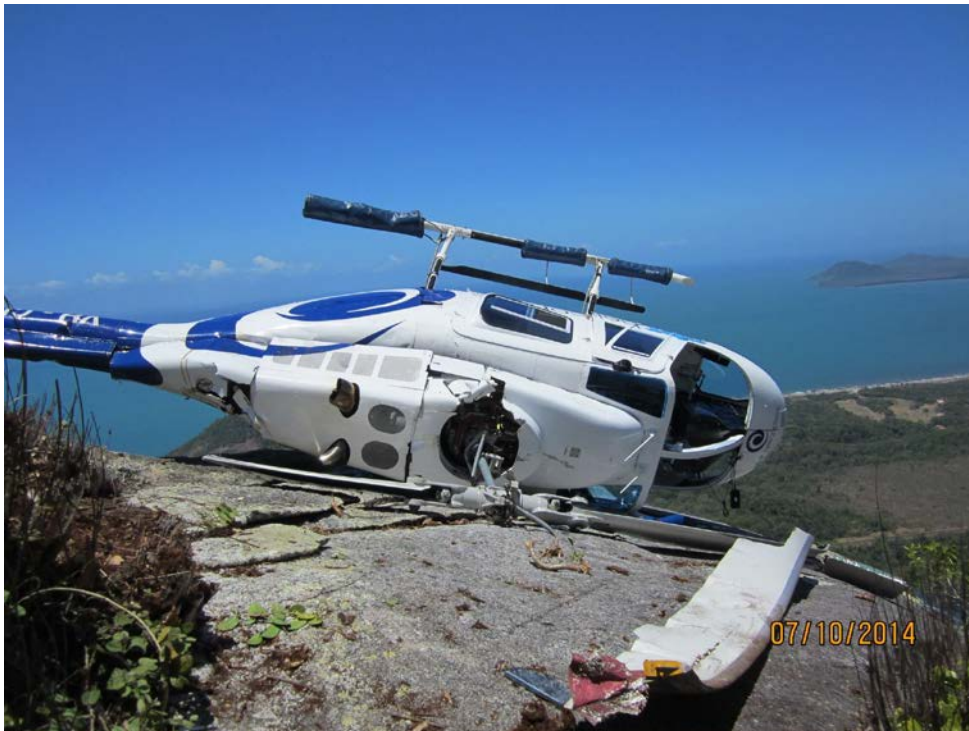
**Figure 2: VH-CLR post accident**

The pilot and one passenger sustained minor injuries and the ground controller was seriously injured. The helicopter was substantially damaged (Figure 2).
