# Proximity event between a Robinson R44, VH-JKF and a Cessna 172, VH-EVR

Essendon Airport, Victoria, 28 December 2014

**ATSB Transport Safety Report**  
Aviation Occurrence Investigation  
AO-2015-003  
Final – 26 February 2015

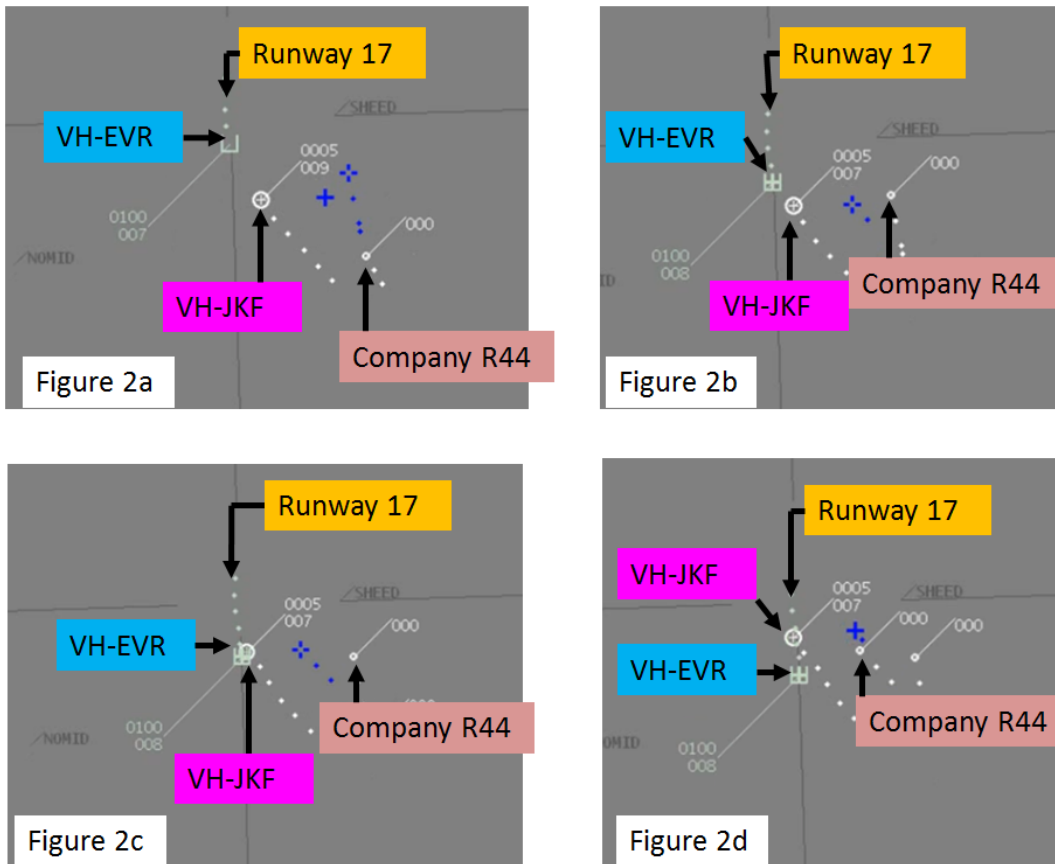
**Figure 2: Radar images depicting event sequence**

At about 1325, the ADC directed JKF and company to track towards the runway 17 threshold and to report sighting the Cessna in the take-off roll. The pilot of JKF read back the instruction, but inadvertently tracked towards the 35 threshold. He responded to the ADC that he was looking for the Cessna. The pilot of the in-company R44 helicopter broadcast that he had the aircraft rolling in sight, and ADC responded that all communications (for the in-company flight) had to be transmitted by the pilot of JKF. The pilot of JKF then responded that he had the traffic in sight. The ADC advised JKF that the Cessna was just crossing the runway intersection and airborne off runway 17 and directed JKF to pass behind it (Figure 2a).

About 16 seconds later, the ADC asked both helicopters to confirm they had the aircraft in sight that was then crossing the freeway (Figure 2b). The pilot of JKF had sighted the Cessna and as he assumed it was tracking to the north, assessed that there was no conflict. The pilot of the R44 travelling in company with JKF, which was tracking correctly to the runway 17 threshold, responded that he did have the traffic in sight. This was partially over-transmitted by the instructor of EVR who had just sighted JKF in close proximity (Figure 2c).

The pilot of JKF then realised that he was tracking to the incorrect threshold and sighted the Cessna. He slowed the helicopter and passed behind and below EVR (Figure 2d).

Airservices Australia analysed the radar data relevant to the incident and provided a copy of the data to the ATSB (Figure 2). The analysis indicated that JKF passed about 100 ft below and about 75 m behind EVR. Airservices advised that the secondary surveillance radar (SSR) horizontal position was accurate to within 52 m and the relative accuracy of two aircraft in close proximity was within 50 ft.

As a result of this occurrence, the helicopter operator has advised the ATSB that they have ceased in-company flights.
