Aviation Short Investigations Bulletin

Issue 30

ATSB Transport Safety Report
Aviation Short Investigations
AB-2014-064
Final – 26 May 2014

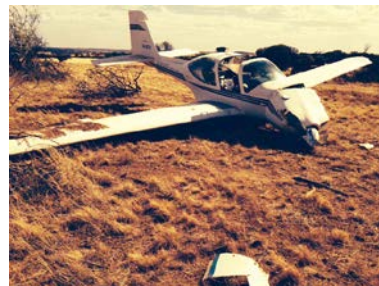
VH-BFW at accident site

The student exited the aircraft and walked to the main building. The duty platform instructor activated the crash alarm. An instructor who was flying in the circuit landed and attended the scene. He switched off the magnetos and master switch in the damaged aircraft. Staff and emergency services attended soon after. The student was not injured, but the aircraft sustained substantial damage.

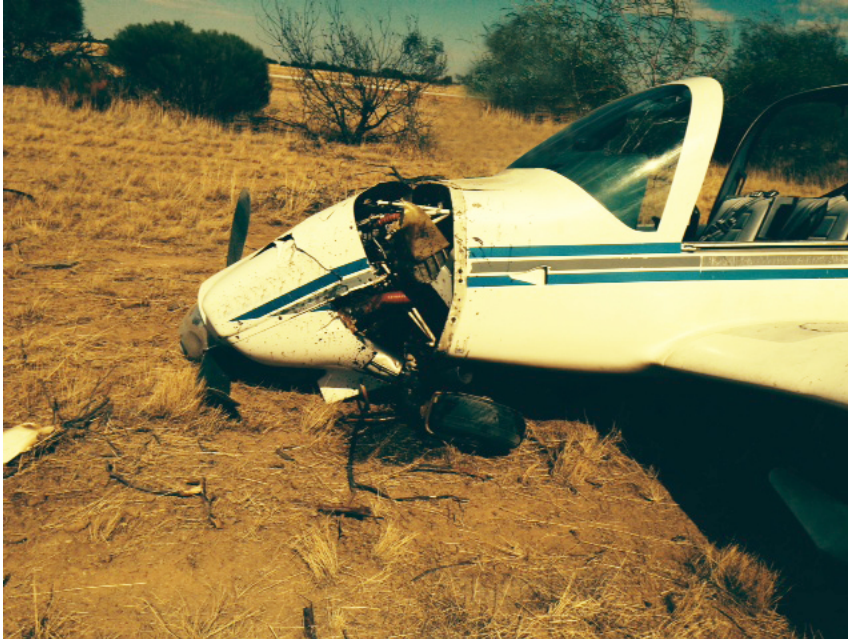
Figure 2: Aircraft damage

After completing the pre-landing checks he configured the aircraft for the final approach, including selecting full flap. Once over the runway, he commenced the round out, but soon realised the aircraft was about 15-20 ft above the ground, and too high to continue with the landing. In the next few seconds, he commenced a go around. He applied full power and a small amount of right rudder, but mindful of a previous instruction not to move the elevator forward while close to the ground, did not make any other changes to the aircraft configuration. The application of power caused the nose of the aircraft to rise. It then encountered a gust of wind, which pushed the nose even higher, with a resultant loss of airspeed.

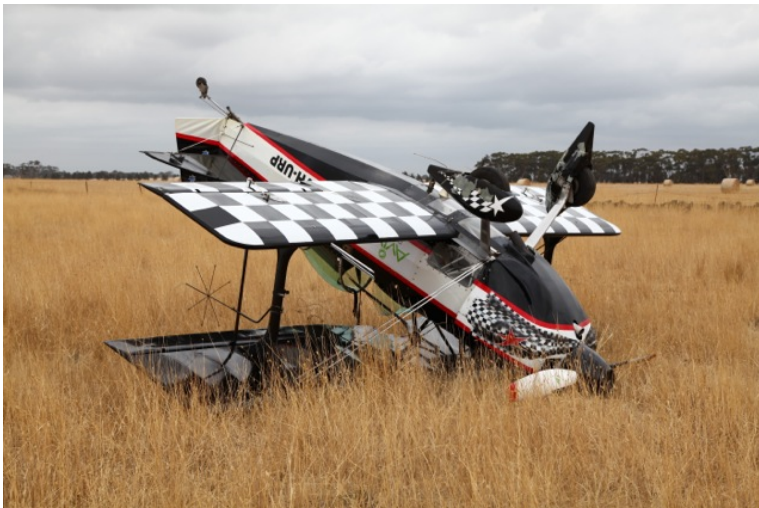
Figure 1: Damage to VH-URP

During the landing roll, the aircraft collided with a rock and nosed over, coming to rest inverted. The aircraft was substantially damaged (Figure 1).

The pilot reported that the 'flop tube' may have become stuck. It supplies the engine with fuel from the top of the tank when the aircraft is inverted. This may have been resolved by rolling the aircraft inverted. However, this was not a safe option at low altitude, with a partial or complete engine failure.

The damage to the aircraft was assessed as being greater than the replacement cost therefore no post-accident engineering inspection was conducted to determine the cause of the engine failure.

The pilot reported that the original plan was to conduct the manoeuvres overhead the airfield; a known safe landing area in case of engine failure. This incident highlights the importance of selecting a suitable landing field as soon as a forced landing appears necessary.

Once a suitable landing area has been selected, within easy gliding distance, the pilot should then plan the approach to the field. Once the plan has been commenced, the pilot can then attempt to rectify the cause of the engine malfunction.

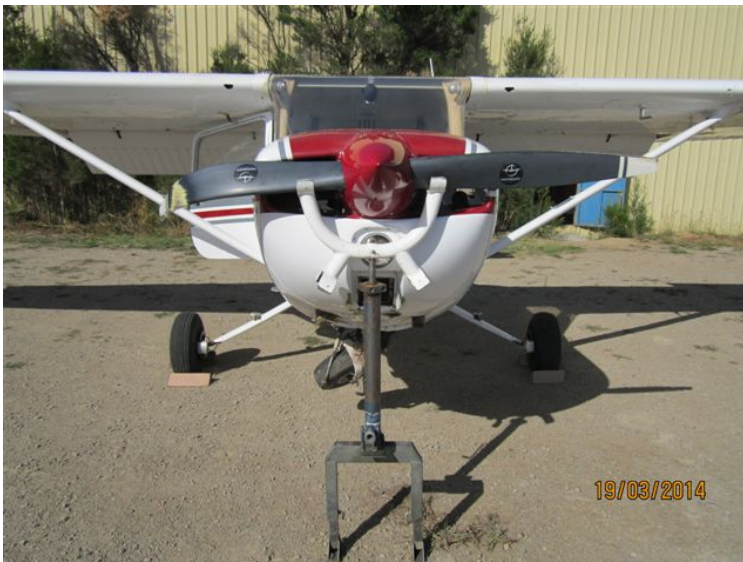
Figure 1: Damage to VH-EAV

The aircraft veered off the runway to the left, rolled down the slope to the eastern side, and collided with a tyre marking the location of a drain. The aircraft continued into the culvert and the nose landing gear subsequently collapsed. The propeller struck the ground, resulting in substantial damage (Figure 1) and the aircraft came to rest on the grass.

After the accident, the pilot observed the windsock veering in an arc from the south-south-east to south-south-west and reported that windshear may have contributed to the incident.

This incident highlights the importance of conducting a go-around as soon as landing conditions appear unfavourable. The following link provides some useful information on go-arounds: *Aviation safety explained – Go-arounds*

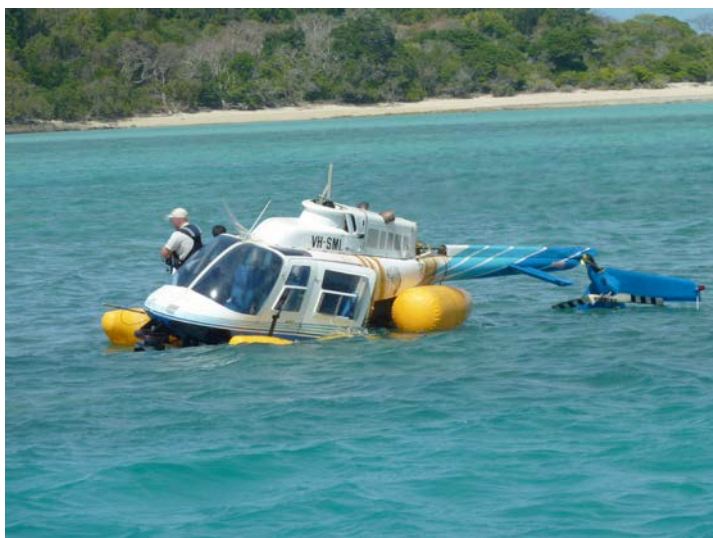
Figure 5: VH-SMI

After having completed the film shot (Figure 4), when at about 450 ft, the helicopter entered an uncommanded yaw right by about 25-30° and started to experience a loss of tail rotor effectiveness (LTE). In response, the pilot attempted to manoeuvre the helicopter into wind by applying forward and left cyclic.¹ The pilot reported that the helicopter rotation stopped, but shortly after, it began to yaw right again. The pilot believed that he was not going to be able to recover from the situation.

During the landing, the left rear float was damaged and deflated. Consequently, the helicopter sat left rear skid low on the water. The main rotor blades and mast became separated, the tail rotor assembly sustained damage, and the oil reservoir fractured (Figure 5).

Certain operations, such as low speed aerial filming/photography flights, lend themselves to being more at risk to LTE than others; where visual cues can be misleading, and pilot attention to airspeed, height and orientation to local wind conditions is critically important. If a helicopter was placed in conditions conducive to LTE, it is crucial that pilots not only recognise the onset of LTE, but respond immediately and appropriately before the situation develops.

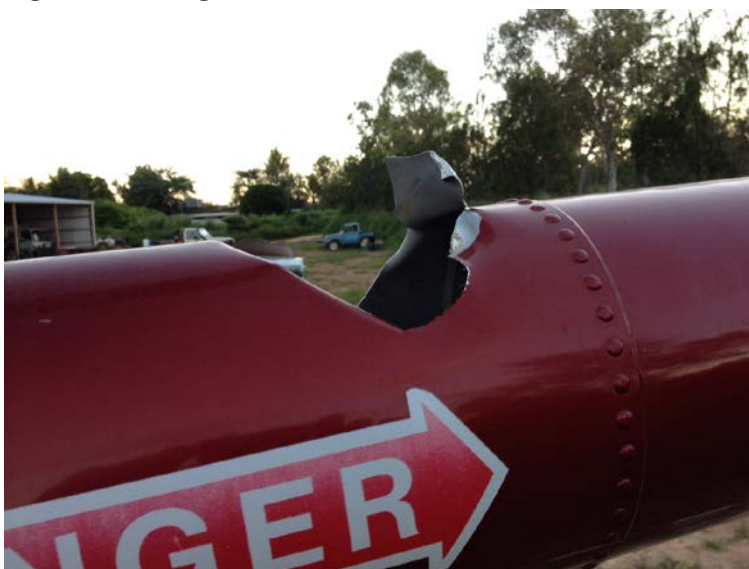
Figure 1: Damage to VH-YY5

The pilot eased the collective into the ground and as the helicopter touched down, it started to roll to the left. He moved the cyclic right, reduced the throttle and the helicopter rocked from side to side and then settled. During the event, the rotor blades contacted the tail boom resulting in substantial damage (Figure 1).

A post-accident engineering inspection did not find any defects other than those resulting from the incident.

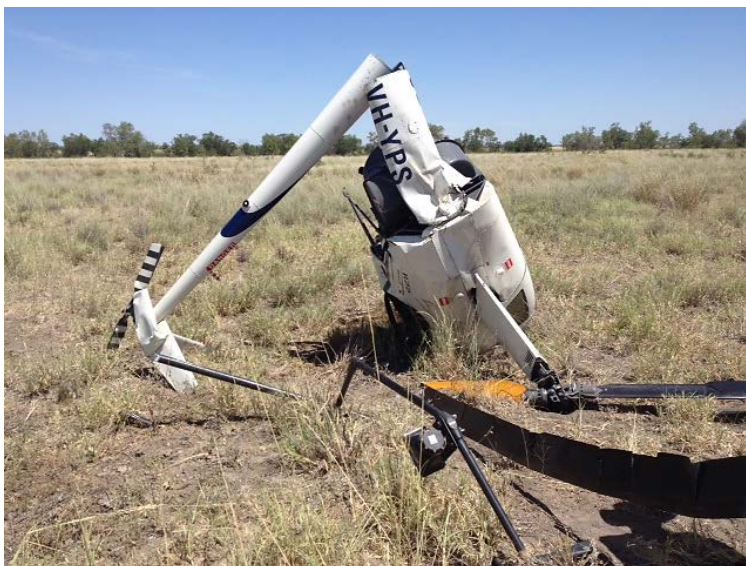
Figure 1: Damage to VH-YPS

The pilot reported that the impact dislodged the top of the front dash board and struck his helmet. He was uninjured and the helicopter sustained substantial damage (Figure 1).
