Fire on freight train 3DA2

Near Snowtown, South Australia | 21 August 2014

ATSB Transport Safety Report
Rail Occurrence Investigation
RO-2014-015
Final – 24 March 2015

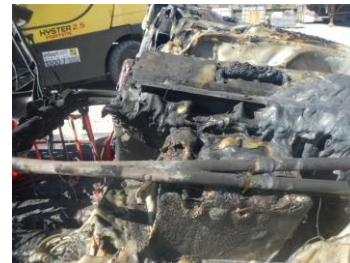
Fire damage to goods

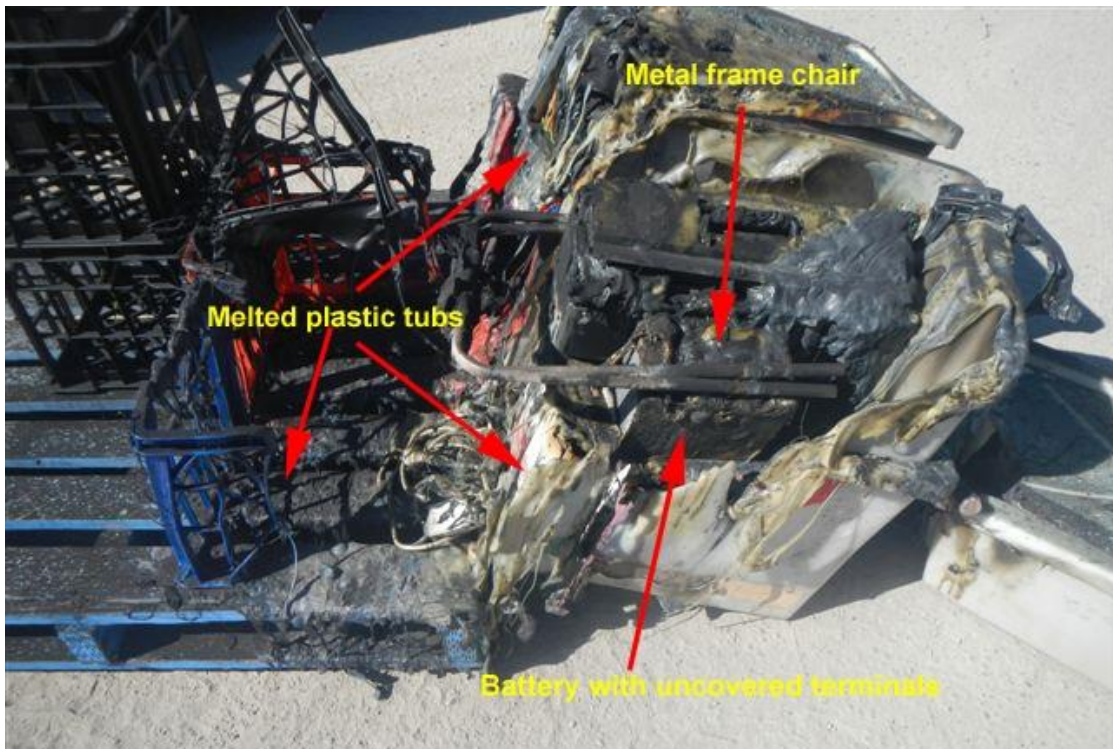
Figure 2: Tub with battery and metal frame of the chair.

Inspection of the container found a number of plastic tubs, one of which contained a lead-acid battery. At some point during the journey, an unsecured metal-framed portable chair had fallen across the exposed terminals of the battery (Figure 2).

The metal of the chair frame had shorted out the battery causing high current to flow and heat the metal frame. The heat transmitted from the chair frame resulted in the melting and combustion of the plastic tubs (Figure 3). The smoke produced by the burning plastic was subsequently observed coming from the container by the GWA train crew.

- When consigned for transport, freight container 4CB215 contained an undeclared lead-acid battery packed alongside other freight that had not been secured in accordance with the operator's requirements or those of the *Australian National Code of Transport of Dangerous Goods by Road and Rail*.
- During transport, it was likely that an unsecured metal-framed chair shorted the battery terminals, with the resulting heat melting and igniting the plastic tubs surrounding the battery.
