# Derailment of freight train 3MP9

East of Malbooma, South Australia | 10 April 2014

**ATSB Transport Safety Report**  
Rail Occurrence Investigation  
RO-2014-006  
Final – 25 March 2015

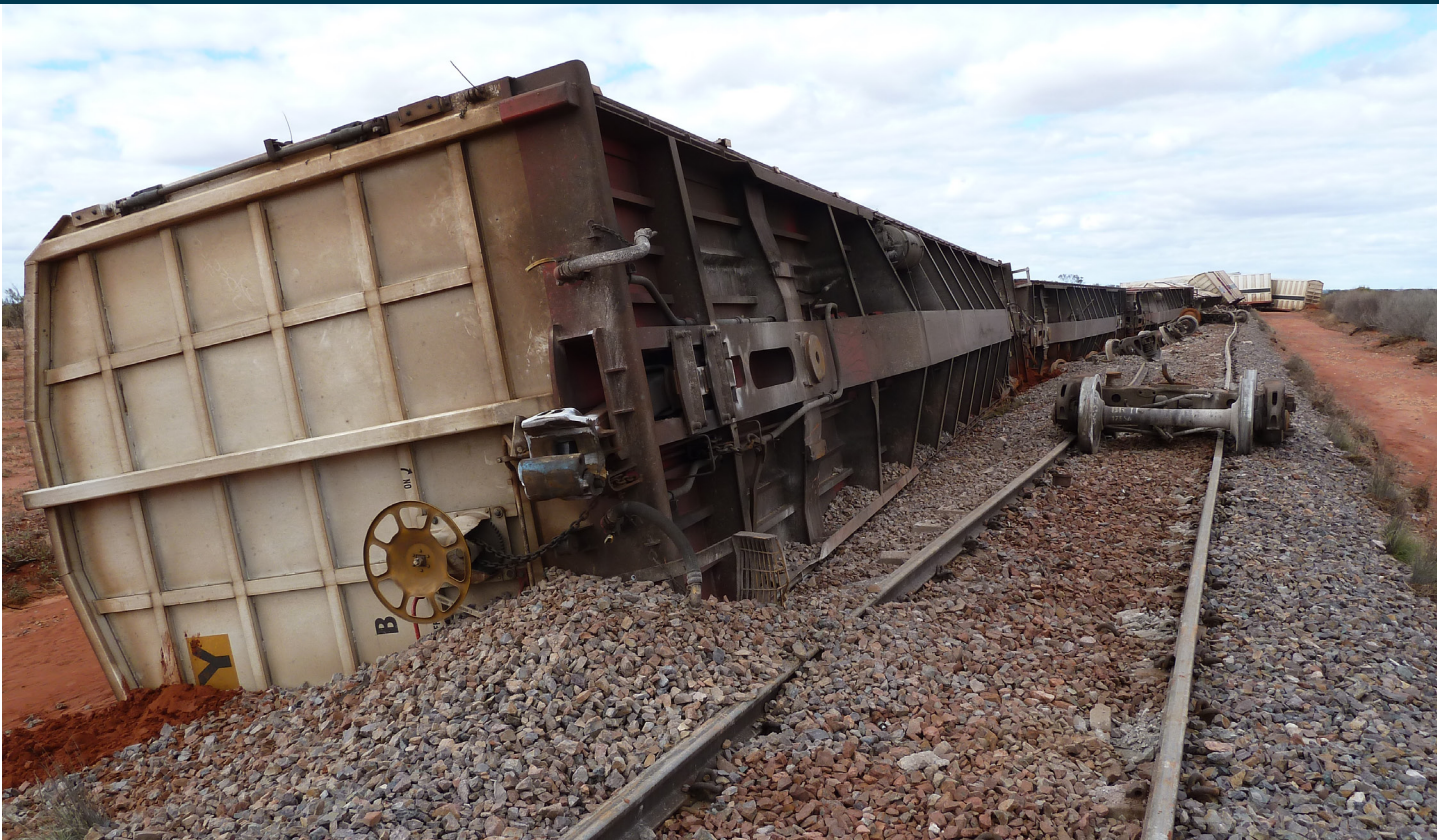
### Track washaway

At about 0011 on 10 April 2014, SCT Logistics train 3MP9 derailed after travelling over track that had been undercut by floodwaters near a culvert at the 535.150 km mark between Tarcoola and Malbooma, South Australia. The floodwaters caused scouring of the track formation, compromising its capacity to support the train.

The magnitude of the scouring meant that the track could not support the weight of train 3MP9 as it passed over the affected areas. The resulting deformation in the alignment of the track initiated the derailment.

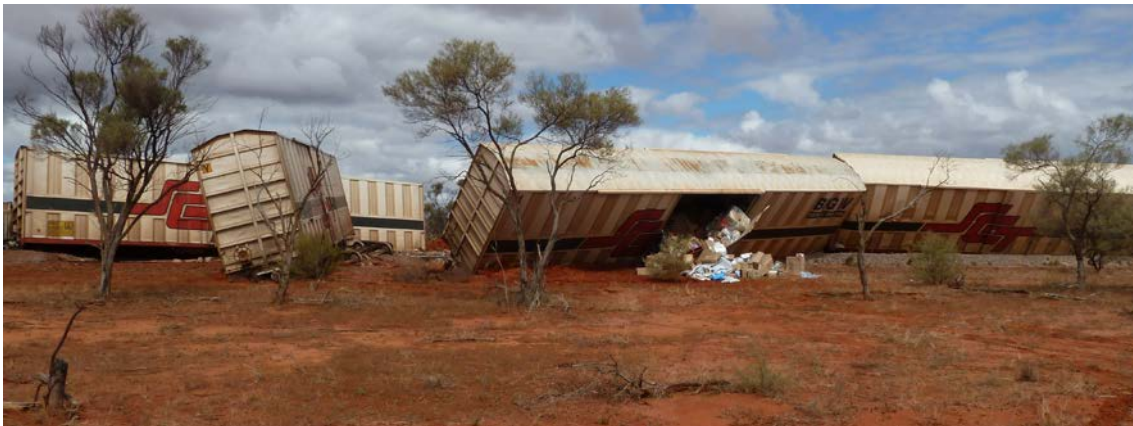
**Figure 2: Derailed wagons north side of track.**

The second driver, accompanied by another driver who had been resting in the crew van, then walked further back along the train and found a separation between wagons and a derailed wheelset. Further in the distance, the drivers could see wagons lying on their sides to the north of the track (Figure 2).

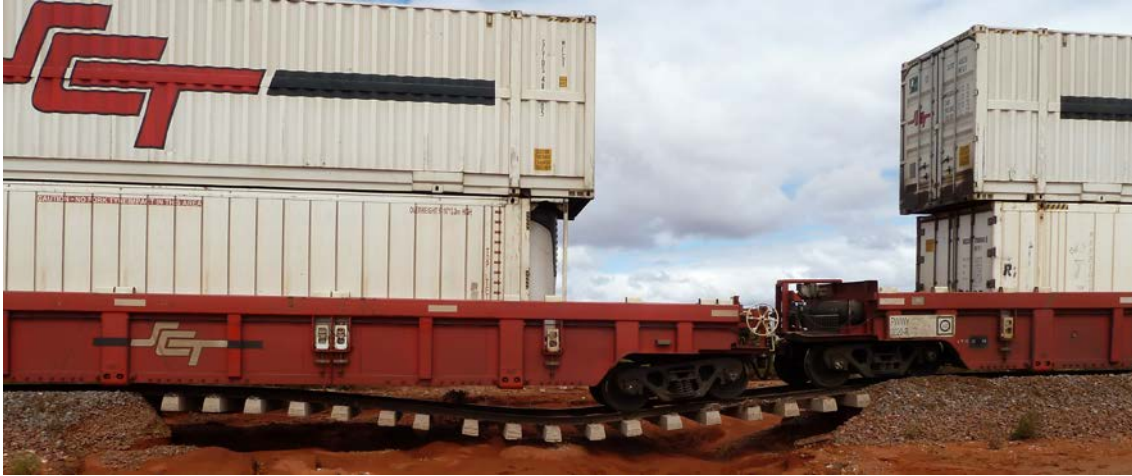
**Figure 3: Well wagons suspended on skeletal track near point of derailment.**

At about 0124, the track supervisor arrived at the derailment site and reported to the NCO that approximately 40 sleepers were undercut, the ballast had been washed away by the floodwaters

and sections of the train remained suspended on skeletal track after the floodwaters had subsided (Figure 3).

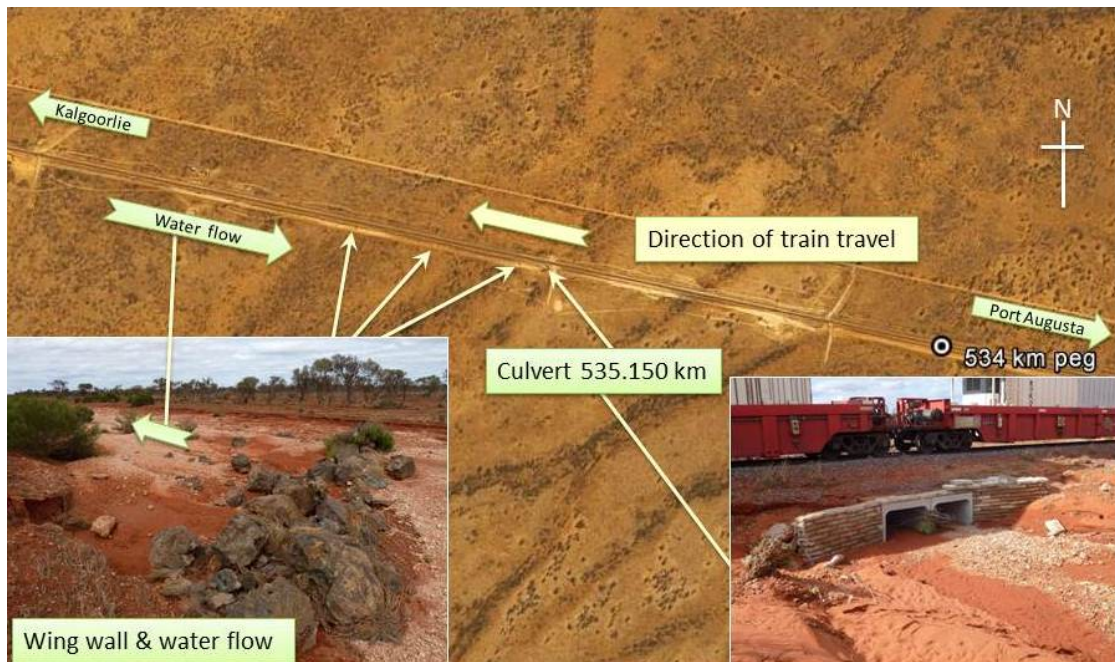
**Figure 5: Derailment location showing barrier wall, diversion channel and culvert.**

The under-track drainage system installed between Tarcoola and Malbooma consisted of culverts of varying types, including concrete box, rail deck, corrugated steel pipe and reinforced concrete pipe. The type of culvert installed near the point of derailment was a double span 1500 mm concrete box culvert (Figure 5).

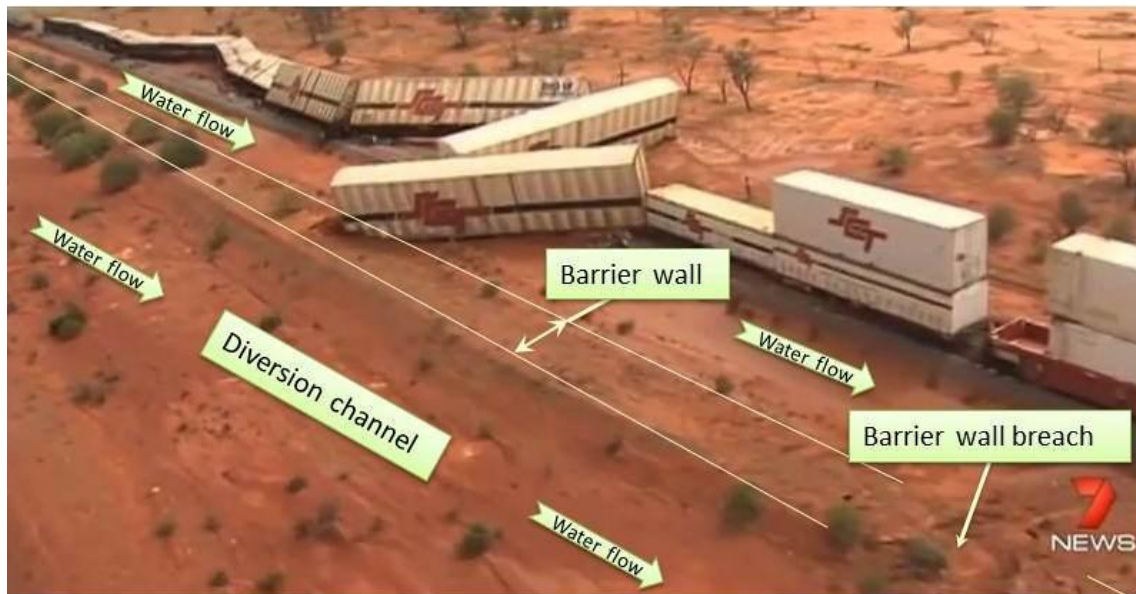
**Figure 6: Water diversion channel and barrier wall near the point of derailment**

Between 9 and 10 April 2014, rainfall resulted in significant water run-off towards the barrier wall on the south side of the track. As the water accumulated and flowed along the barrier wall in an easterly direction, the volume of water increased to the point where the wing walls were unable to interrupt and divert the flow. As a consequence, the water over-topped and eroded the barrier wall. The barrier wall was breached in two places between the 536 km post and the culvert, allowing excess water from the diversion channel to flow against the railway track formation (Figure 6).

About 8 m before the double box concrete culvert at the 535.150 km mark, it was evident that an eddy current<sup>8</sup> had formed before the water was redirected through the culvert. The circular motion of the eddy current progressively eroded the track formation and ballast, weakening the track structure and causing it to slump.
