Derailment of ore train 4413

Bonnie Vale, Western Australia | 14 May 2014

ATSB Transport Safety Report
Rail Occurrence Investigation
RO-2014-008
Final – 27 March 2015

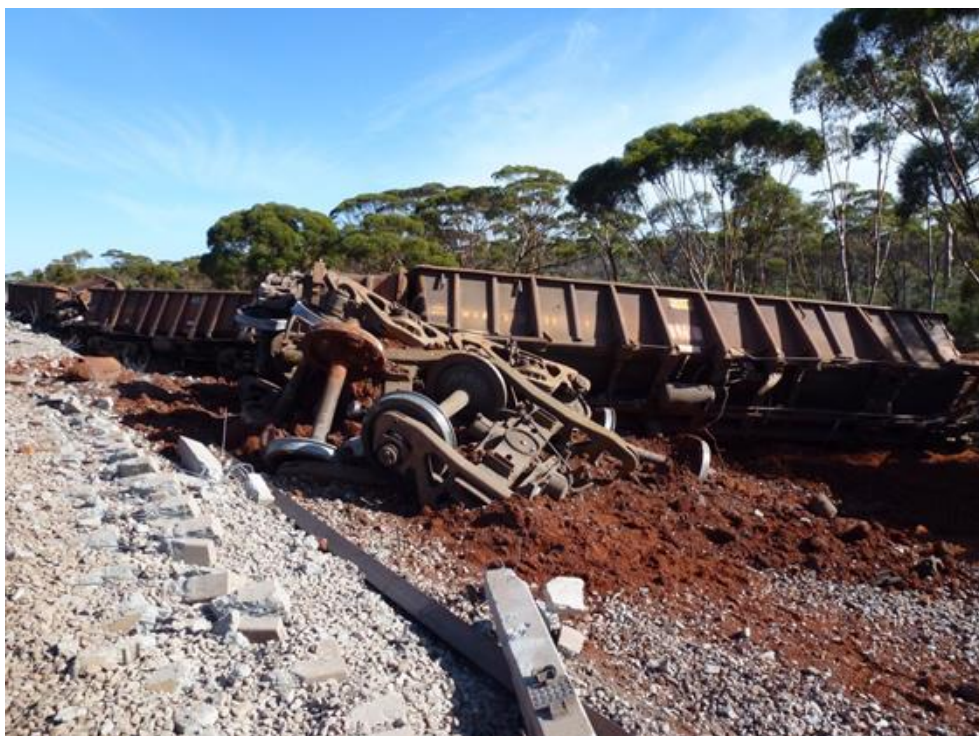
Figure 2: Derailed ore wagons and destroyed track infrastructure

The second driver walked towards the rear of the train and progressively reported to the driver the extent of the derailment and the damage sustained to the track infrastructure and rolling stock (Figure 2). The driver relayed the information to the train controller.

There was evidence of flange climb¹² on the left side running rail (direction of travel) at 600.729 km, followed by witness marks over a distance of about 5 m that were consistent with a wheel flange crossing over the rail head (Figure 5). Damage to sleepers was observed only after the point where the wheel(s) dropped off the rail head. Beyond the drop off point, the wheels and bogies of derailed wagons advancing along the sleepers had progressively damaged the track structure both within the four foot¹³ and on the field side of the rail (left side direction of travel). This led to the loss of structural integrity and the subsequent destruction of the track, with rolling stock ploughing into the ballast giving rise to the multi-wagon pile-up shown at Figure 2.

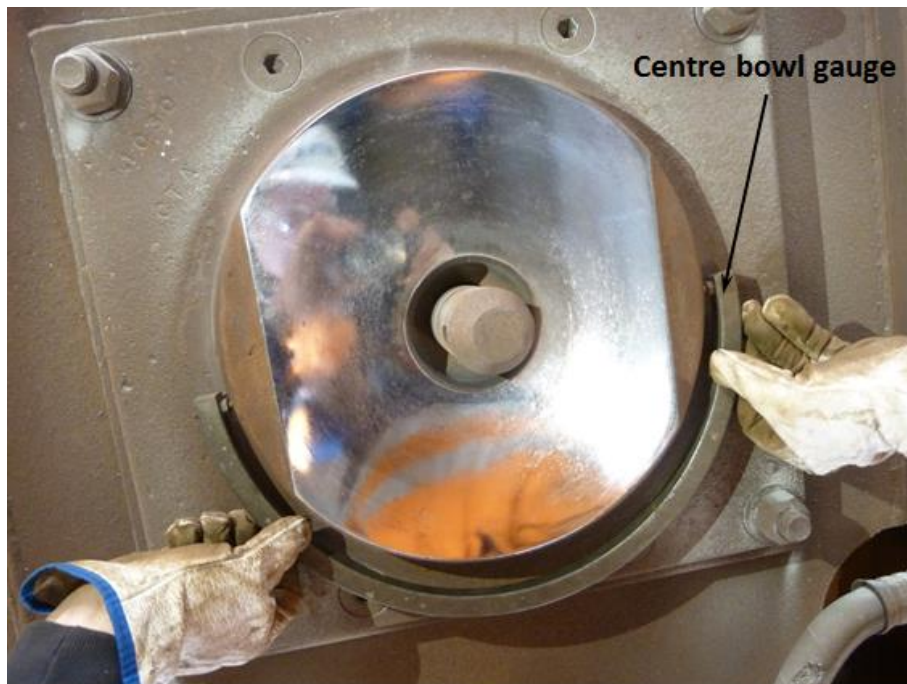
Figure 3: Gauging of centre bowl, wagon WOE33548K

The wagon was initially examined on site and later at Aurizon’s West Kalgoorlie maintenance facilities. The wagons were fully inspected including bogie frames, centre bowl centricity (Figure 3) sidebearer assemblies, friction wedges, lead bogie’s wheelsets and wheel profiles. All were found to be operationally fit for purpose and in compliance with maintenance specifications.

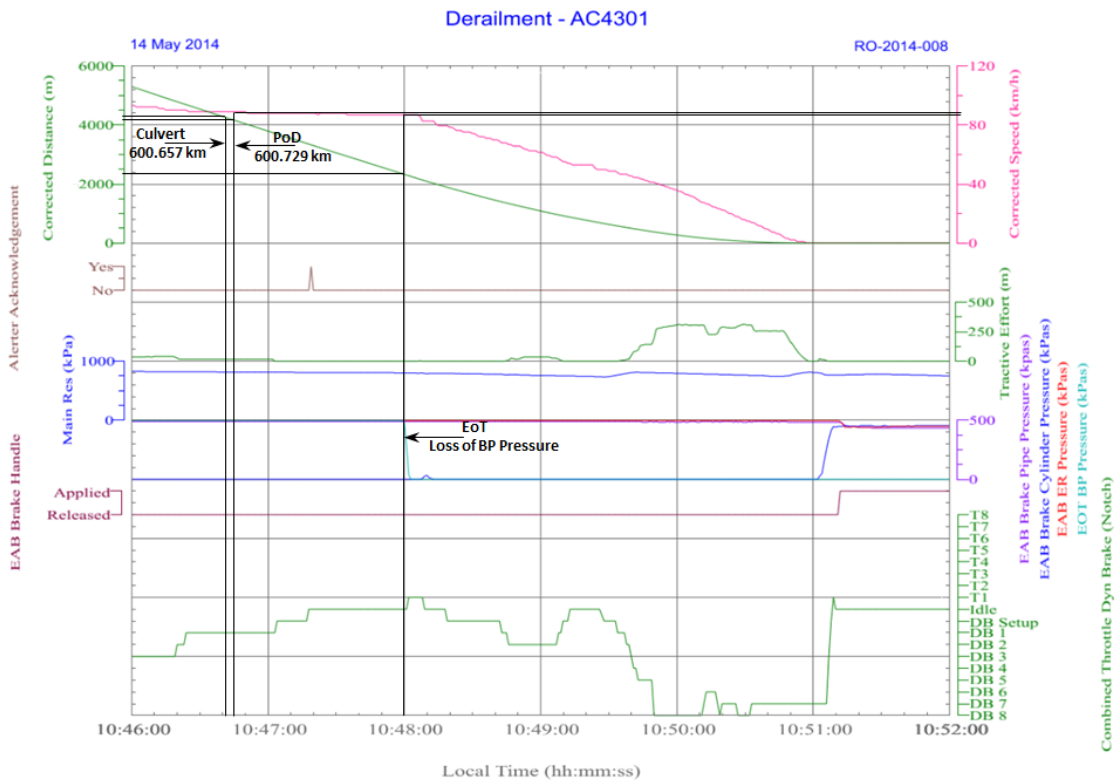
Figure 4: Graph derived from extract of loco-log data from AC4301

- The train was travelling at 87 km/h as wagon WOE33548K (first to derail) passed over the PoD. At that time, locomotive AC4301 was in idle/coasting, after coming out from light dynamic braking.
- About 3 seconds after wagon WOE33548K passed over the PoD, the end-of-train monitor (EoT) registered a complete loss of brake pipe pressure. This event probably coincided with wagons breaking away from the main body of the train, and was about the time the driver recalled observing the EoT alert.

- Although the EoT provided an alert, this was not reflected as a loss of brake pipe pressure on the driver's cab controls. The loss of brake pipe pressure that was registered by the EoT did not automatically activate entire train braking. As a consequence, the driver initially assumed a malfunction of the EoT until he observed dust in the train's rear vision mirror.
- The driver slowed the train using dynamic braking, coming to a standstill about 2 km after the initial EoT alert.

While there was no apparent maintenance deficiency that contributed to the derailment, and recorded braking performance was consistent with the operation of the dynamic braking system, the fact that the loss of brake pipe integrity did not automatically activate the train brakes is an operational concern. The loss of brake pipe integrity (loss of air) should always result in the prompt activation of train brakes along the entire length of the consist.

- Aurizon will investigate and resolve the braking performance issues that relate to a loss of brake pipe integrity (loss of air) failing to automatically activate train brakes.
- Brookfield Rail has issued a safety advice to all above rail operators highlighting the identified post-derailment braking issues.

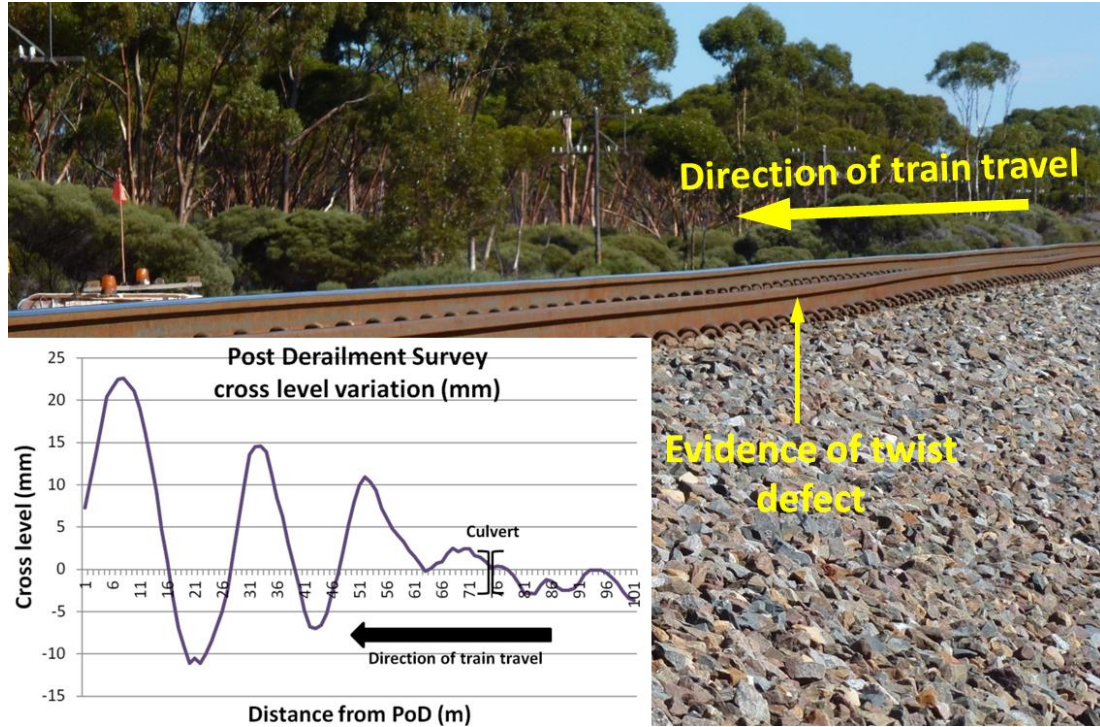
Figure 6: Evidence of minor twist defect in advance of PoD at 600.729 km

Although the track leading into the derailment site appeared to be in good condition, there were signs of pre-existing lateral vehicle oscillations (characterised by flange contact wear along the gauge face of the rails at regular intervals), and evidence of minor cyclic cross level (Figure 6) and lateral track irregularities before the PoD.

Post-derailment, the track was surveyed by Brookfield Rail (unloaded) for a distance of 100 m leading into the PoD. The plot at Figure 6 *cross level variation (mm)*¹⁶ was derived from survey measurements and substantiated observations of a minor cyclic twist defect in advance of the PoD. The plot shows a cross level variation of near zero about 100 m before the PoD, which then increases in magnitude to about 22 mm at a location 6 m back from the PoD. Under the *Westrail S.G. Code of Practice Track and Civil Infrastructure (CoP)*, it is unlikely that this specific magnitude of cross level variation would have triggered remedial action by Brookfield Rail. However, the CoP (Table 6.2, Note [7]) also identifies that the onset of a rough ride caused by a combination of laterally induced vehicle oscillations in an area of track with a cyclic twist defect may present a heightened derailment risk and should not be ignored.

- Brookfield Rail and Aurizon will fit instrumentation to a WOE class wagon for examination of lateral harmonic vehicle oscillation.
- Brookfield Rail and Aurizon will support RISSB in a review of track geometry standards in relationship to combinational and cyclic track defects.

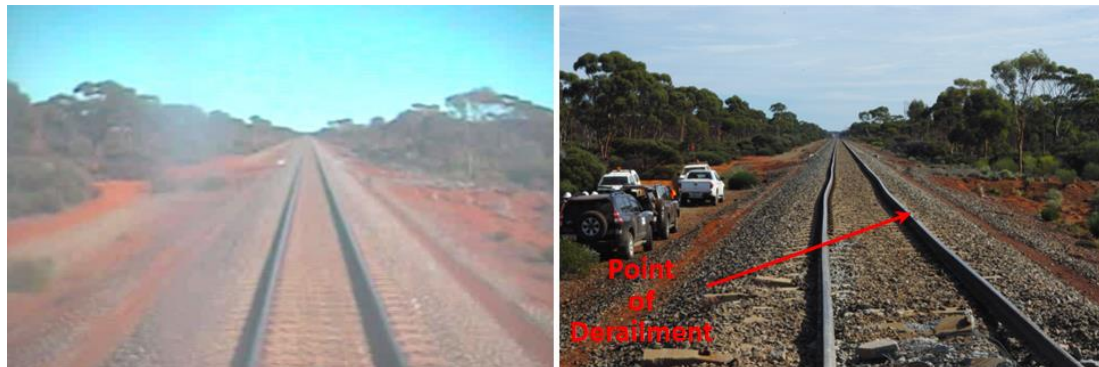
Figure 7: Video image from train 4414 (left) and photo post derailment (right)

- Statements from the train drivers, who both indicated that the track was rough (side-to-side oscillations) leading into the derailment site and that the train shuddered at or near the derailment site.
- Forward facing video (Figure 7) from train 4414,¹⁴ which had passed through the site earlier that morning (about 0940), showed very little evidence of any lateral track misalignment at, or near the derailment site.
