# SPECIAL INVESTIGATION REPORT

BASI REPORT 896/3051

Boeing 747 VH-EBU  
&  
Boeing 767 ZK-NBE

93km East of Narrandera

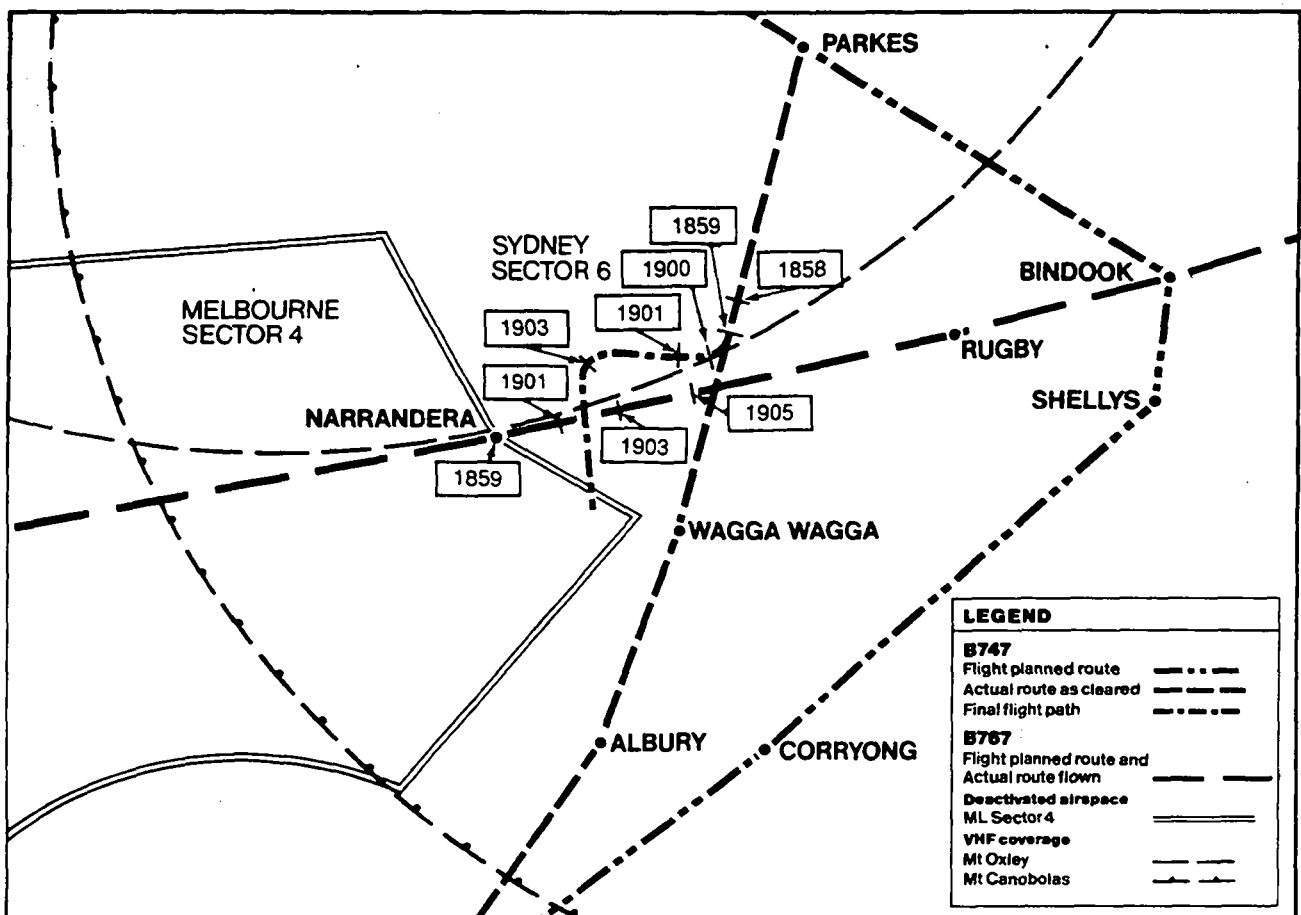
7. The ergonomic placement of the VHF frequency call indicator lights on the Sector 6 workstation made it extremely difficult for the operator to determine the frequency on which an aircraft was actually calling

as all call indicators operated simultaneously when the retransmission was active.

5. Are provided with training in VHF communications characteristics of the CAA radio telephony systems.
6. Have the control and presentation of the VHF/UHF frequency call lights modified so that controllers can immediately determine the frequency on which an aircraft is calling.
