# Flight envelope protection event involving an Airbus A320, VH-VQY

near Mildura Airport, Victoria, 12 March 2014

**ATSB Transport Safety Report**  
Aviation Occurrence Investigation  
AO-2014-049  
Final – 17 June 2014

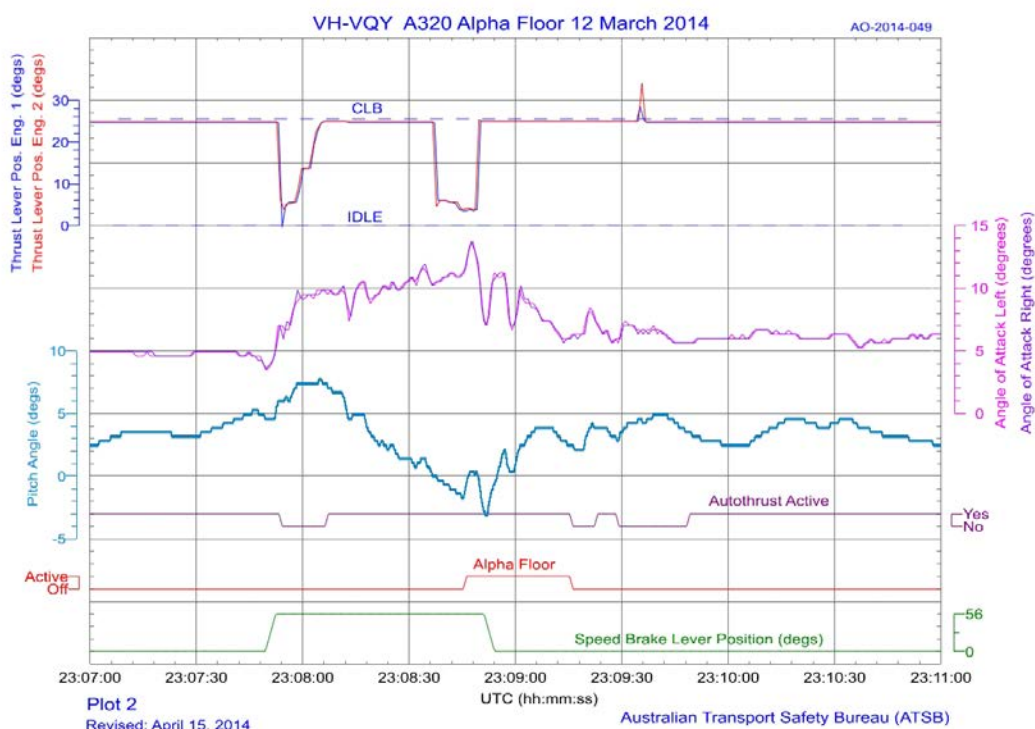
**Figure 2: Thrust settings, angle of attack, pitch, speed brake and Alpha Floor**

The aircraft then descended and the airspeed slowed below the  $V_{LS}$  speed: the lowest selectable speed that autothrust permits. The first officer then applied rearward pressure on the sidestick in an attempt to regain FL 380 and reduced the thrust levers towards idle, but short of the idle stop position. This limited the maximum amount of thrust available. The application of back pressure increased the aircraft's angle of attack. At the Alpha Protection speed,<sup>4</sup> which corresponds with the angle of attack at which Alpha Protection becomes active, the Alpha Floor function activated. In that mode, the speed brakes retracted<sup>5</sup> (Figure 2) and the take-off/go-around (TOGA) thrust lock was activated.

The first officer reported that the aircraft changed very rapidly from an overspeed to an Alpha Protection state, and this rate of change may have been due to a combination of the high altitude and the light weight of the aircraft. He observed the TOGA LOCK display on the electronic centralized aircraft monitoring (ECAM), but did not recall an ALPHA FLOOR annunciation on the Flight Mode Annunciator (FMA).

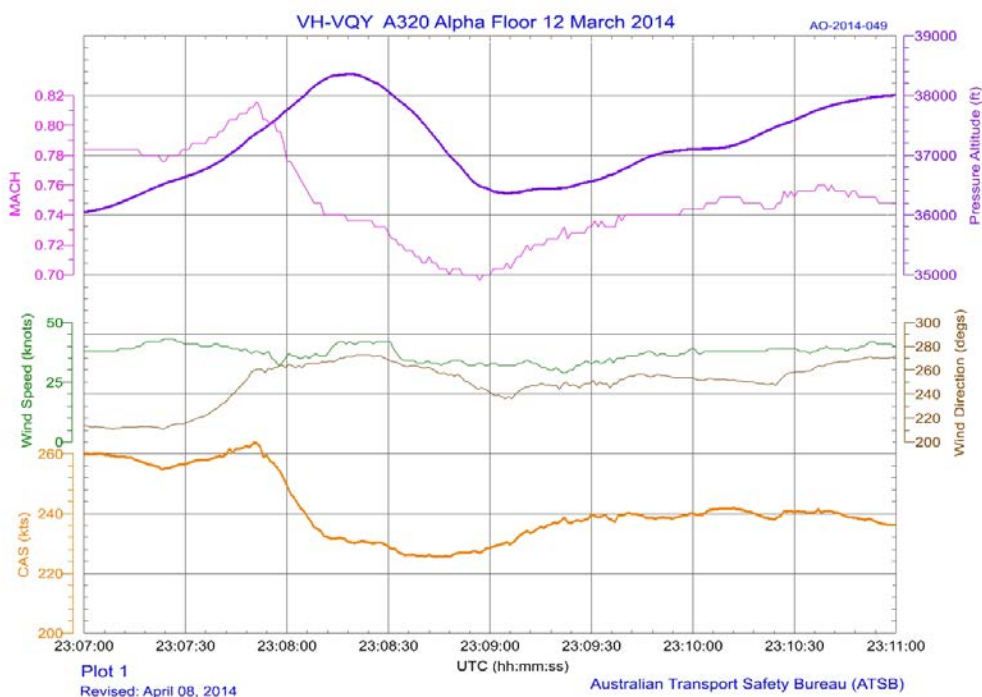
**Figure 3: Altitude, Mach, Wind speed and CAS**

The flight data indicated the following (Figure 3):

- During the climb, passing about FL 365, the wind shifted from a tailwind of about 20 knots to a headwind of about 15 kt, resulting in an effective 35 kt windshear on the aircraft. This resulted in a rate of climb of 3,005 fpm and a transient Mach increase.
- The computed airspeed (CAS) increased about 6 kt from 256 to 262 kt.
- The Alpha Floor activated when the aircraft was on descent passing about FL 370, at a CAS of 226 kt, thrust levers just above the idle stop with autothrust disconnected, and the aircraft descending at about 4,500 fpm.

In a report provided to the ATSB by the Bureau of Meteorology, a significant change in wind direction and speed was forecast for the incident area. The wind was forecast to veer from 253° at 31 kt at FL 340, to 268° at 60 kt at FL 380.
