Aviation Short Investigations Bulletin

Issue 32

ATSB Transport Safety Report
Aviation Short Investigations
AB-2014-099
Final – 14 July 2014

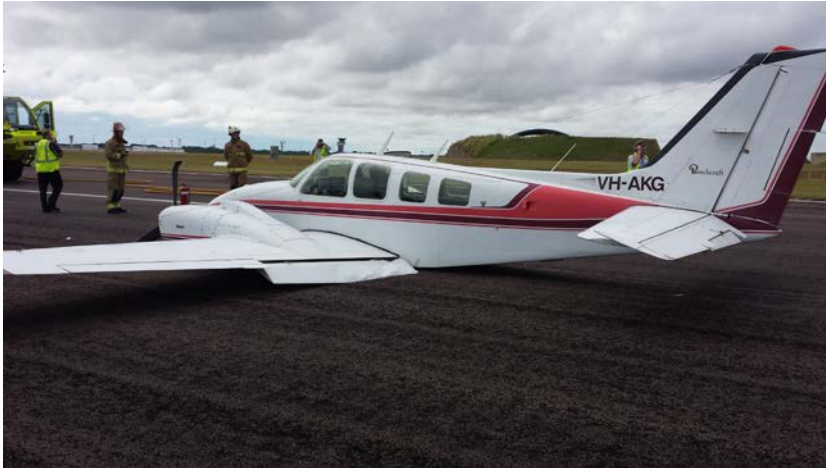
Figure 1: Damage to VH-AKG

The tower controller cleared AKG to land on runway 36, however the pilot requested holding at Lee Point to brief the passengers for a wheels-up landing and subsequent exit from the aircraft. He then fully extended the flaps, which took some time, with repeated resetting of the circuit breaker. At about 1145, the pilot was cleared to land on runway 36. He reported that the workload on the final approach was high, as the aircraft was more responsive without the landing gear extended. He kept some power on during the approach in case a go-around was required. When over the runway threshold, the pilot selected the mixture levers to idle cut-off. The rear step scraped on the runway, the flaps then contacted it, followed by the aircraft fuselage, and the left propeller, which caused the aircraft to yaw to the left. The pilot used right rudder to keep the aircraft straight and then the right propeller contacted the runway and the pilot again corrected the yaw. The aircraft came to rest about half way along the runway and the pilot switched all the electrics and fuel off. The pilot exited the aircraft and assisted the passengers to disembark. No injuries were sustained and the aircraft was substantially damaged (Figure 1).

An engineering inspection found that the up-lock assembly on the right main landing gear was binding and prevented extension of the right main landing gear. The up-lock mechanism pivots on a bolt, which was not listed in the lubrication chart for the aircraft. The binding of the assembly damaged the retract-extend rod and prevented any further movement of the retraction mechanism on the right main landing gear.

The damaged retract-extend rod placed load on the flap actuating cable, causing the flap circuit breaker to trip. This prevented the flaps from extending and retracting normally.

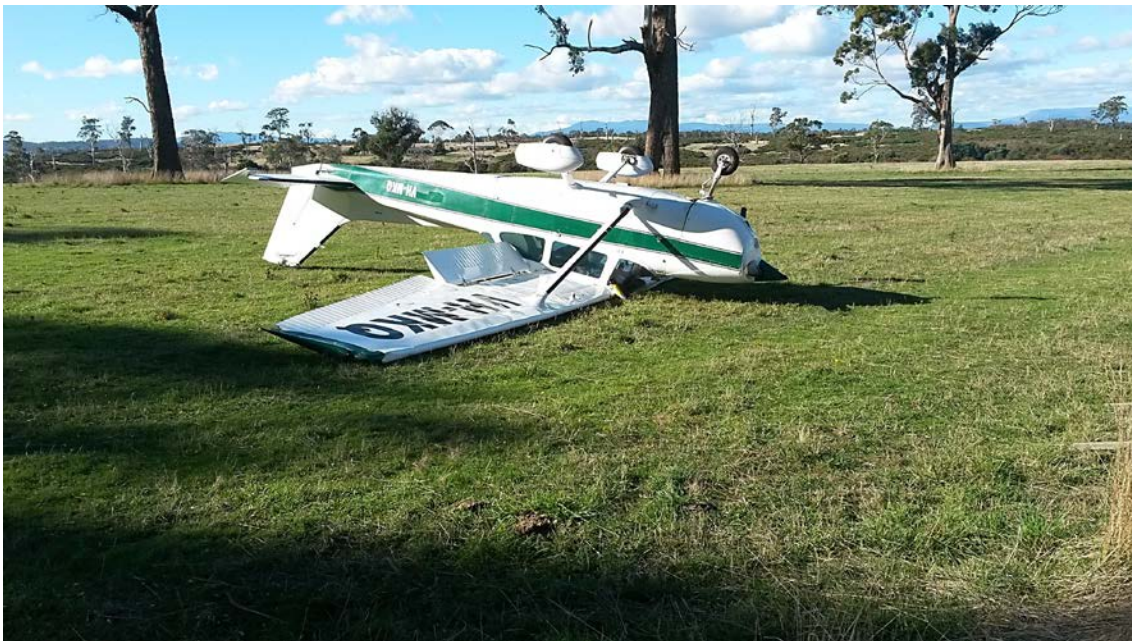
Figure 1: Damage to VH-MKQ

The pilot selected the fuel mixture to idle cut-off and the engine stopped. The aircraft collided with the fence and the nose landing gear entered a ditch. The aircraft nosed over and came to rest inverted. The aircraft was substantially damaged (Figure 1) and the pilot was uninjured.

- He had calculated the landing distance available to be 440 m, and taken into consideration the approach path, including some trees. This was sufficient for the aircraft, however, the surface condition did not provide the deceleration he had expected. It had rained the previous day, however the surface was dry.

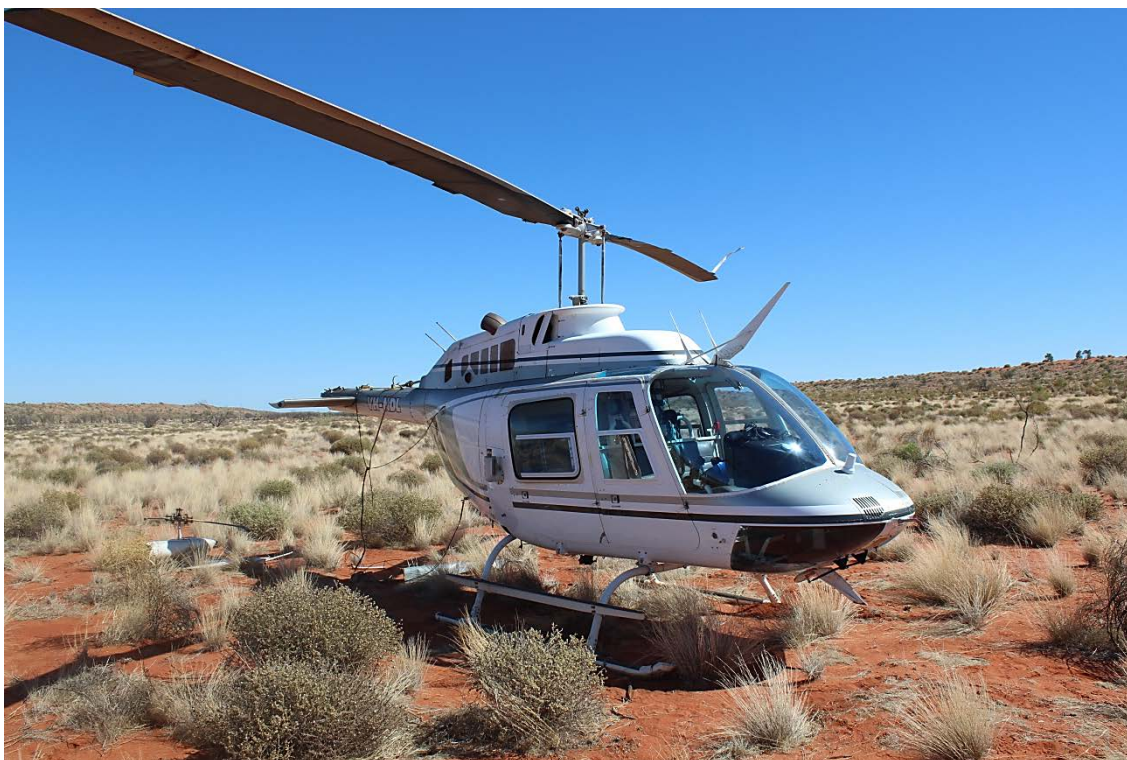
Figure 1: VH-NDL

On 12 November 2013, a Bell 206B helicopter, registered VH-NDL, departed a camp site located 51 NM SE of Alice Springs, Northern Territory, on a charter flight with a pilot and three passengers on board. The flight was conducted in visual meteorological conditions. About an hour into the flight and 2 NM from the landing area, the pilot commenced a slow descent from 2,000 feet above the ground (AGL). When lowering the collective, the pilot heard an intermittent grinding noise above the cockpit. The pilot checked the gauges, with nothing unusual noted. The noise continued to develop and the pilot elected to land. As the helicopter descended through 400 feet, a clunking noise was heard and power was lost to the main rotor. The pilot initiated an auto rotation and briefed the passengers for an emergency landing. During the touch down at about 0705, the main rotor blade severed the tail boom (Figure 1). The pilot secured the helicopter, waited for the main rotor to slow and assisted the passengers to exit. The helicopter sustained substantial damage; the occupants were not injured.

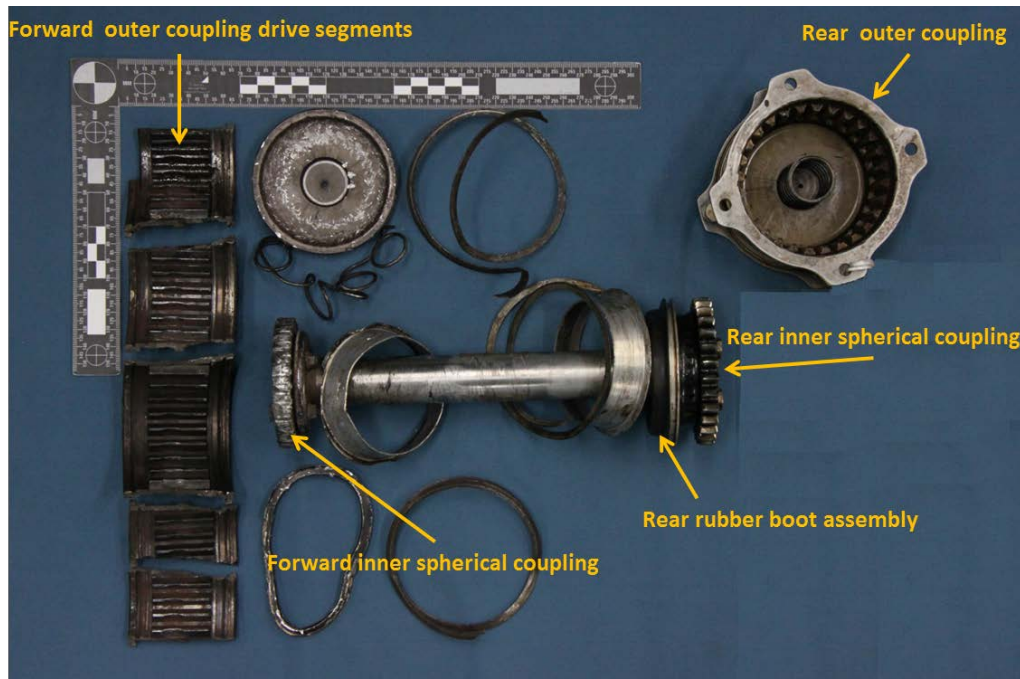
Figure 2: Main drive shaft VH-NDL

The operator determined that the engine-transmission main drive shaft¹ had failed due to the failure of the forward drive shaft boot. They reported that, during the week prior to the accident, the helicopter had operated short flights to landing areas with extended ground running, in high temperatures and with the helicopter loaded to near its maximum all up weight.

The main drive shaft installed on NDL failed about 603.4 hours after it was overhauled. It had been inspected and lubricated and the forward and rear boots were replaced about 132.7 hours prior to the accident.

The forward outer coupling had failed, in overload, into five segments. The surfaces of the segments had evidence of discolouration due to over-temperature and most of the surfaces had turned into red oxide (which forms in air at high temperatures, estimated to be over 500 °C). There was no detected grease that is needed for lubrication to reduce friction (heat) between the rotating parts. Without the grease, the gear teeth on the forward inner spherical coupling softened, deformed, fractured and became jammed, resulting in the forward outer coupling shattering into the five segments. The four Temp-Plate indicators (which indicate when there has been excess temperature) were not present on the forward outer coupling exterior. There were no detected remnants of the forward rubber boot that is part of the seal assembly for containment of the grease.

The rear outer coupling and rear inner spherical coupling were well lubricated and exhibited normal condition. All four Temp–Plate indicators were attached to the rear outer coupling exterior, with no apparent indication of an over-temperature. The rear rubber boot, which is part of the seal assembly for containment of the grease, was flexible and undamaged.

- Replace the main drive shaft assembly with a KAflex drive shaft system to all operator effected helicopters.
