Derailment of ore train 24KW

near Whyalla, South Australia | 7 July 2014

ATSB Transport Safety Report
Rail Occurrence Investigation
RO-2014-012
Final – 28 April 2015

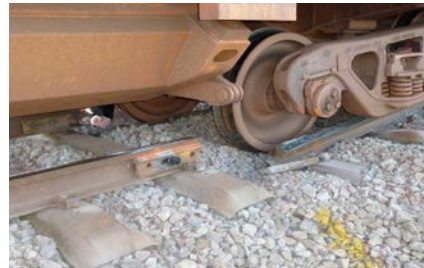
On 7 July 2014, Genesee & Wyoming Australia train 24KW departed from Iron Duke, a mine site near Whyalla, South Australia. The train was loaded with iron ore destined for the port of Whyalla. Shortly after the train entered the Iron Baron to 21km Junction section, the driver felt a slight 'bump' and noticed a loss in brake pipe pressure, before observing a large cloud of dust toward the rear of the train. Once the train had come to a stand the driver walked back along the consist and saw several wagons had derailed, resulting in significant track damage.

Derailed wagons of train 24KW

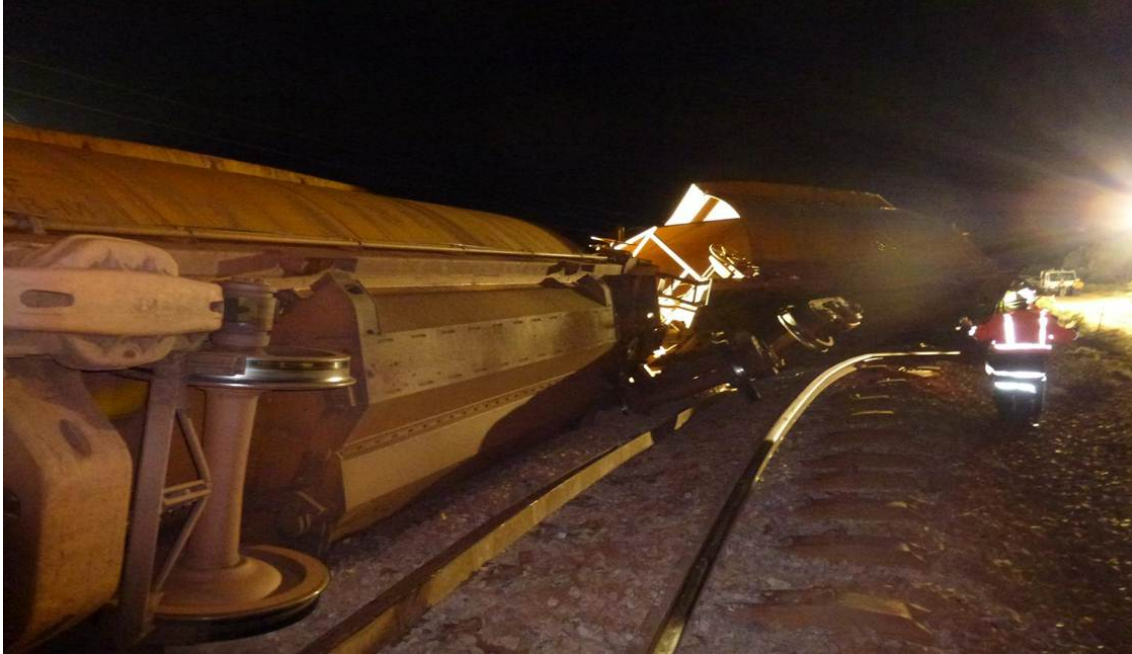
Figure 2: Train 24KW – Derailed Ore Wagons

The driver walked back along the train where he saw a number of derailed wagons in the middle to rear portion of the train. After an initial assessment of the damage, he contacted train control and reported that a total of seven wagons had derailed and, except for one bogie, the rear two wagons of the consist were still on the rail.

The wagons had predominately derailed to the left of the track (in the direction of travel). While it was unclear as to which wagon and wheel-set had derailed first, examination of the derailed wagons did not find any mechanical deficiencies or issues with the rolling stock that may have contributed to the derailment.

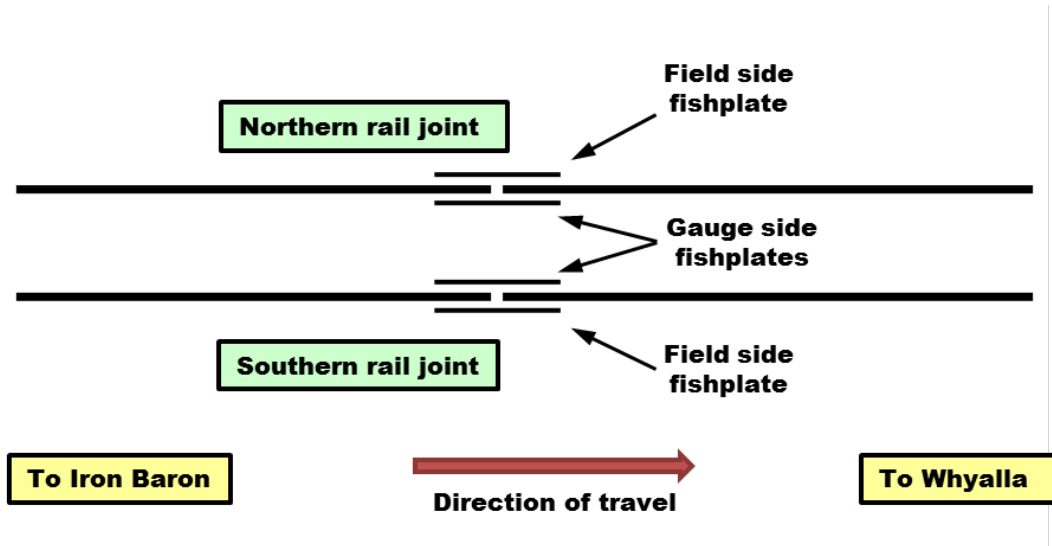
Figure 3: Site orientation and component naming convention

Site observations around the point of derailment (PoD) showed broken mechanical joints on both the northern and southern rails at the 108.100 km mark (Figure 3).

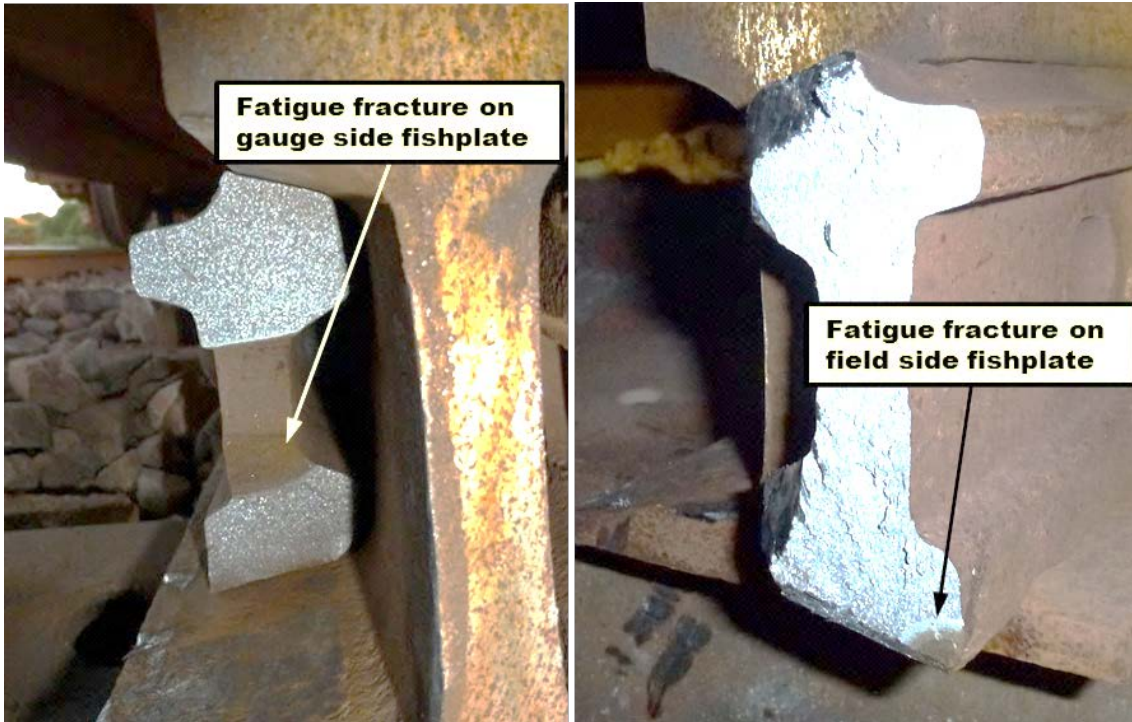
Figure 4: Northern rail joint fracture surfaces

Examination of the northern rail joint showed that the joint had been fastened with four bolts, two on each side of the rail joint. The fracture surface of the gauge-side fishplate showed evidence of a substantial and pre-existing fatigue crack extending from an unused bolt-hole (Figure 4, left). The fracture surface of the field side fishplate also showed evidence of pre-existing fatigue cracking, but originating from the lower outside corner of the fishplate (Figure 4, right). The remainder of each fracture surface was rough and matt grey/silver in appearance, consistent with a fracture due to mechanical overload.

As rail wheels passed over the failed southern joint, increased impact forces and lateral pressure through the track structure, together with the pre-existing fatigue cracks in *both* fishplates, probably resulted in the failure of the northern rail joint. With both joints failed, the continued impact of rail wheels likely led to the progressive misalignment of the track until wagons inevitably derailed.

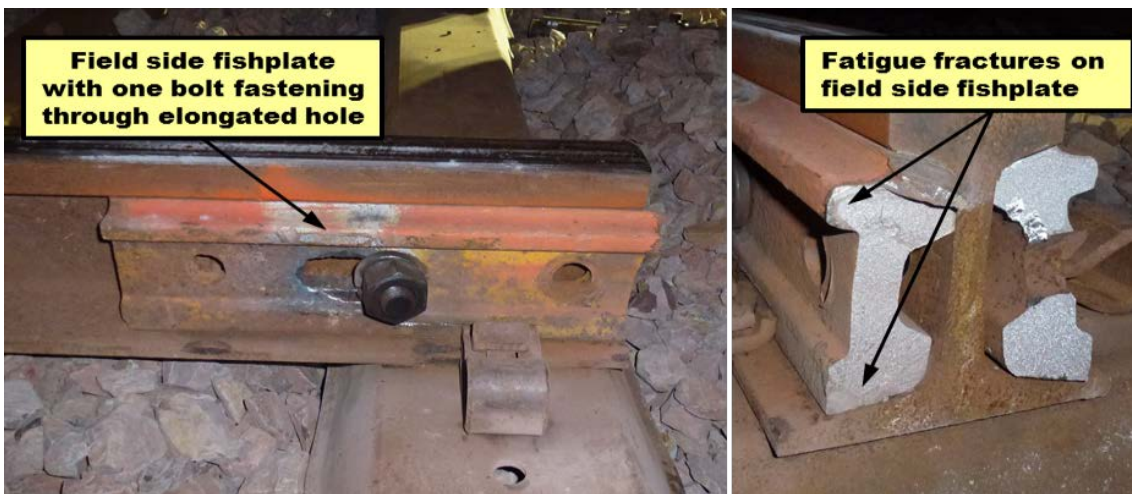
Figure 5: Southern rail joint

Examination of the southern rail joint showed that the Iron Baron end of the joint had been fastened with only one bolt. It was also evident that both the field and gauge-side fishplates had been modified by slotting (elongating) the bolt hole using an oxy/acetylene thermal cutting tool. There was evidence that the fishplate in this location had moved in relation to the rail, which was consistent with the use of only two bolts for the joint, and also possibly suggested that the bolt through this hole had not been sufficiently tightened. Again, pre-existing fatigue cracks were evident; originating from the lower and upper outside corners of the field-side fishplate. The remainder of the fracture surfaces on both fishplates were consistent with a fracture due to mechanical overload (Figure 5).

Based on the evidence available, the ATSB concluded that the southern rail joint was probably the first to fail from a combination of pre-existing fatigue cracks in the field side fishplate and the joint being in a condition of weakened structural integrity due to inadequate fastening.

Regardless of the number of bolts, the action of flame cutting slots in the fishplates resulted in a joint that was of a standard lower than that of a permanent joint. The rough edges of the flame cut holes were unlikely to provide a flat interface surface for the bolts, nuts and washers. Marks on the foot of the rail and the fishplate contact surface (Figure 6) showed movement within the joint and suggested that the bolts were not sufficiently tightened. As such, the joints were not structurally sound and, without an appropriate speed limit, the joints were likely to move under the load of a train – placing excessive stress on the bolts and fishplates.

To mitigate the likelihood of a similar derailment, GWA conducted an inspection of all mainline fishplated joints to ensure structural integrity of each joint and have since removed all the joints through a welding program.

- inspection of used fishplates prior to installation
- removal of fishplates with flame cut bolt holes from service
- improving the training of track inspectors with respect to monitoring and maintaining mechanical joints the accurate recording of the derailment risks attributable to the activities carried out by track maintenance staff
- track standards to determine what constitutes a temporary joint along with track speeds and the inspection frequencies that should apply.

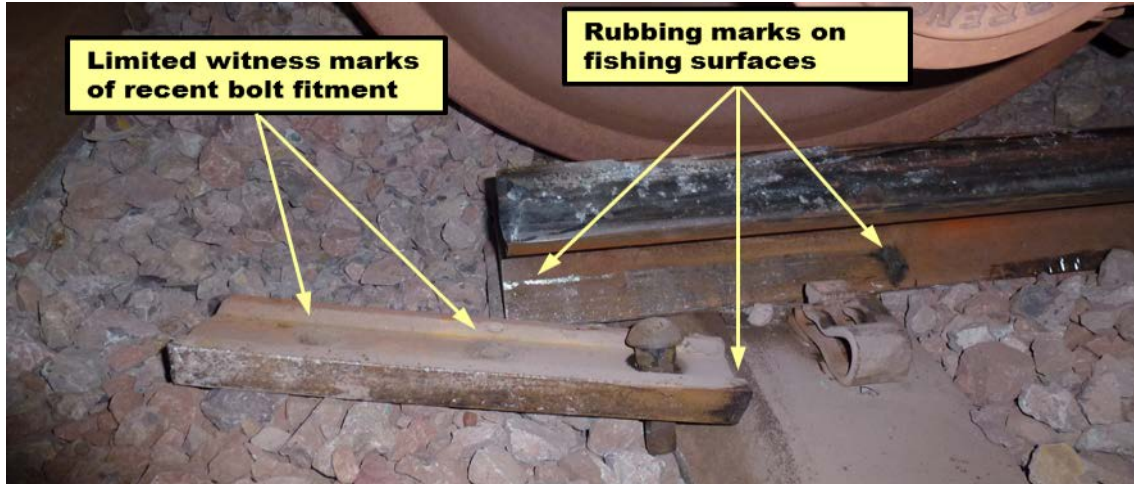
Figure 6: Southern joint, Whyalla end

While the Whyalla end of the southern rail joint had completely separated during the derailment sequence, the components were recovered and examined. The holes through both fractured fishplates and the rail web showed no definitive indication that bolting had been installed through

two of the three bolt holes, suggesting that the assembly had also been secured by a single bolt through this end of the joint. Rubbing marks were evident on the fishplate/rail web contact surfaces, indicative of excessive movement within the joint (Figure 6).

Heavy battering on the Whyalla side of both rail joints indicated that a number of rail wheels traversed the joints while in a spread (failed) condition. Leading up to the broken rail joints there was no evidence of any other track anomaly, such as wide track gauge or broken/fractured rail.
