Derailment of freight train 9054

Pyramid Hill, Victoria | 5 March 2013

ATSB Transport Safety Report
Rail Occurrence Investigation
RO-2013-010
Final – 29 April 2015

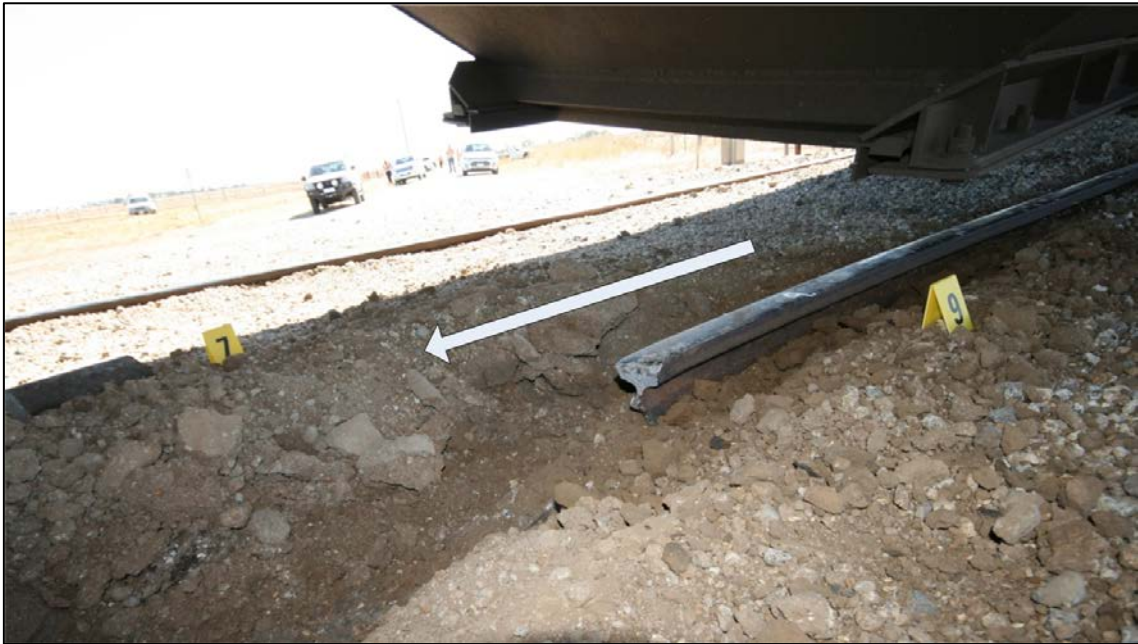
Figure 2: The broken rail within the level crossing

The train derailed at the break in the rail that was about mid-crossing (Figure 2).

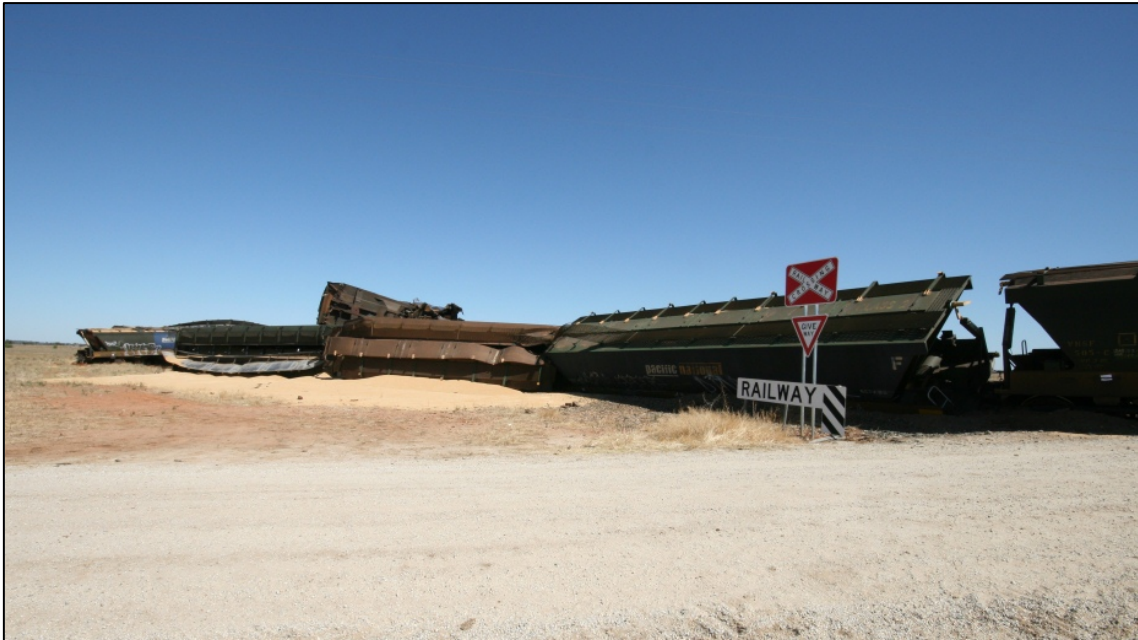
Figure 3: Derailed wagons beyond the level crossing

The locomotives stayed on track, except for the derailment of one wheel set on the second locomotive, and came to a stand after losing brake-pipe pressure. Nineteen of the 20 wagons that passed over the fractured rail derailed. The derailment was severe with wagons toppling, leading to a significant loss of load and damage to about 270 m of track. No one was injured.

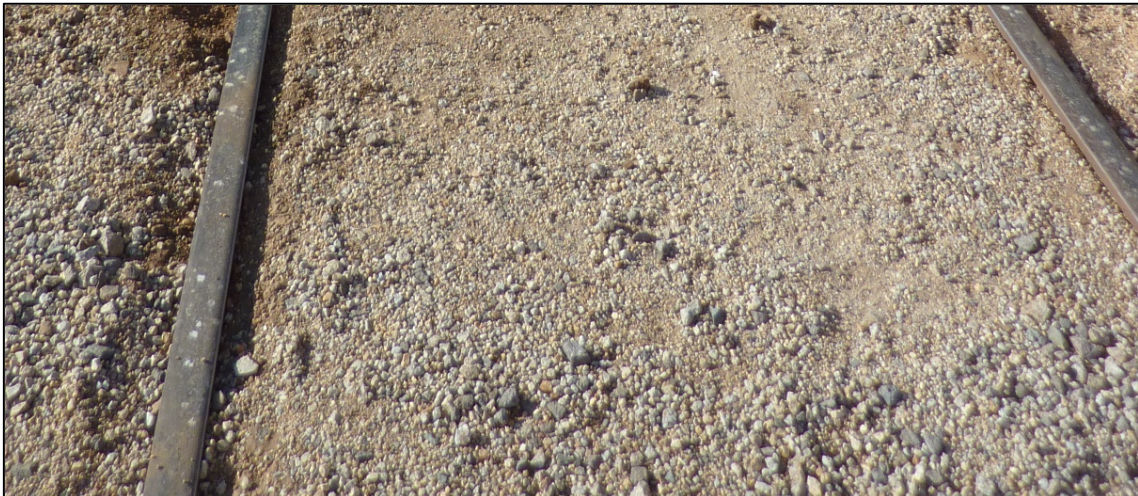
Figure 5: Level crossing surface and buried rail

The O'Tooles Road level crossing is located about six km SSE of the township of Pyramid Hill in northern Victoria and 242.302 rail km from Melbourne. The road is public access and services the local farming community. It was unsealed and comprised of soil, sand and gravel (Figure 5). The top surface of the road materials was found to be dry and that around the rail web and foot, moist. Post incident testing of the soil did not identify any unusual corrosive components.

The track through the crossing was classified as Class 3⁵ and comprised 94 lb/yd (47 kg/m) rail fastened to timber sleepers using baseplates and dogspikes. The rolling brand of the rail indicated that the section was produced in 1971 to Australian Standard AS E22:1964.

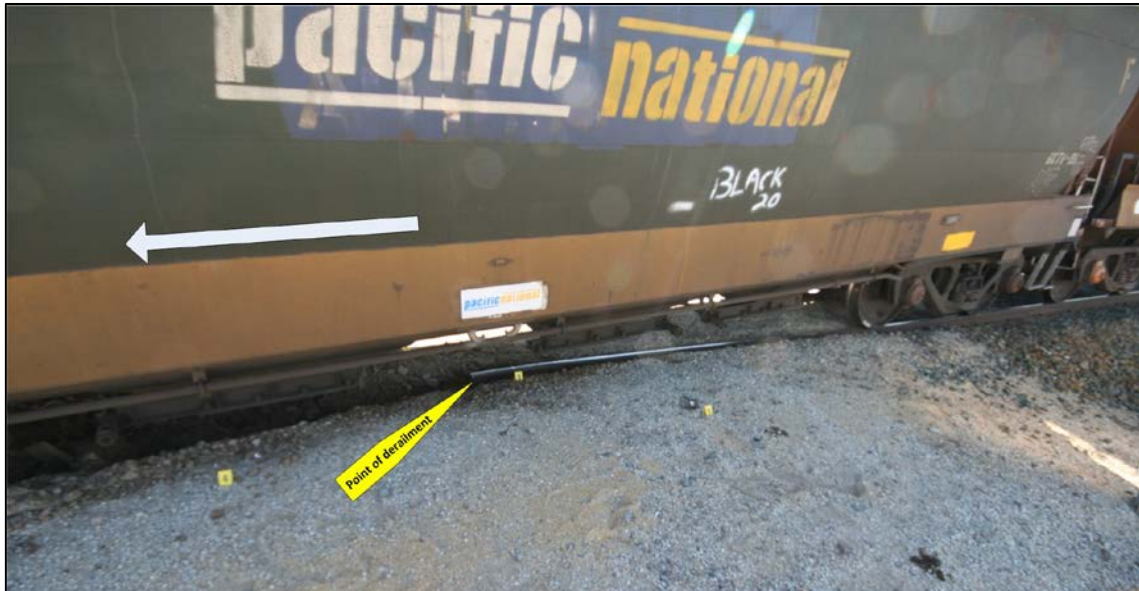
Figure 6: Point of derailment

The point of derailment (PoD) was at the rail fracture mid-crossing (Figure 6). All 20 wagons on the Down (Kerang) side of this point remained on track. Beyond the rail fracture on the Up (Melbourne) side, the track was severely damaged.

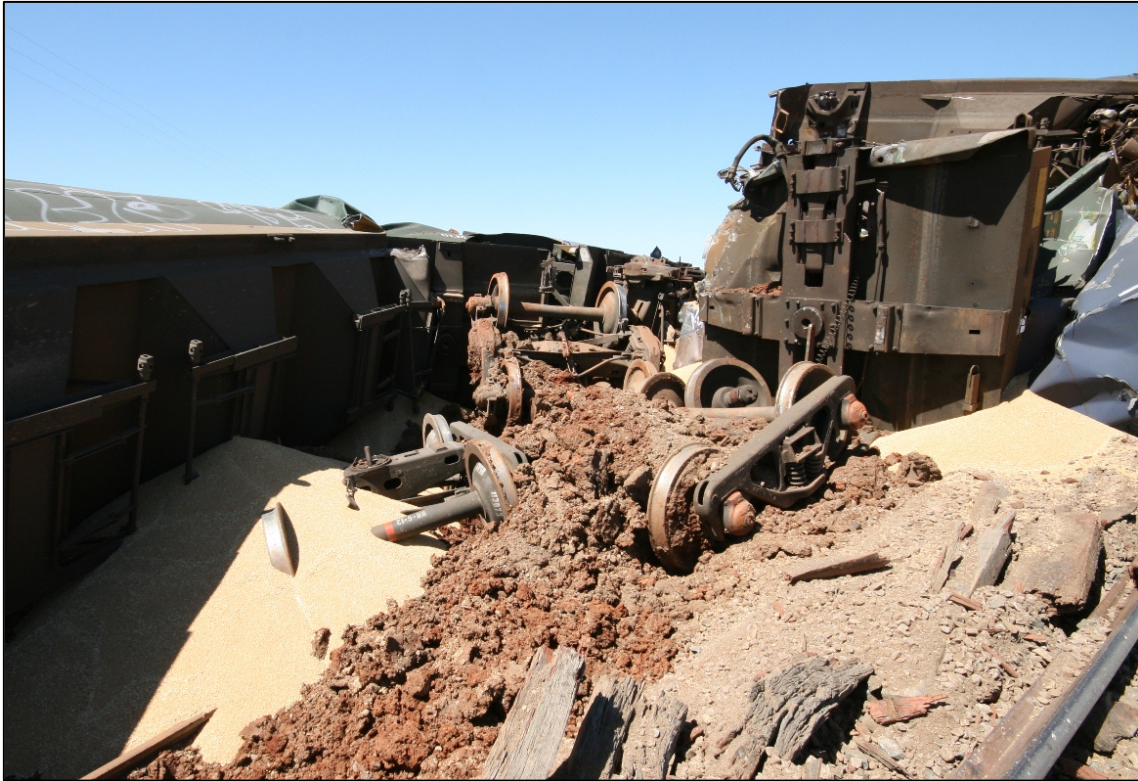
Figure 8: Extensive damage to derailed wagons

Damage to the derailed freight wagons was extensive and there was a significant loss of load (Figure 8).

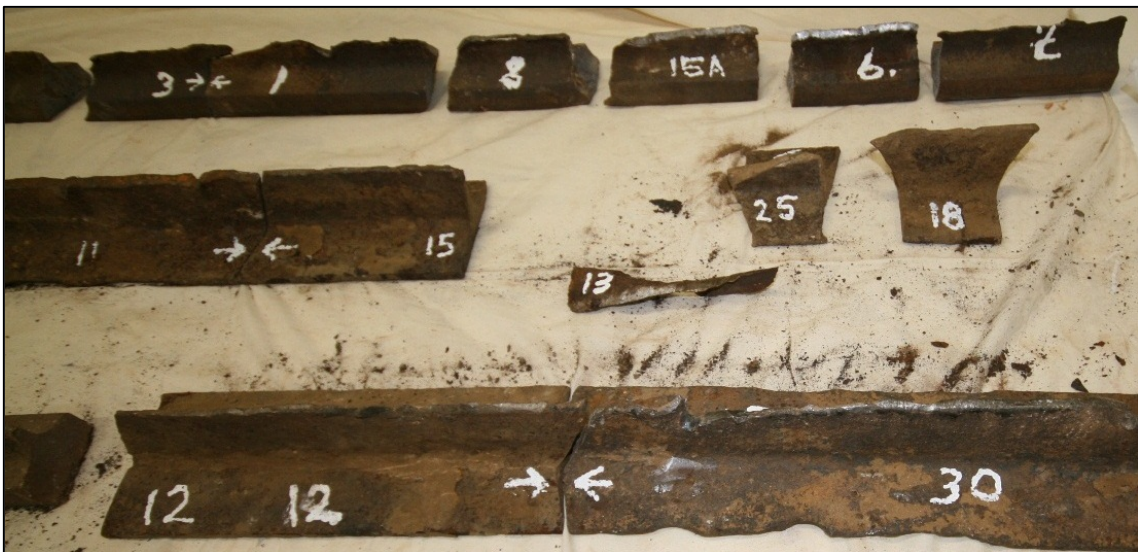
Figure 9: A selection of the fractured rail examined

Twenty three pieces of broken rail and several rail fasteners were examined.

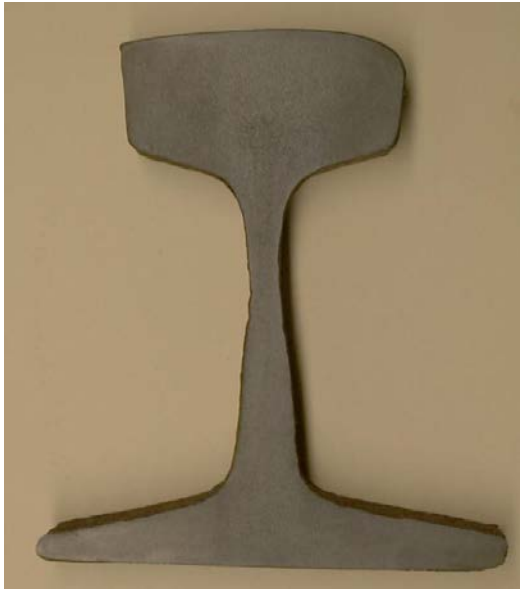
Figure 10: Wasted rail, intact section

The external surfaces of the rail foot and the web had been wasted by corrosion. The thickness of the web in the intact section of rail was reduced to about 6.5 mm. Figure 10 shows the typical wasted cross section including a zone of more severe corrosion in the web below the rail head.

Where the head had separated at the horizontal web fracture, the web thickness was reduced further to 5.5-6 mm.

It was concluded that the corrosion had caused a loss of about 8 mm (4 mm either side) in the thickness of the web from its new condition.

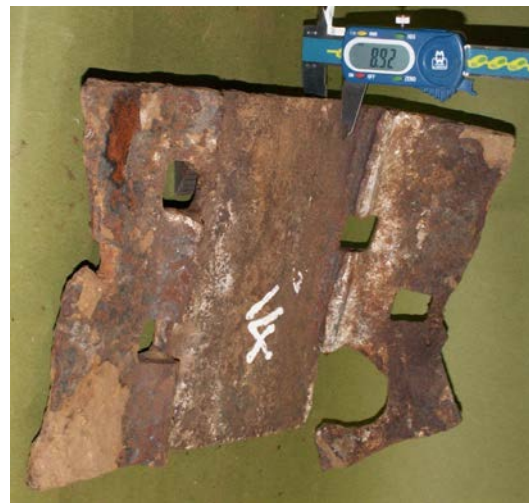
Figure 11: Typical base plate

There was evidence of heavy corrosion of the rail baseplates (Figure 11). Wear also indicated that relative movement of the rail fixtures had been occurring for some time.

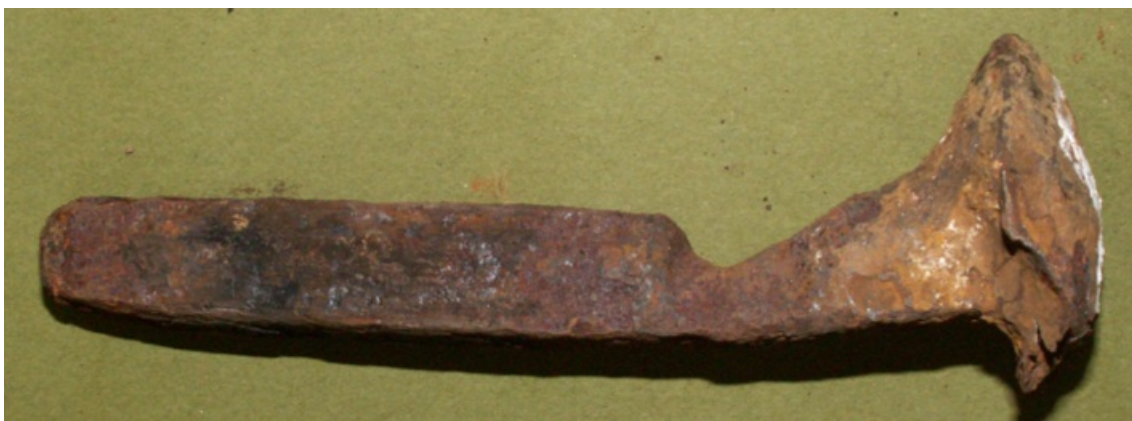
Figure 12: Typical corroded and worn dog spike

Wastage of rails at dog spikes is known to occur where corrosion conditions are favourable. This type of corrosion can be exacerbated by relative movement between rails and dog spikes when spikes are loose or broken.

Dog spikes were likewise heavily corroded and worn (Figure 12).

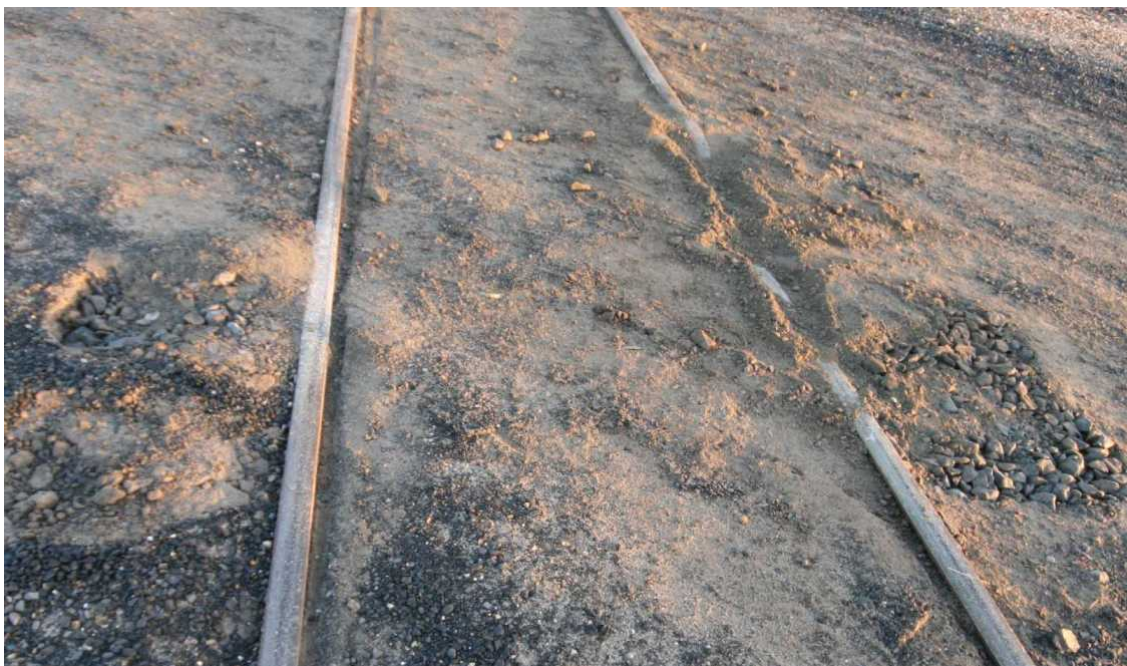
Figure 13: Mellis Road level crossing, Warracknabeal

A freight train derailed in similar circumstances about two years prior on the Murtoa to Hopetoun freight line at the Mellis Road level crossing near Warracknabeal, about 160 km west of the Pyramid Hill. The crossing formation was similar to the O'Tooles Road site, with web and rail foot covered with road material (Figure 13).

The investigation⁷ concluded that the rail was heavily corroded and the web wasted, leading to a loss of load bearing capacity. A horizontal web fracture about 1400 mm in length had developed leading to head separation and the collapse of the rail under load. The previous ultrasonic inspection had identified some ultrasonic indications, however; the indications did not meet the criteria for reporting and a closer (manual) inspection of the site was not undertaken.

Recommendations were made to V/Line to review ultrasonic testing protocols and, noting the reliance on ultrasonic inspection to detect rail defects, to holistically review the condition monitoring of track at level crossings with unsealed roads.

A recommendation was also made to V/Line to review the standard of construction of level crossings at unsealed roads, noting the potential for a corrosive environment and the limitations to the visual inspection of the track, including rails and support structures.

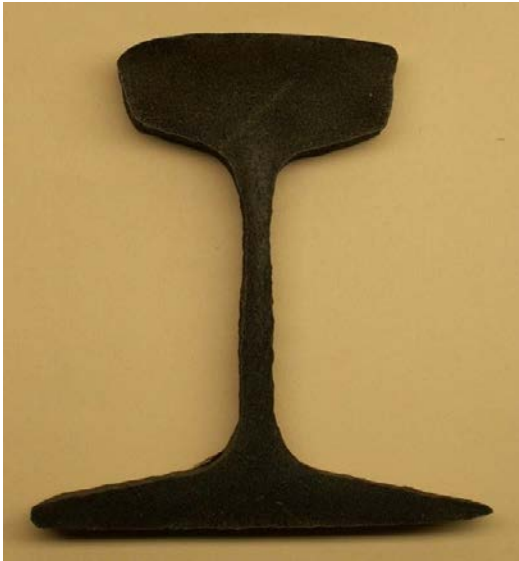
Figure 14: Wasted rail, Warracknabeal

Similar to the degraded rail at the O'Tooles Road crossing, the rail web had been reduced to a thickness of about 5.5 mm and exhibited a band of greater wastage just below the rail head (Figure 14). The head separation had occurred in this zone.

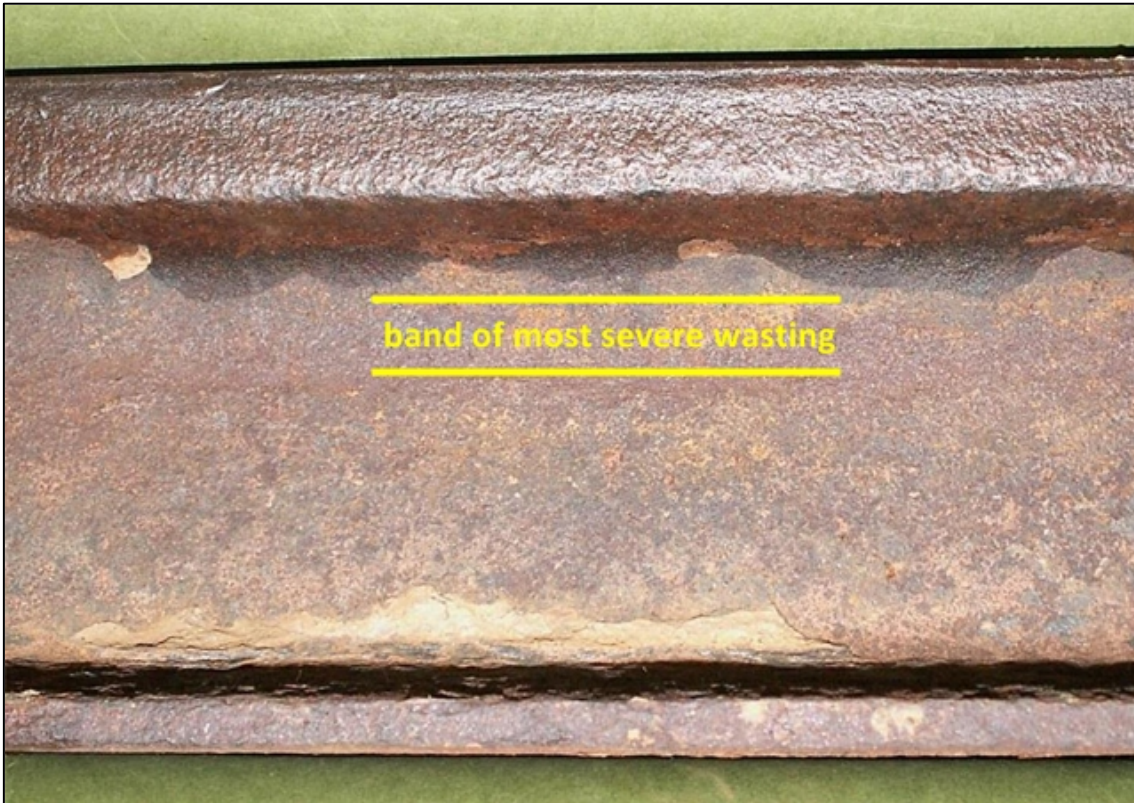
Figure 15: Corrosion band on intact rail

Along the full length of the rail examined, the rail web was most severely wasted in a horizontal band approximately 20 mm wide, commencing about 50 mm below the top surface of the rail head (Figure 15). This suggested the presence of a localised interface between moisture and air that provided the conditions under which the most vigorous corrosion was likely to occur.

The wasting of the rail web by corrosion led to a loss of load bearing capacity in the rail and the corrosion pitting of the rail surface had produced notches which contributed to stress concentration. This subsequently resulted in the development of a horizontal crack within and along the web, head separation and ultimately rail foot and head fractures.

Corrosion rates for unprotected carbon steel in soils are typically considerably higher than in atmospheric environments, and may approach 0.5 mm per annum⁸. At this rate, it would take eight years to produce an eight mm loss of web thickness (four mm each side of the rail web). The rate of corrosion reduces significantly with less favourable conditions with a commensurate increase in the time required to produce this level of corrosion.
