Navigation event involving Embraer E170 VH-ANO

232 km north-west of McArthur River Mine, Northern Territory | 10 January 2013

ATSB Transport Safety Report
Aviation Occurrence Investigation
AO-2013-010
Final – 22 August 2014

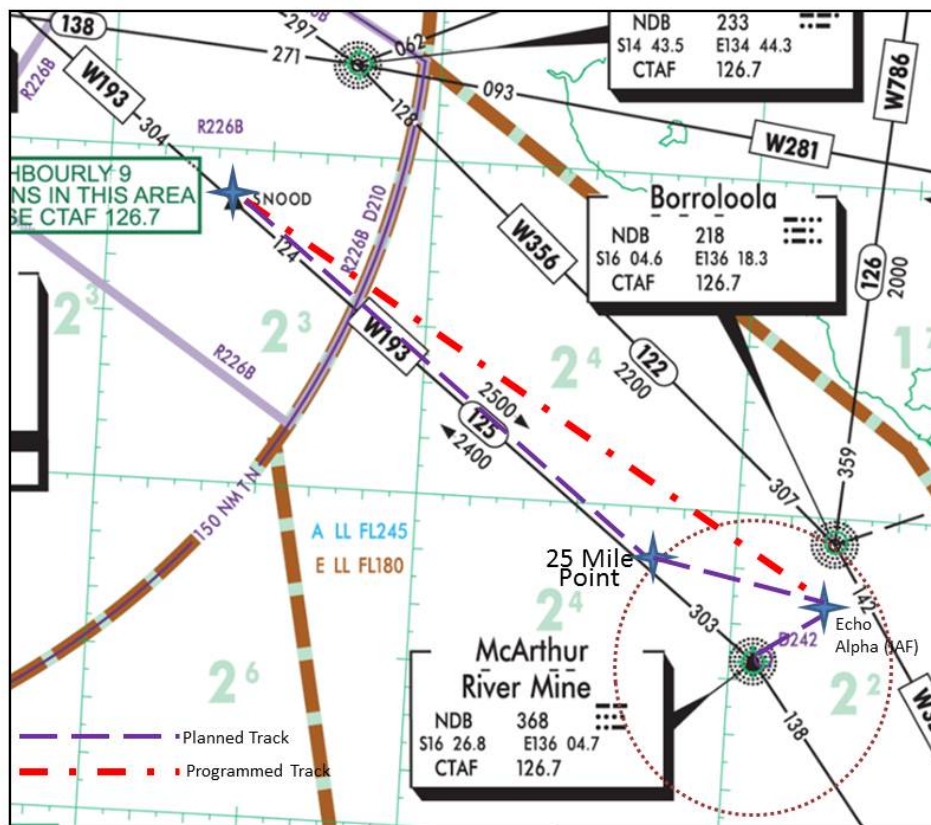
About 125 NM (232 km) north-west of McArthur River Mine, approaching waypoint SNOOD (Figure 1), the captain commenced programming the aircraft's flight management system (FMS) for the descent and landing. The crew's intention was to fly to a crew-initiated waypoint 25 NM (46 km) north-west of McArthur River Mine, then conduct an Area Navigation (RNAV)³ approach to runway 24, commencing the approach at the initial approach fix MHUEA (labelled 'Echo Alpha (IAF)' in Figure 1). The crew reported they were using runway 24 to avoid landing into the sun. The operator's crews used the 25-NM waypoint as part of a standard procedure to help maintain the aircraft above minimum sector altitudes prior to joining the approach, as well as assisting with air traffic management. Figure 1 illustrates the crew's intended and actual tracks. Figure 2 shows an excerpt from the instrument approach chart.

Figure 1: Intended (purple) and flown (red) tracks into McArthur River Mine (tracks are not to scale)

At 0737, the aircraft passed overhead SNOOD. From this point, the autopilot flew the aircraft direct to waypoint MHUEA. This resulted in a track that gradually diverged left of the intended track (Figure 1).

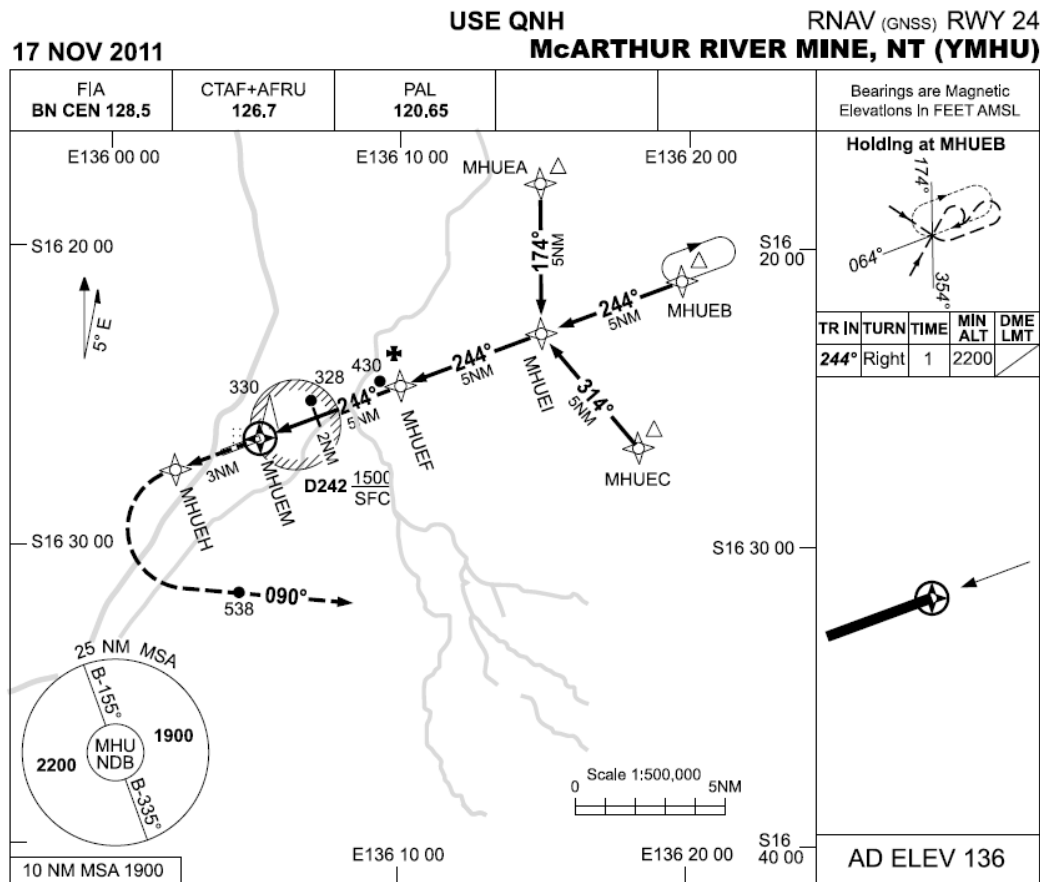
Figure 2: Excerpt from RNAV approach for runway 24 (not for navigation)
