Derailment of ore train 4413

Bonnie Vale, Western Australia | 14 May 2014

ATSB Transport Safety Report
Rail Occurrence Investigation
RO-2014-008
Preliminary – 28 August 2014

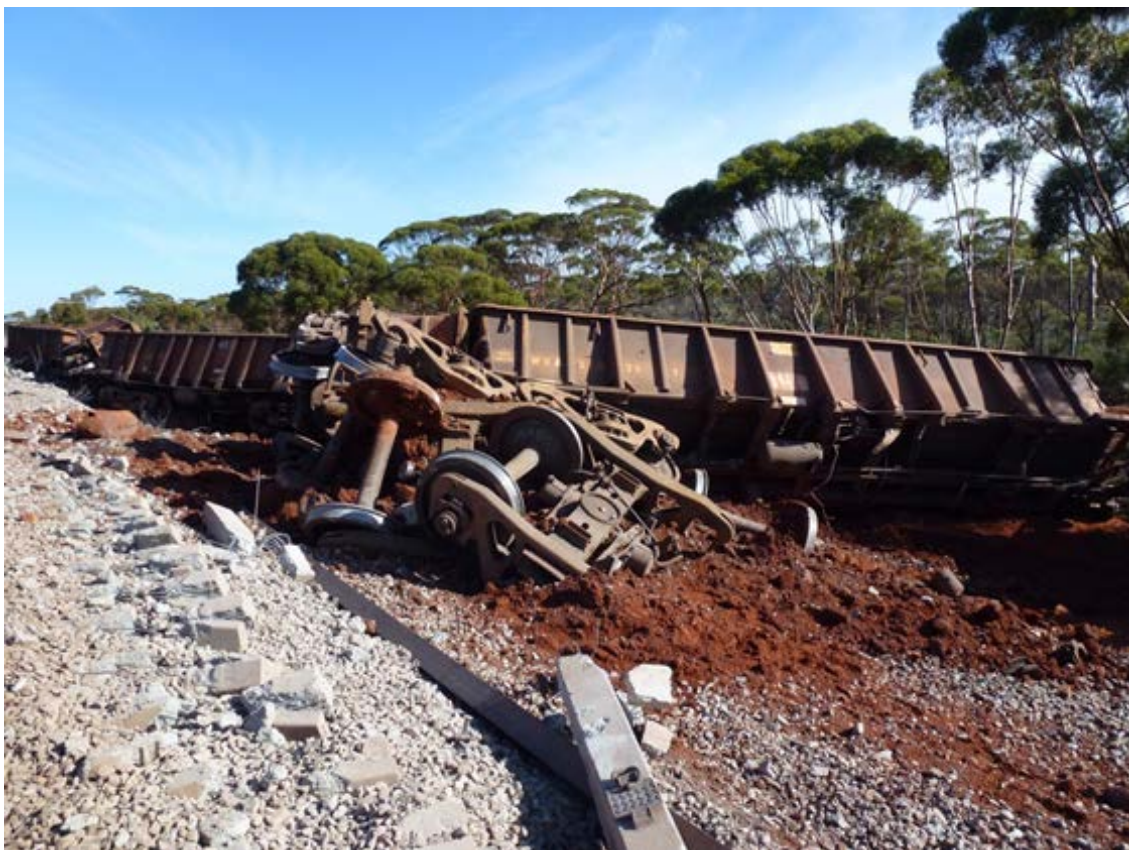
Figure 2: Train 4413 End of Train – Derailed Ore Wagons

The second driver walked towards the rear of the train and progressively reported to the driver the extent of the derailment and associated damage (Figure 2). The driver relayed the information to the train controller.

Examination of the derailed wagons primarily focused on wagon WOE33548K, which was considered as the first wagon to have derailed. It was evident that the leading wheel-set of its lead bogie had derailed to the left (in the direction of travel) and had travelled about 2.5 km past the PoD.

Damage to sleepers was observed only after the point where the wheel(s) subsequently dropped off the rail head. Beyond the drop off point, the wheels and bogies of derailed wagons advancing along the sleepers, progressively damaged the track structure both within the four foot¹⁰ and on the field side of the rail (left side direction of travel). This resulted in the loss of track structural integrity and the subsequent destruction of the track, with rolling stock ploughing into the ballast and resulting in the multi-wagon pile-up (Figure 2 and 3).

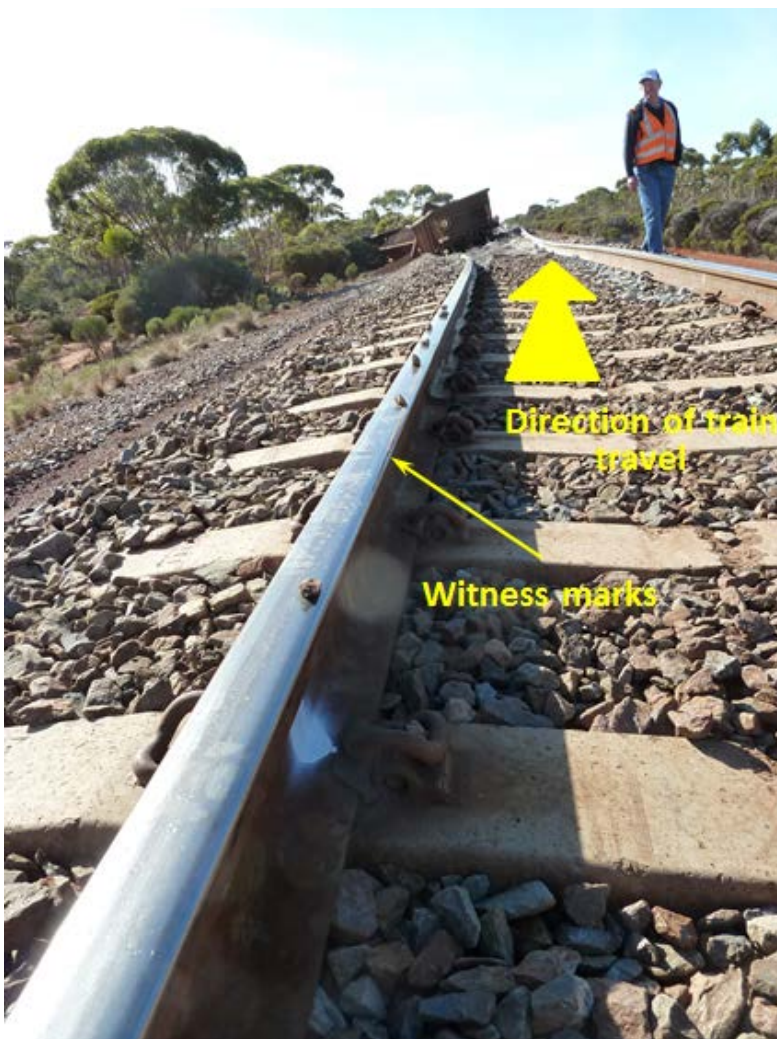
Figure 3: Witness marks caused by a wheel flange at PoD (600.729 km) shown by line of stones on rail head

An examination of the track at the PoD showed evidence of flange climb on the left side running rail (direction of travel) and witness marks over a distance of about 5 m which indicated that the wheel flange crossed over the rail head (Figure 3).

There was no evidence of spread in the section of track leading up to the PoD, so gauge widening was not considered to have been a factor in the derailment. Similarly, there were no signs of any broken/fractured rail immediately at or before the PoD.

Although the track structure leading into/out of the derailment site appeared to be in good condition, there were signs of lateral vehicle oscillations along the length of track leading up to PoD. This was characterised by flange contact wear along the head of the rails at regular intervals. There was also evidence of a vertical twist defect immediately after a culvert at 600.657 km.

The available evidence, as detailed above, indicates that the derailment of ore train 4413 near Bonnie Vale in Western Australia was the result of flange climb.

There was evidence of lateral track vehicle oscillations along the length of track leading up to the PoD and a twist defect immediately after the culvert at 600.657 km. Although the locomotives and ore wagons appeared to be in good condition it is considered that the vehicle oscillations may have been of sufficient magnitude to cause the leading wheel of wagon WOE33548K to unload, mount the rail head at 600.729 km and derail.
