Derailment of freight train 3PS6

Yunta, South Australia | 17 January 2013

ATSB Transport Safety Report
Rail Occurrence Investigation
RO-2013-002
Final –26 May 2015

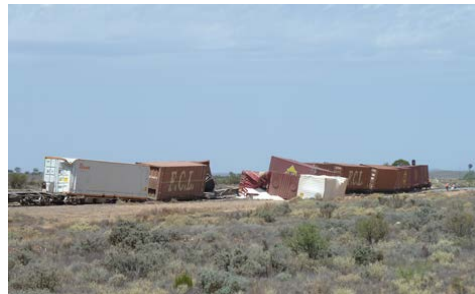
Derailed 3PS6 at Yunta

At about 1453¹ on Thursday 17 January 2013, train 3PS6 derailed on the main line at the north eastern end of the Yunta passing loop, after a track buckle formed under the train. No injuries resulted from the incident; however, a number of wagons were derailed and approximately one and a half kilometres of track was damaged. Two months prior to the derailment new rail had been placed on both legs of the track.

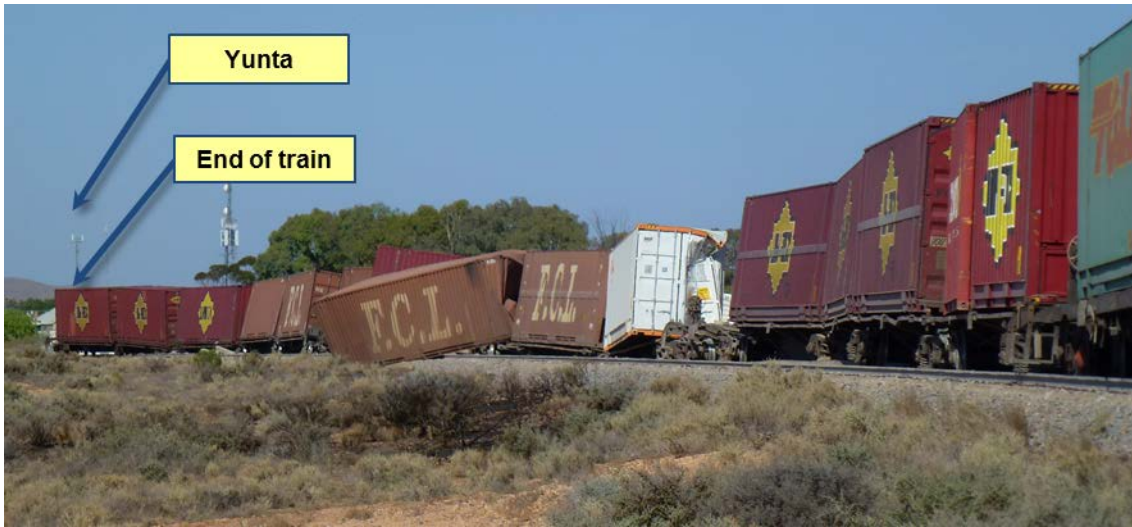
Figure 2: Derailed wagons at the end of train 3PS6

The crew found that the rear 19 wagons of the 52 wagons hauled by train 3PS6 had derailed, with the last 11 of these wagons separated from the front portion of the train by approximately 800 m (Figure 3). The last wagon of the train stopped approximately 30 m past number 14 points and a notable track buckle was evident between the train and the turnout.

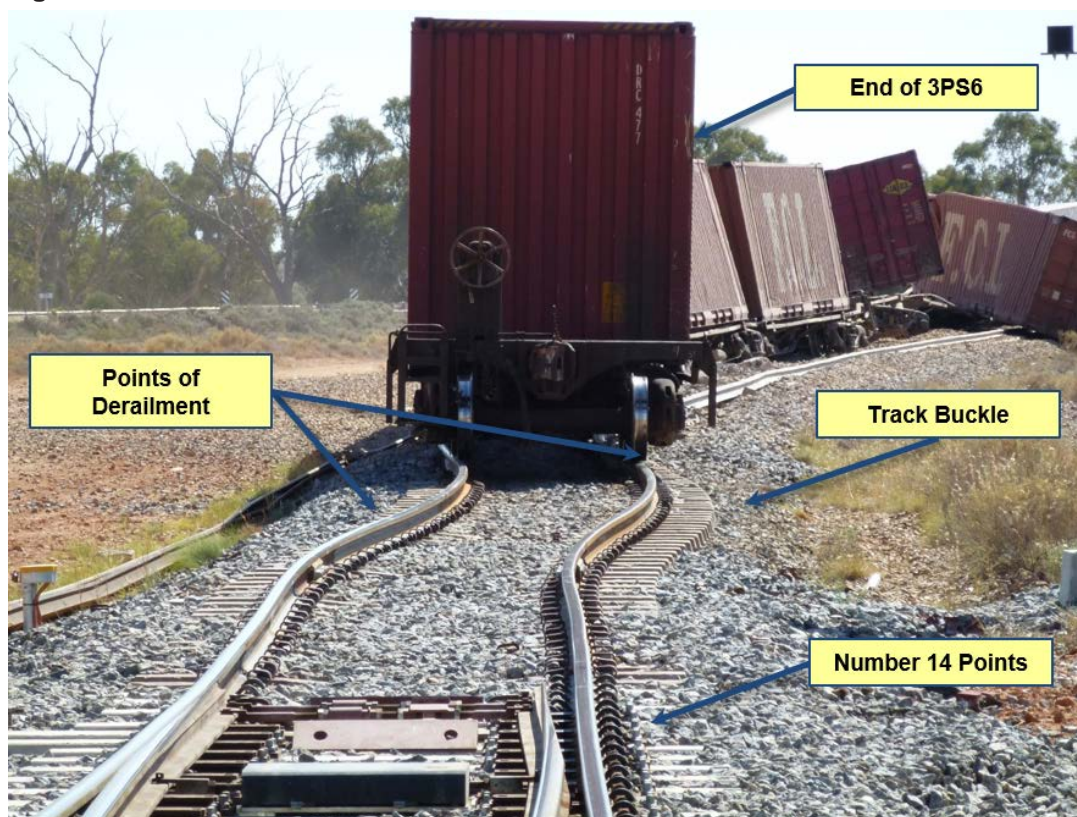
Figure 5: Track Buckle in front of Number 14 Points

An examination of the derailment site found over 1500 m of damaged track. Between number 14 points and the rear of the derailed train, about 10 m of track was displaced to the right⁴ in a crescent shape (Figure 5). The geometry of the displaced track was consistent with the development of a lateral track buckle. No vertical displacement of the track was evident.

Witness marks present on both rails and the sleepers through the track buckle indicated that wheels had derailed to both sides of the track through the buckled area. There was no evidence of

derailed wheels having run-through number 14 points or over the 10 m of track between the turnout and the track buckle.

Based upon the evidence available, the ATSB concluded that the derailment of train 3PS6 had been initiated by this localised track misalignment (buckle) at the 196.577 km mark. The ATSB also concluded that the track had most likely “kicked” or buckled under train 3PS6 during its passage, as the drivers did not see or feel anything unusual when the locomotives passed over that section of track, and the derailment had initiated part-way along the train length.

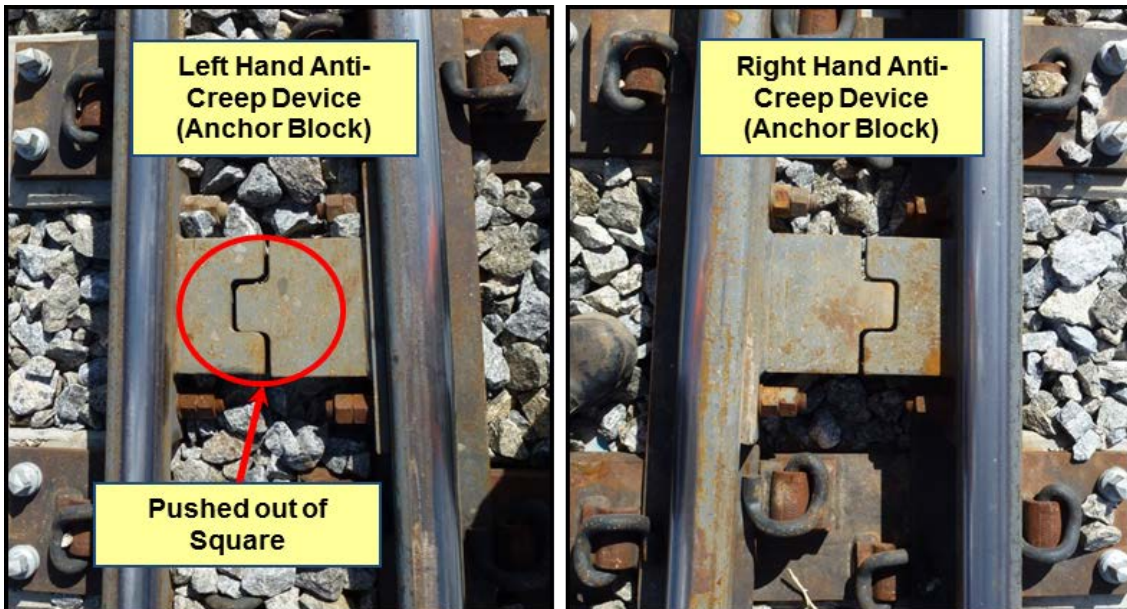
Figure 6: Left and right hand⁹ anti-creep devices Number 14 Points

In this case, the derailment site was adjacent number 14 points, which is a fixed point in the track. Examination of number 14 points found that the switch area had been pushed out of square, with the blocks in the left switch anti-creep devices pushed hard up against each other (Figure 6). This suggested that the rail adjacent to the turnout was probably under excessive stress.

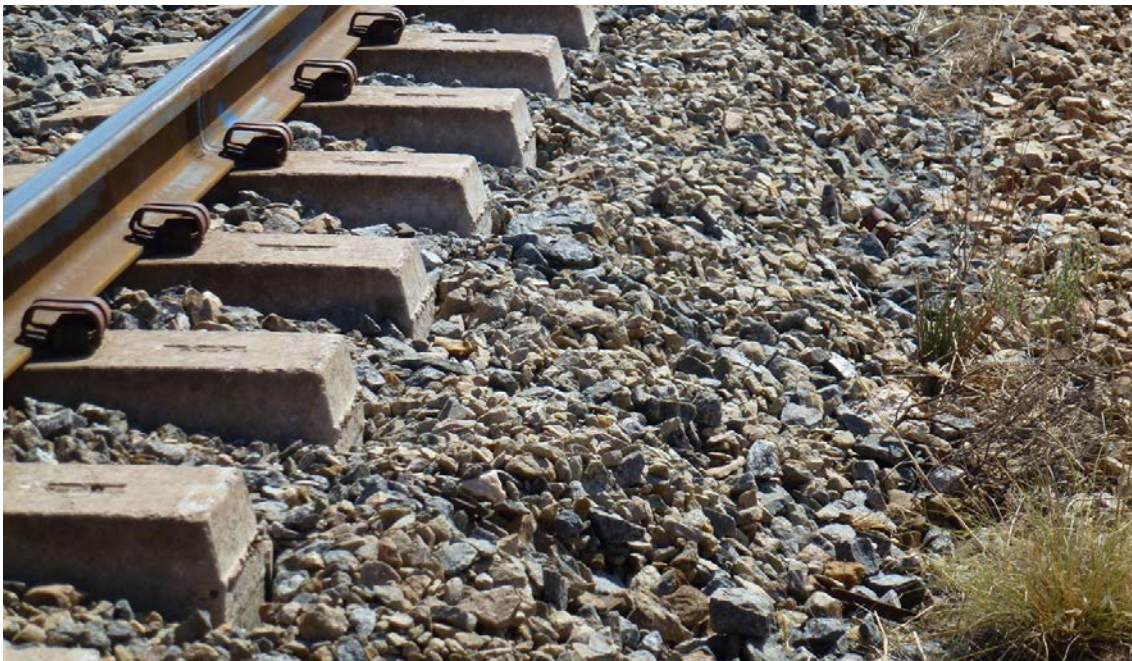
Figure 7: Shoulder ballast and exposed sleeper ends adjacent to the derailment site.

In this case, the track through the derailment site had not experienced any track-disturbing works immediately prior to the derailment, and 300 tonnes of new ballast had been added to the track during the installation of the new turnout (number 14 points). Examination of the inspection reports for the new turnout installation found an entry listed for ‘boxing up and levelling’ the ballast as activities needing to be completed. While fresh ballast was evident on the left hand side¹¹ ballast shoulder, no new ballast was evident on the right hand side of the track. The shoulder ballast on the right hand side had been disturbed by the displacement of the track during the derailment, but the ballast profile on this side did not appear as full as that on the left hand side of the track (Figure 7). It is possible that the sleeper ends had been partially exposed prior to the passage of train 3PS6, reducing lateral track stability and creating an increased risk of track displacement.

Works records showed that up to 300 tonnes of new ballast was delivered to site for the replacement of number 14 points. Fresh ballast was evident on the left hand shoulder of the track where the track buckle occurred, but not on the right. The track deflected to the right under train 3PS6.

Evidence suggests that the right hand ballast shoulder lacked depth and width, resulting in the sleeper ends being partially exposed. Normally track buckles will kick to the outside of a curve since a kick to the inside would require greater force to overcome the natural compressive strength of the curve. In this case however, the track buckled right (inside the curve) – probably due to the sound ballast profile on the left hand side and deficient ballast profile on the right.

In areas where ballast profile is reduced, the ARTC CoP requires the application of a temporary speed limit to reduce the possibility that operational loading compromises the track alignment due to track instability. In instances where a half depth / half width ballast profile exists (as may have been the case at Yunta), the CoP requires that a temporary speed limit to be applied, or the ballast profile to be repaired prior to the passage of the next train. Reducing the train speed reduces the forces the train exerts upon the track and reduces the consequences of a derailment. The ATSB investigation was unable to locate any records of a speed restriction being applied through the Yunta area.

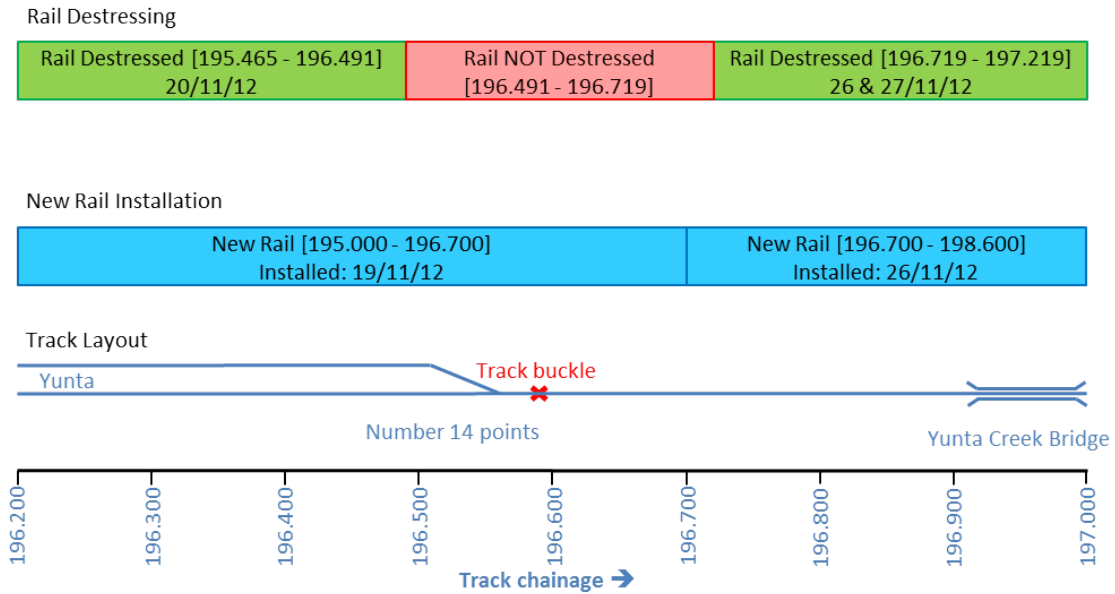
Figure 9: Track layout, rail installation and destressing diagram

An examination of project documentation indicated that number 14 points were renewed in early October 2012, with 220 m of existing rail adjacent to the points being destressed a month later. On 19 November 2012, new rail was installed on both legs of the main line for the length of Yunta Yard, and also on the track between the number 14 points and Yunta Creek Bridge. Documentation indicates that the track through the crossing loop was destressed on the following day. Five days later, on 26 November 2012, 1900 m of new rail was installed abutting the rail installed on 19 November extending beyond the Yunta Creek Bridge. The left hand rail between number 14 points and the Yunta Creek bridge was also destressed on 26 November, with the right hand rail destressed the following day. Notably however, the works documentation did not contain any records of destressing operations on the 228 m of rail between 196.491 km and 196.719 km. It was this area where the buckle occurred under train 3PS6 on 17 January 2013. The activities described above are illustrated in Figure 9, with the red section indicating the length of track where no destressing documentation was available.
