Australian Government
Australian Transport Safety Bureau

Aviation Short Investigations Bulletin

Issue 35

ATSB Transport Safety Report
Aviation Short Investigations
AB-2014-146
Final – 15 October 2014

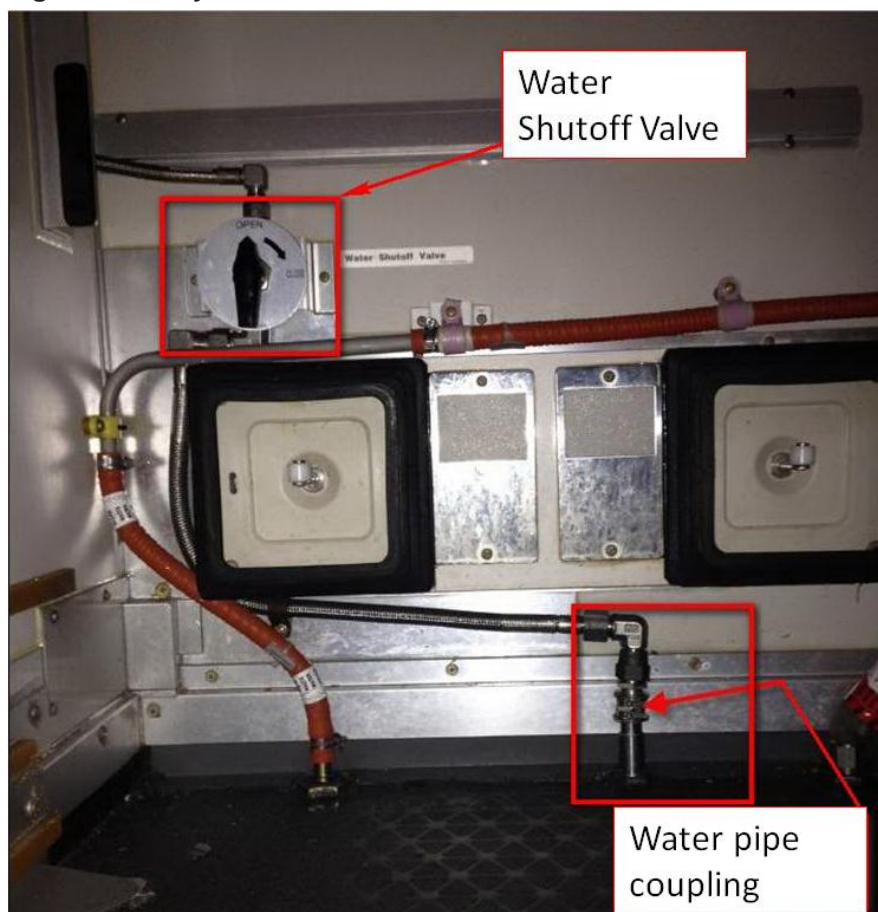
Figure 1: Galley shut off valve and clam shell location

The cabin supervisor then entered that galley and pulled the carts forward to access and switch off the water shut off valve (Figure 1), but that did not stem the flow of water. The cabin attendant contacted the flight crew and alerted them to the situation. The cabin crew used blankets and pillows in an attempt to direct the water down the drain; however the water flow rate was too high and the water continued to flow into the aircraft cabin.

An initial engineering inspection found that the coupling that joins the water pipe at the floor level where the water supply enters the galley was unlatched.

There was evidence that the rope-style mops used by cleaners may have contributed to the coupling coming undone. Fleet-wide inspection of the fittings found strands of cleaning mops tangled in the brackets, with evidence of couplings rotated in opposing directions.

Within 72 hours of the incident, a fleet wide inspection of all Qantas A380 aircraft was carried out and temporary preventative action taken on all similar galley installations. Each clamp was inspected, cleaned and refitted and then tested with the water tanks pressurised. When nil leakage was ensured, the clamp was then protected.

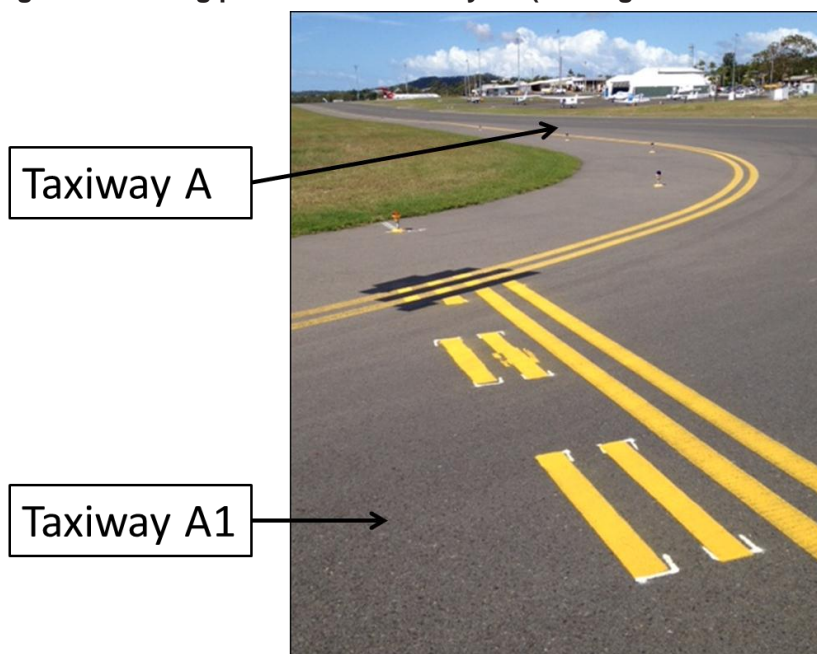
Figure 5: Holding point line on taxiway A1 (looking in a south-easterly direction)

The crew of VH-QOP made a right turn from taxiway A onto taxiway A1 as the ATR-72 was on late final approach, but did not notice the holding point line near the commencement of taxiway A1 (Figure 2). The crew inadvertently continued over the holding point line before coming to a stop on taxiway A1, as the ATR-72 continued its approach and landed.²

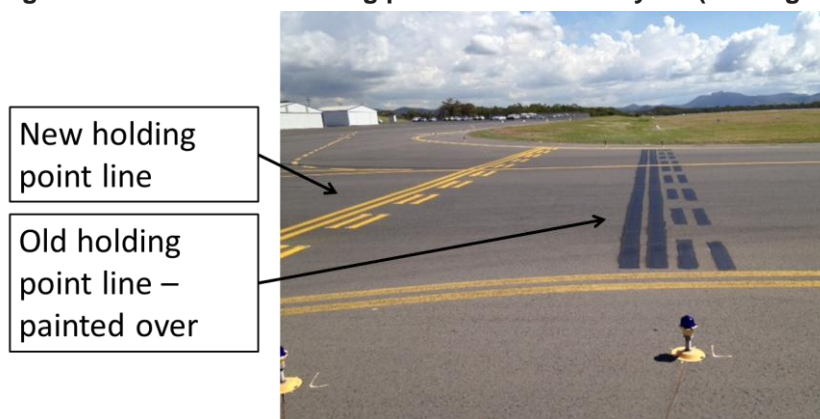
Figure 6: New and old holding point line on taxiway A1 (looking in a westerly direction)

While it does not appear to have been a factor in this incident, it is noteworthy that the holding point on taxiway A1 had been moved back from the runway a small distance about a week prior to this incident (associated with airport infrastructure improvements). A new holding point line was painted, and the old line painted over with dark grey paint.

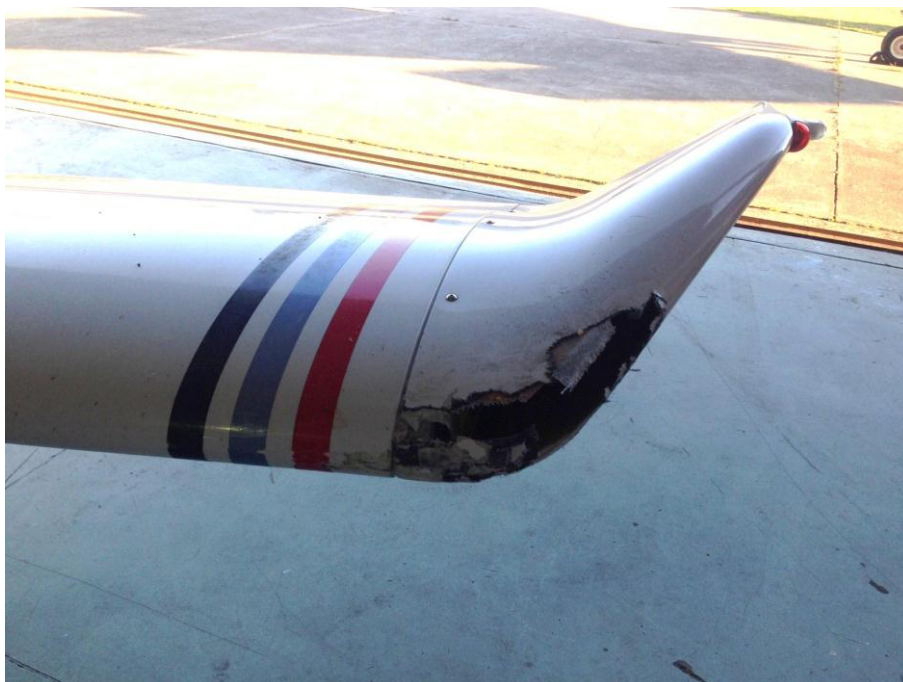
Figure 1: Left wingtip damage

airport officer arrived on the scene, the student was still in the aircraft. Emergency services arrived shortly after. The student was not injured; however, the aircraft was substantially damaged.

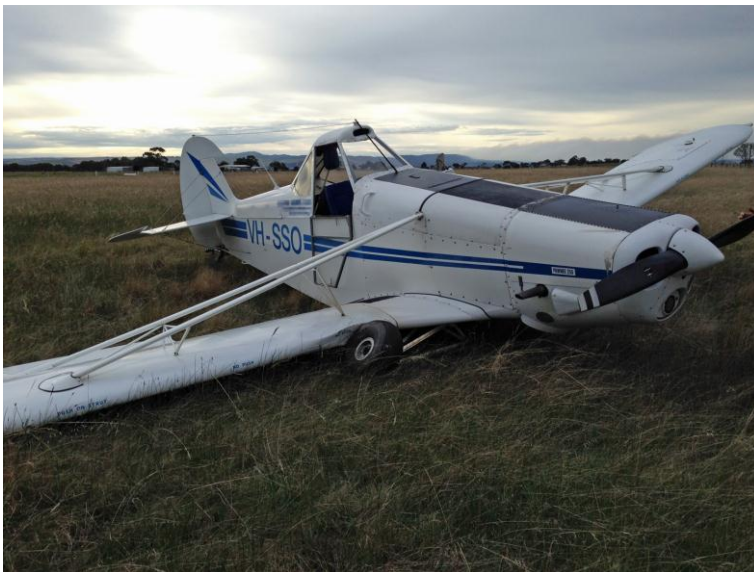
Figure 8: Damage to VH-SSO

As the aircraft impacted the ground, the right main landing gear collapsed and the aircraft slewed to the right, coming to rest facing towards the east-south-east. As the right landing gear collapsed it impacted the right wing, damaging the leading edge (Figure 2). One of the propeller blades was also damaged when it struck the ground during the accident. After the aircraft came to a stop, the pilot turned off the electrical system and exited the aircraft uninjured. Subsequent inspection found that the aircraft fuel supply was exhausted.

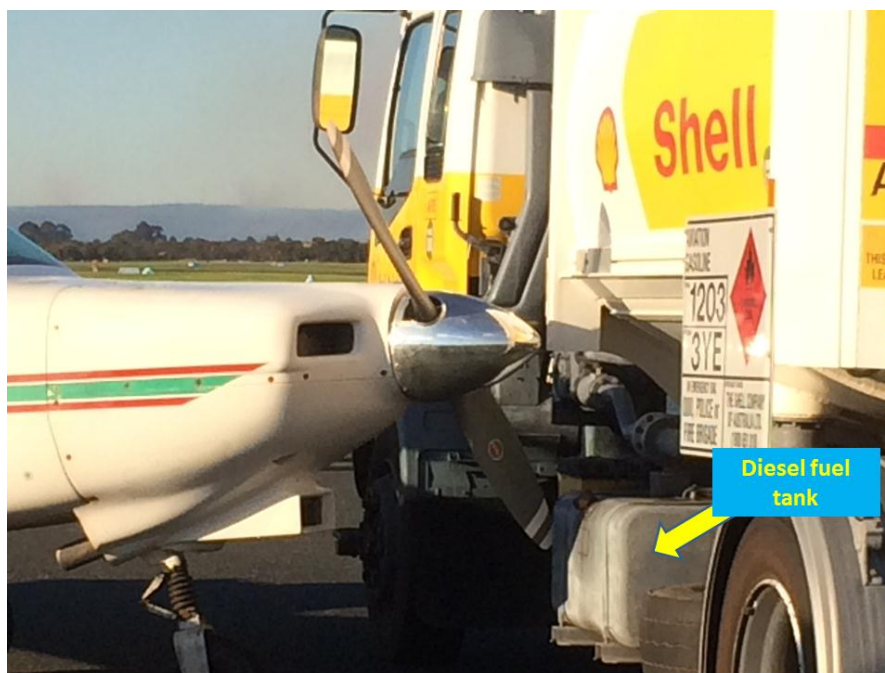
Figure 2: Position where VH-ZYM came to a stop

When he first noted the fuel vehicle, as it was parked close to the left of the taxiway, he felt there was sufficient space for the aircraft to taxi past. He had heard other students calling to him as he turned and started to taxi past the truck, but could not understand what they were saying.

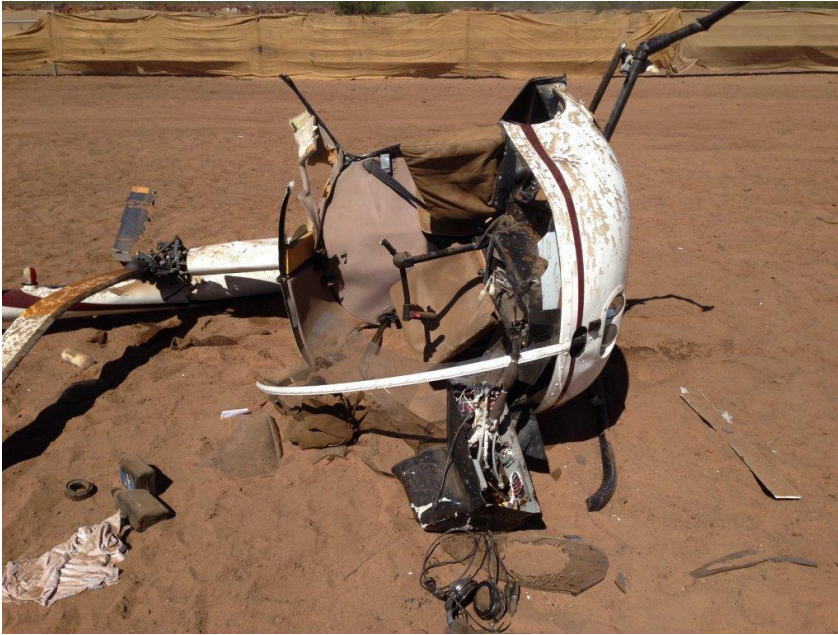
Figure 1: VH-HAY damage

To arrest the yaw, the pilot immediately closed the throttle, resulting in a rapid rate of descent. In an attempt to lessen the rate of descent, the pilot raised the collective. The helicopter struck the ground heavily, and then rolled onto the right side. The pilot sustained serious injuries and the helicopter was substantially damaged (Figure 1).

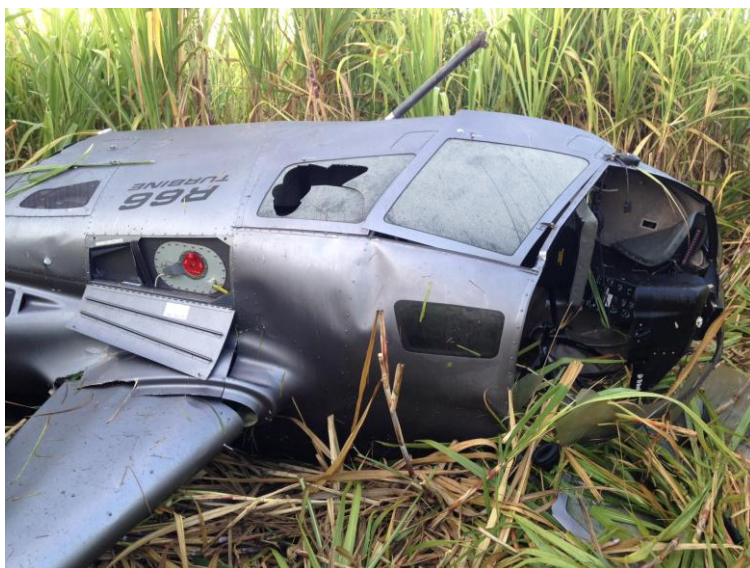
Figure 2: Damage to VH-JRX

The main rotor blade hub struck the powerlines and the helicopter collided with the ground. The helicopter was substantially damaged (Figure 2) and the pilot sustained minor injuries.
