Collision between *Kota Wajar* and the yacht *Blazing Keel*

Moreton Bay, Queensland | 6 July 2014

ATSB Transport Safety Report
Marine Occurrence Investigation
311-MO-2014-006
Final – 30 July 2015

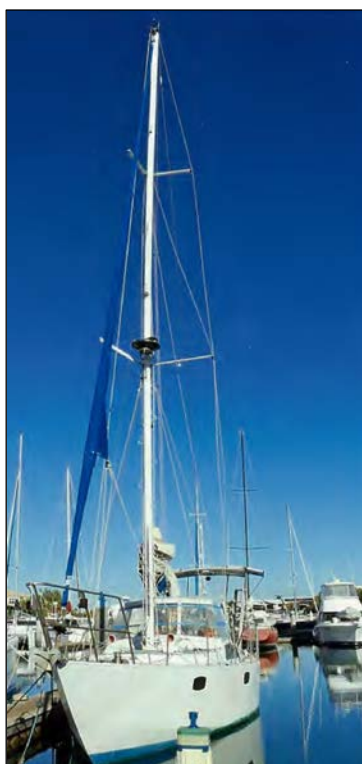
Figure 1: *Blazing Keel*

At 0630, *Blazing Keel's* skipper established radio contact with Redcliffe coastguard and reported the collision. By 0730, the yacht had berthed in Newport Marina and the skipper then completed a thorough inspection of the yacht. There was extensive hull damage on its starboard side, both above and below the waterline, and the ship's red boot-topping paint marks were clearly visible. The handrails, rigging and a number of mast stays and spreaders were damaged.

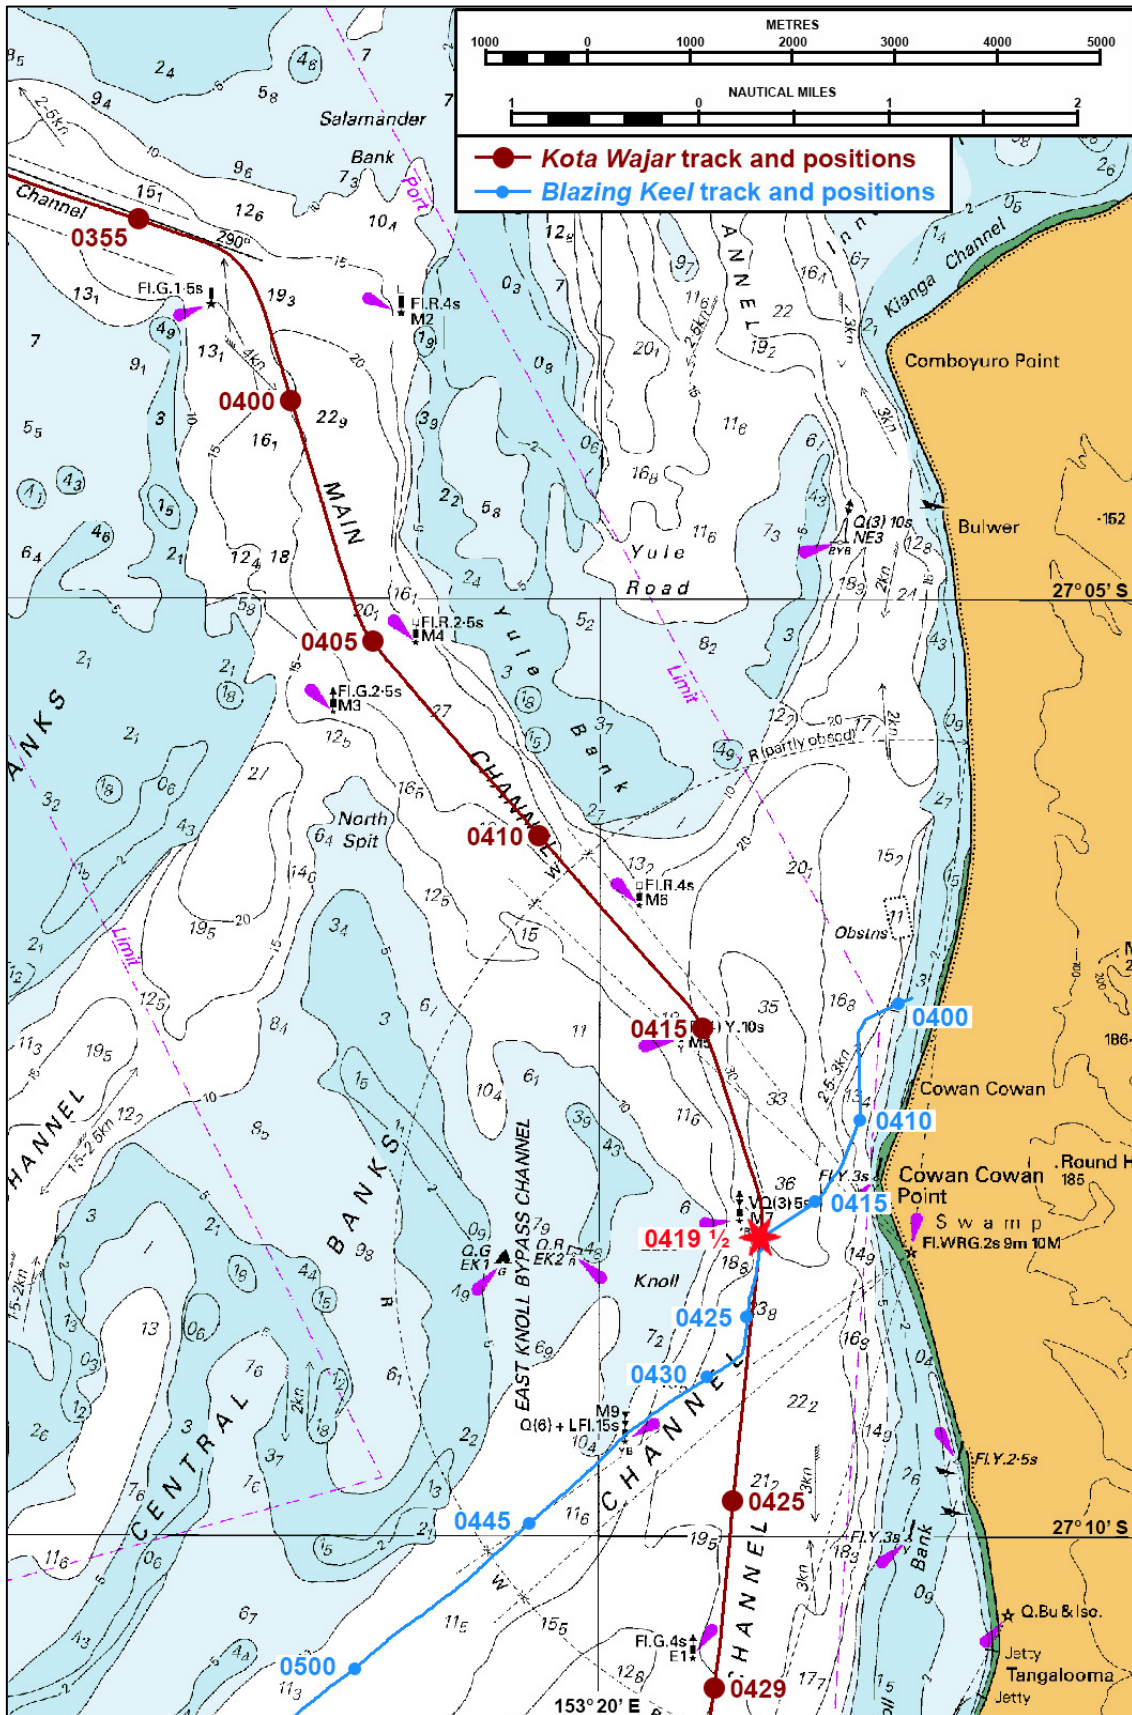
Figure 3: Section of navigational chart Aus 236 showing the tracks of both vessels

By 0410, the distance between *Kota Wajar* and *Blazing Keel* had closed to 2.2 miles. The ship's heading was now 139° with Cowan Cowan Point lighthouse directly ahead, M6 beacon to port and the yacht fine on its port bow. The bridge team remained unaware of the approaching yacht.

At 0413, *Blazing Keel* crossed 1.6 miles ahead of the ship (that is, from the ship's port bow to its starboard bow). The skipper and his wife did not see any ships in the channel and he decided to cross it near M7 beacon. By 0415, the yacht was on a south-westerly course at 4.5 knots.

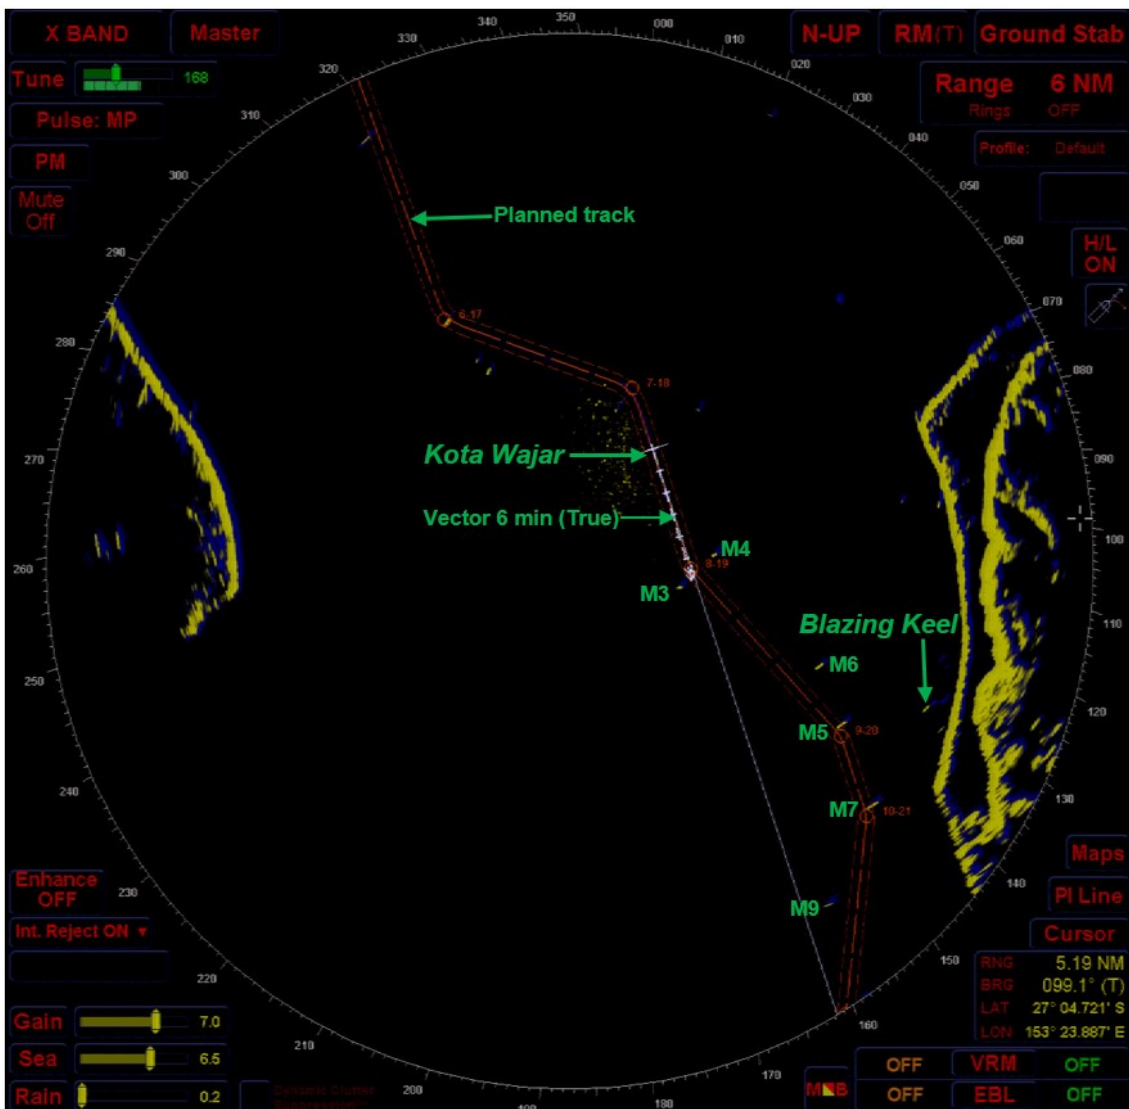
Figure 4: *Kota Wajar's* x-band radar's main display at 0400 on 6 July 2014

The x-band radar's main display was set to its north-up, relative motion mode on a 6 mile range scale (Figure 4). The display was set up to show the planned tracks and track limits (in red). The 'trail' function was set to indicate the true motion of targets over the past 10 minutes (so moving targets left trails on the display). Trails make a target more conspicuous and distinguish it from sea clutter. The electronic bearing line (EBL) and variable range marker (VRM) were not switched on. The cursor had been placed near the edge of the display on a 099° bearing.

Over a 5 minute period around 0400 on 6 July, the second mate handed over the watch to the chief mate. The duty helmsman had changed some time earlier. Between 0357 and 0358, *Kota Wajar's* course was altered from 109° to 162° and its position at 0358 was plotted on the chart. By 0400, about 20 minutes before the collision, *Blazing Keel's* radar echo was consistently appearing on the x-band radar's display, about 30 degrees on the port bow at a range of 4.5 miles. None of the three mates or the pilot saw the yacht's echo or, if they did, paid any attention to it.

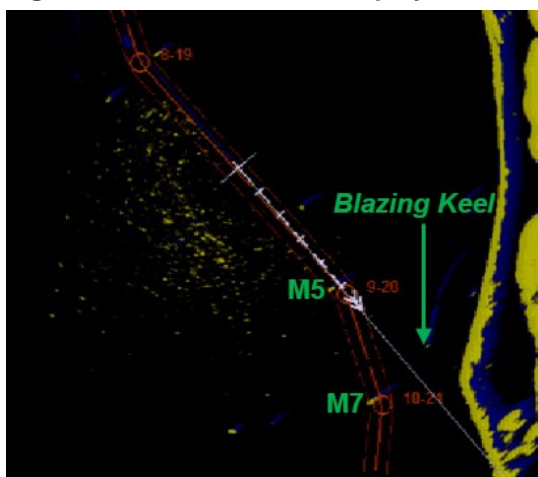
Figure 5: Section of radar display at 0410

By 0410, *Blazing Keel* was fine on the ship's port bow and 2.2 miles away (Figure 5). At 0413, the yacht was right ahead of *Kota Wajar*, crossing to its starboard bow. Shortly before 0415, the pilot began conning the ship to its next course of 162°. As the ship's heading changed to starboard, the yacht was once again on its port bow. At 0415, the yacht was 1.1 miles away, fine on the port bow (Figure 6). Its radar echo and trail remained readily discernible, distinct from sea clutter.
