# Separation issue involving a Cessna 208, VH-LNH, and a Cessna 207, VH-WOX

near Kununurra, Western Australia, 15 May 2015

**ATSB Transport Safety Report**  
Aviation Occurrence Investigation  
AO-2015-050  
Final – 27 August 2015

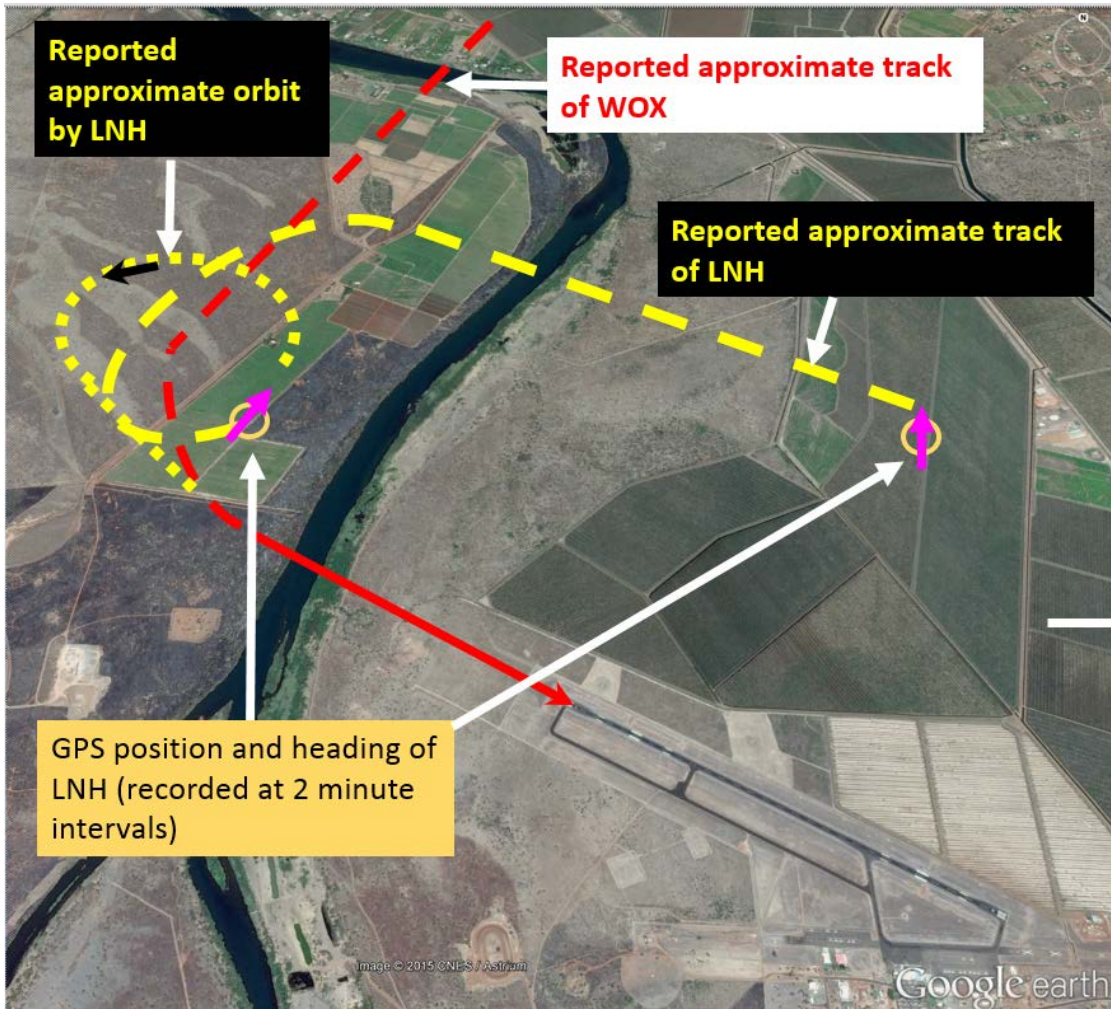
Figure 1: Kununurra aerodrome with the approximate aircraft tracks

At about 0812,<sup>1</sup> when about 5 NM from the airfield on an extended base leg, the pilot of WOX broadcast that they had completed airwork and were tracking to join on base for runway 12 (Figure 1). At the time, the first of the Caravans had landed and the pilot of the second Caravan, then ahead of WOX, had broadcast turning base. About 10 seconds later, LNH broadcast joining midfield crosswind. Eight seconds after the broadcast from LNH, the pilot of WOX reported being about 2 NM from the runway, on base leg. The pilot of WOX then broadcast that they had both the aircraft ahead on final approach, and LNH abeam WOX and turning downwind, in sight.

The pilot of LNH reported conducting an oval-shaped circuit pattern, flying a curved base leg with a constant left turn from the downwind leg to the final leg for runway 12. After commencing the turn, the pilot of LNH reported hearing the broadcast from WOX stating they had LNH in sight. The pilot of LNH did not sight WOX and assumed the pilot would sequence to join the circuit behind LNH.

At about 0813, the pilot of WOX turned onto final for runway 12 and broadcast doing so. The Caravan ahead had landed and cleared the runway. LNH did not broadcast turning base and the pilot of WOX assumed that LNH was then still well behind WOX. When about three quarters of the way through the continuous left turn from downwind and approaching the final leg, the pilot of LNH configured the aircraft for landing and selected full flap. At that time, the pilot of LNH reported hearing WOX broadcast turning final. A few seconds later, the pilot of LNH sighted WOX ahead, to the right, slightly above, and in close proximity to LNH. The pilot of LNH then continued a steeper left turn to increase separation with WOX. As the aircraft turned to the north-east, the pilot of LNH sighted a company aircraft on downwind and at about 0815, broadcast conducting a left orbit. The pilot of LNH also asked the pilot of the following aircraft to conduct an orbit to increase separation between those two aircraft.
